# Commission of Architectural Review SUBMISSION APPLICATION

LOCATION OF WORK: Cedar Street Baptist Church of God

DATE: November 15, 2016

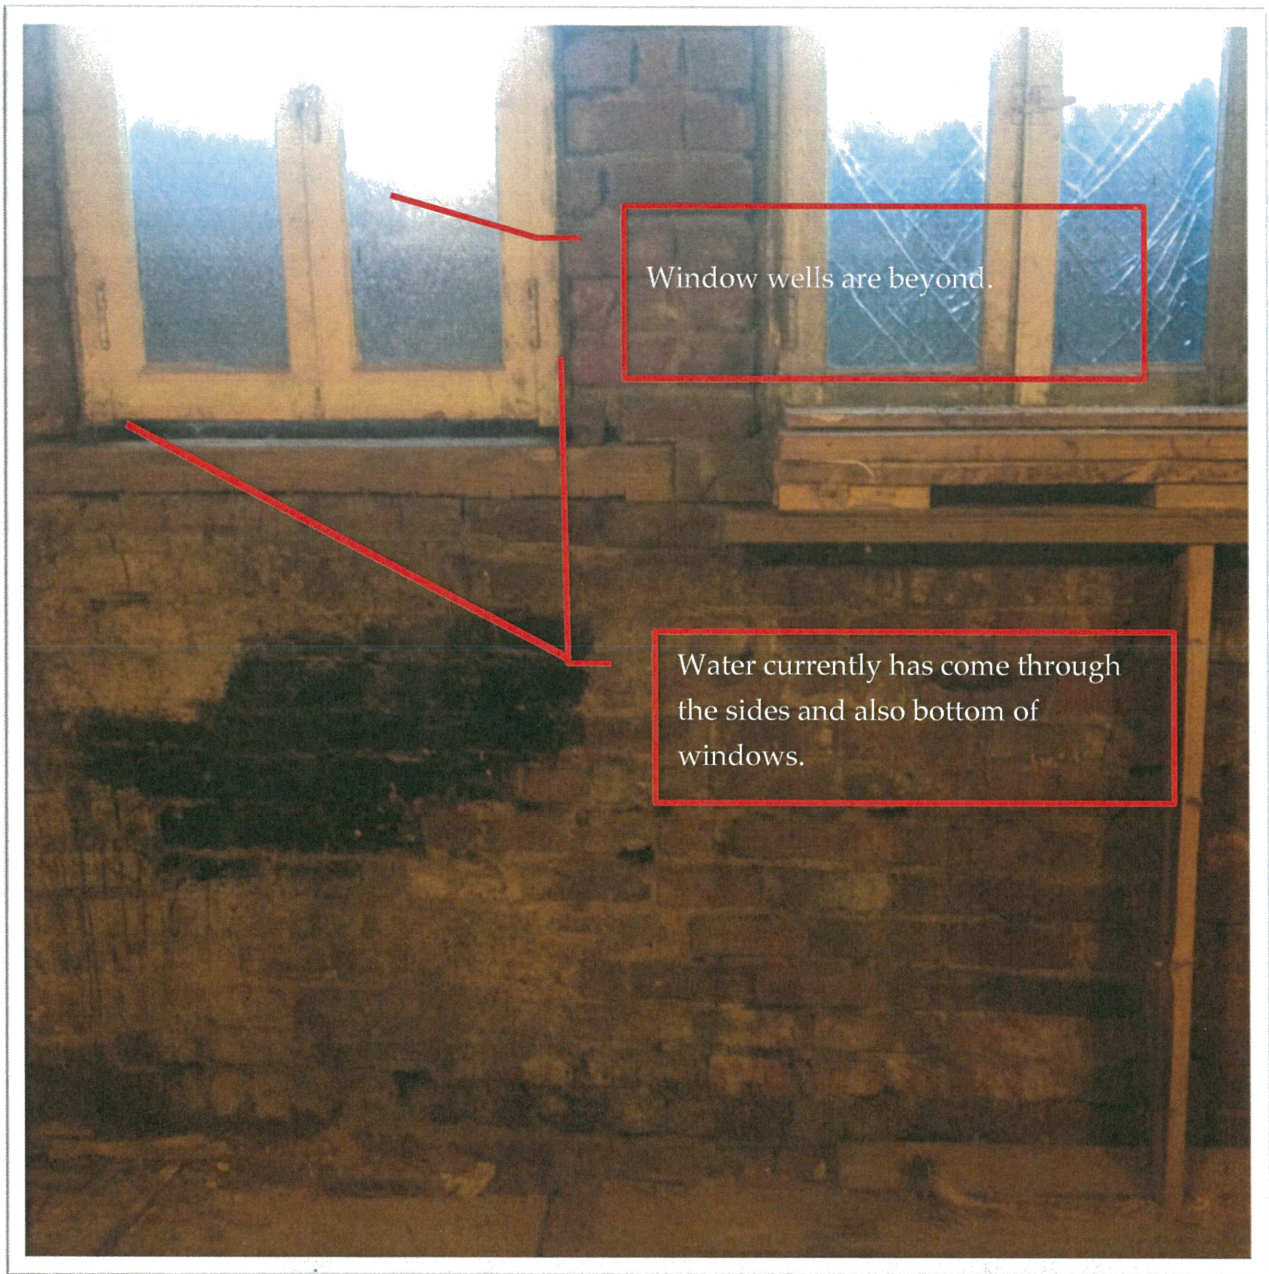
Figure 1.

The attached pictures will show the amount of mold that has to be remediated with the existing amount of water damage that is currently in the basement area. The windows are allowing a large amount of water in the building. Figure 1 shows the existing window and the damage done over the year. The water travels to the corner of the building and standing in the corner. Figure 1A shows the small profile that is visible to the street.

The main concern is Health and Welfare for the church. They want to remove any items that could cause an issue for its members. To ensure this the churches intent is to brick up the existing windows with a 6" indentation to replicate where the window were. The sidewalk is to be brought up to the face of the exterior wall and slope away from the church.
