## Commission of Architectural Review

4. COA-178062-2026	Final Review	Meeting Date: 1/27/2026
Applicant/Petitioner	Phoebe Mix	
Project Description	Rehabilitation/partial demolition of an existing two-story accessory building	
Project Location		
Address: 3110 East Broad		
Historic District: St. John's Church		
<p>High-Level Details:</p> <p>The applicant proposes rehabilitation and exterior alterations to an existing two-story brick outbuilding. The structure is square in plan with a flat roof and parapet, and is accessible from the alley.</p> <p>The scope includes selective demolition of deteriorated brick masonry and parapet elements, replacement of removed masonry with fiber cement siding, installation of a new bracketed porch element, replacement of the roof and parapet, and revisions to window and door openings.</p>		
Staff Recommendation	Approval, with Conditions	
Staff Contact	Yara Iwaz, Yara.Iwaz@RVA.gov, (804)646-6031	
Previous Reviews	<ul style="list-style-type: none"> <li>N/A</li> </ul>

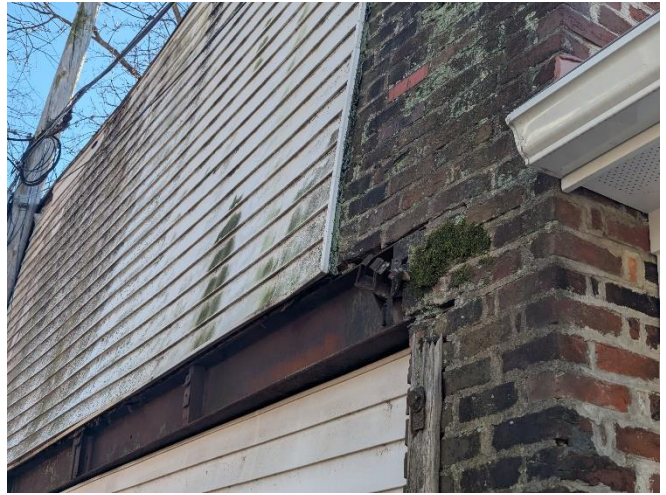
Figure 7: deterioration of the historic brick

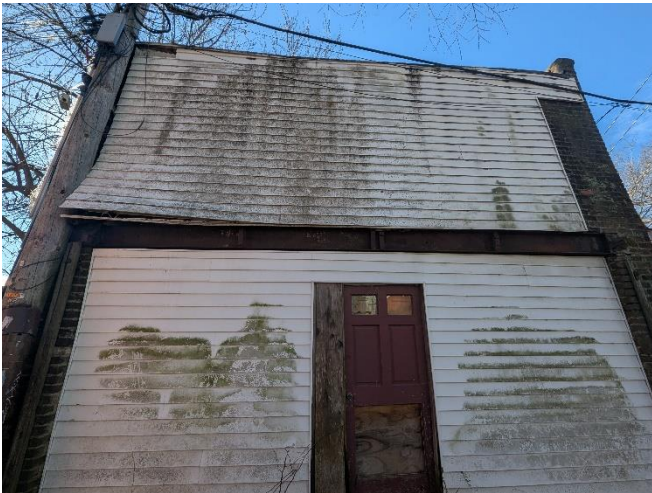
Figure 10: siding appears to have been used to replace deteriorated brick
