Staff Report
City of Richmond, Virginia

Commission of Architectural Review

6. COA-123343-2023	Final Review	Meeting Date: 1/24/2023
Applicant/Petitioner	Dr. Amanda George	
Project Description	Replace deteriorated wooden architectural elements with substitute materials.	
Project Location		
Address: 509 N 29 th Street		
Historic District: Church Hill North		
<p>High-Level Details:</p> <p>The applicant proposes to replace deteriorated architectural elements with substitute materials. The subject dwelling is a vernacular, frame, Italianate building with a full-width covered front porch circa 1880.</p> <p>It appears that the front porch posts and brick piers are not original to the building. The building also has a large rear addition.</p> <p>On the rear, the applicant proposes to remove a drip cap, fascia, window trim, soffit, and a door; replacing with PVC elements.</p> <p>On the front facade, the applicant proposes to remove the upper crown molding, fascia, and soffit; the front porch crown molding, fascia, and soffit, and replace with PVC elements.</p>

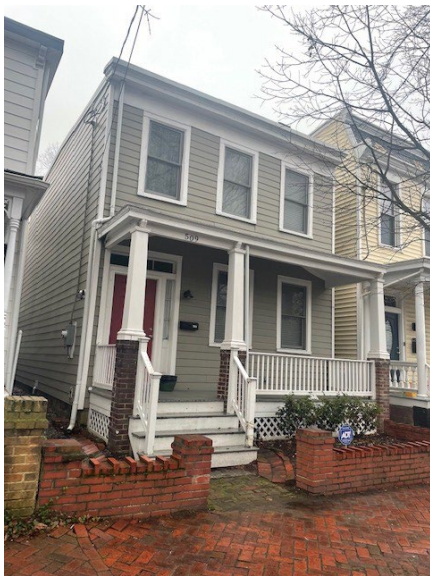
Figure 1. 509 N 29th Street front façade 2023

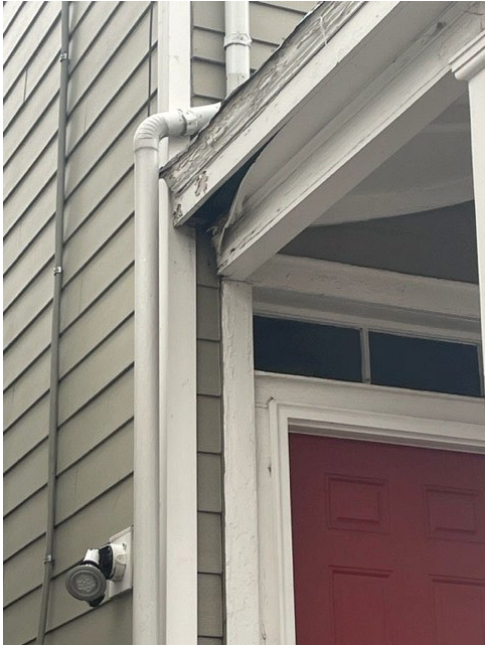
<p>On the front façade, the applicant is proposing to replace the existing upper crown molding, fascia, and soffit and the front porch's crown molding, fascia, and soffit. These elements will be replaced with PVC</p> <p>The applicant also proposes to replace the front door. Staff does not believe that the existing front door is original to the property.</p> <p>The front stairs, hand rails, and post are proposed to be removed and replaced with wooden posts, composite wood treads and PVC risers with concealed fasteners. Railings will be TimberTech's Impression Rail Express Aluminum Railing System in white. City records indicate that the existing stairs and railings are not original to the structure and were constructed in 2007-2008. Staff supports the replacement of the front porch stairs with the listed materials.</p>
<p>Substitute Materials, pg. 60</p>	<p><i>When and where to use substitute materials is a decision to be reached only after careful consideration for the consequences to an historic structure and not before more appropriate preservation options have been explored.</i></p> <p><i>The use of synthetic materials that will alter the appearance, proportion and/ or details of an historic structure is strongly discouraged.</i></p> <p><i>The Guidelines give the Commission guidance, and ultimately the authority, to approve substitute materials, stating that, "substitute materials may be appropriate and economical replacements" in the following circumstances:</i></p> <ol style="list-style-type: none"> <i>1. Unavailability of Historic Materials</i> <i>2. Unavailability of Skilled Craftsman</i> <i>3. Replacement of poor quality materials.</i> 	<p>Staff was unable to locate any documentation that demonstrated the front façade materials listed for replacement (other than the front stairs and railing) are not original to the dwelling.</p> <p>On a site visit, staff observed some deterioration on the front porch entablature likely caused by a leaking downspout, but only in the areas that were connected to the face of the building. Paint was peeling on the crown molding due to what looked like excess moisture.</p> <p>The molding details on the front porch and upper cornice are not elaborate and would be easily replicated; however, Staff doesn't believe the entirety of the front porch and upper cornice molding, fascia, and soffit are deteriorated beyond repair and recommends that other preservation measure be explored prior to allowing for their removal and replacement with a substitute material.</p> <p><u>Staff recommends that the front porch and second-story cornice molding, fascia, and soffit be repaired rather than replaced.</u></p>

Figure 3. 509 N. 29 front porch deteriorated wooden elements.

<p>In addition, staff advises that issues with water drainage from the front downspout be resolved to prevent future deterioration.</p> <p><u>Staff recommends that the new front door design be simple and submitted to staff for review and approval.</u></p>
<p>Building Elements, Porches and Porch Details, #5, pg.49</p>	<p>Porch roofs are encouraged to utilize standing- or flat-lock metal seam roofs that are hand-seamed, or closely approximate handseaming. Seams that, in section, are large, rectangular seams, reminiscent of pre-formed seams utilized on prefabricated industrial or commercial structures, are not acceptable. Membrane roofs are acceptable substitutes for flat-lock seamed metal roofs.</p>	<p>The applicant proposes to replace the existing front porch roof with black EPDM roofing. Black EPDM is an appropriate substitute material for front porch roofs.</p>

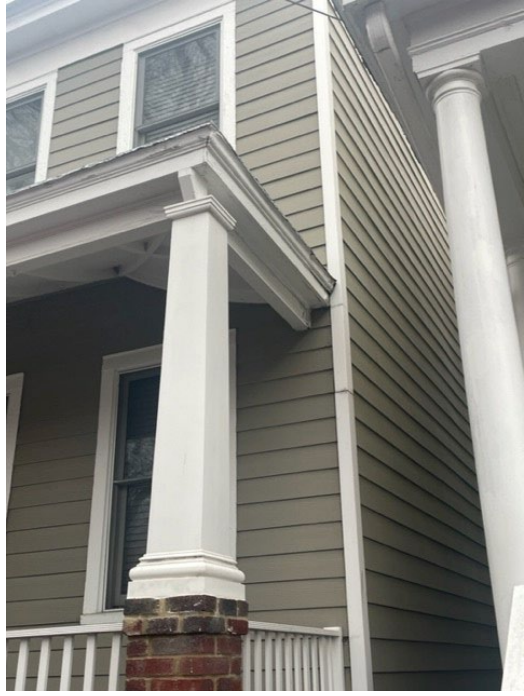
Figure 4. 509 N. 29 front porch wooden elements.
