2. COA-052438-2019

2300 Monument Avenue

Commission of Architectural Review

STAFF REPORT

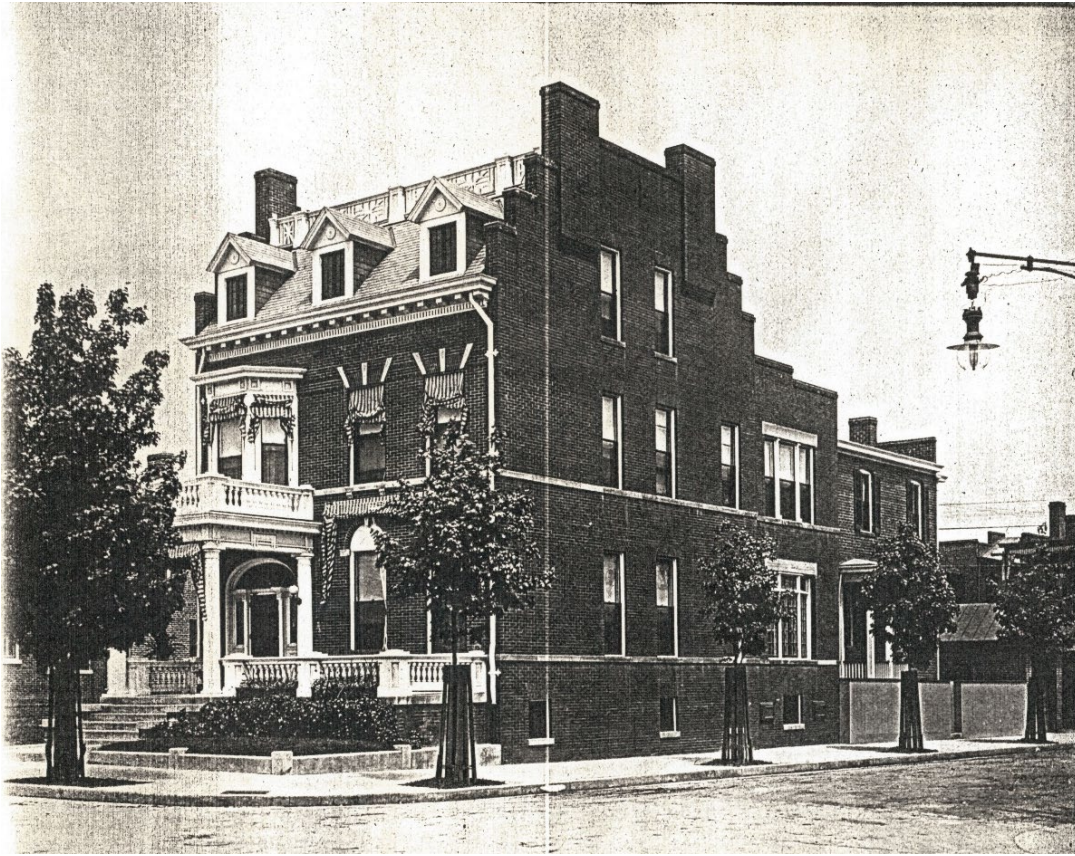
Figure 1. 2300 Monument Avenue ca. 1920

The home historically did not have any copper coping, which tends to be a decorative element indicative of more eclectic styles. Staff has located a photograph of the house dating from the 1920s which shows the brick parapet walls had no coping. In addition, other parapet walls on nearby buildings also do not have any coping. The addition of a significant amount of a new material that was not historically present and that would be highly visible is not consistent with the *Guidelines* and staff recommends denial of the installation of copper on the parapet walls.

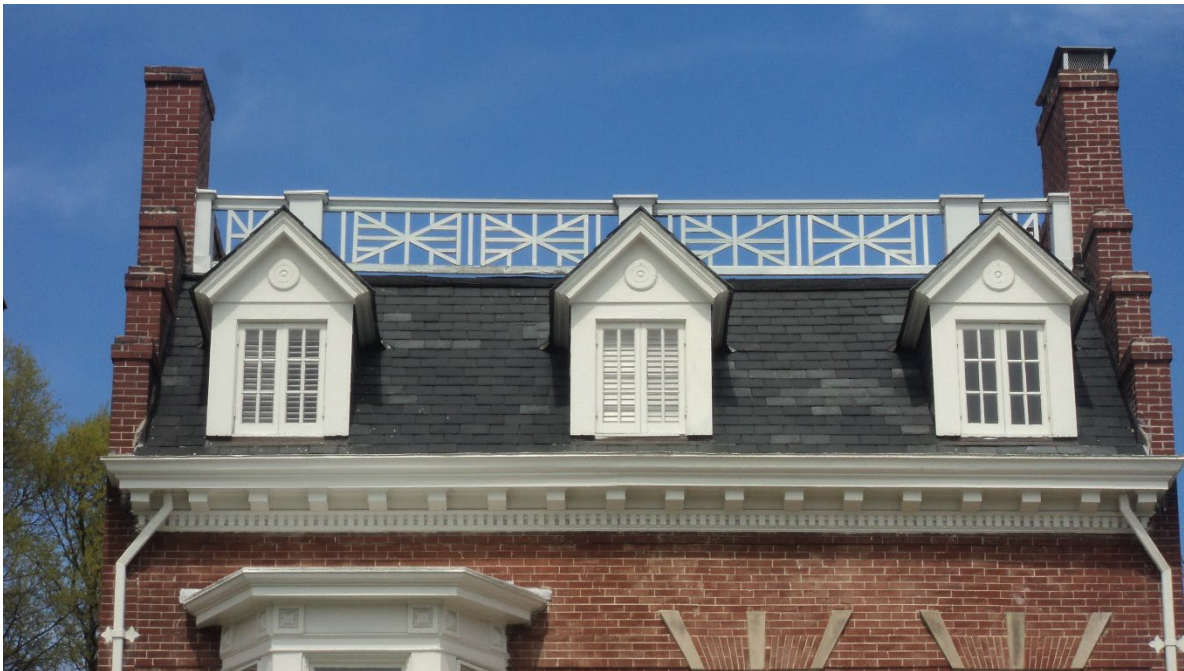
Figure 2. Roof detail

Maintenance and Repair, Masonry pg. 89	<i>1. Loose flashing and leaking roofs, gutters and downspouts can cause extensive damage to masonry walls if left unchecked and unmaintained.</i>	The roofer has indicated that the existing flashing on the parapet walls appears to have been installed during the building's most recent renovation. However, staff believes that the flashing is not

traditional step flashing and may not have been installed properly. Step flashing should be stepped along the roofline and toothed into the brick wall. If the flashing was installed incorrectly, this could be the source of the water issues. If further investigation determines that the existing flashing is inadequate, staff recommends the flashing at the parapet wall be replaced with step flashing that is properly installed.

This repair work may be adequate in preventing further water damage. If further protection measures are necessary, staff recommends the least invasive treatment possible be used, up to and including the installation of a galvanized metal cap on the top of the parapet walls that does not extend down the sides, details to be submitted to staff for administrative review.
