**Staff Report**  
**City of Richmond, Virginia**

**Commission of Architectural Review**

1. COA-101636-2021	<b>Final Review</b> <b>Meeting Date: 11/23/2021</b>
<b>Applicant/Petitioner</b>	Timothy Dickson
<b>Project Description</b>	Replace a tiled front porch with a concrete floor.
<b>Project Location</b>	
<b>Address: 2609 W. Grace St.</b>	
<b>Historic District: West Grace Street</b>	
<b>High-Level Details:</b> <ul style="list-style-type: none"> <li>The applicant requests permission to replace a tiled front porch floor on a Ca. 1910 masonry Colonial Revival residence with a concrete front porch floor</li> <li>The original tiled front porch floor was removed without receiving approval from the Commission of Architectural Review</li> <li>The applicant requests permission to replace the front porch floor with concrete, as the original tile was damaged beyond repair and cannot be easily replicated or obtained</li> </ul>	
<b>Staff Recommendation</b>	<b>Partial Approval</b>
<b>Staff Contact</b>	Alex Dandridge, <a href="mailto:alex.dandridge@richmondgov.com">alex.dandridge@richmondgov.com</a> , (804) 646-6569

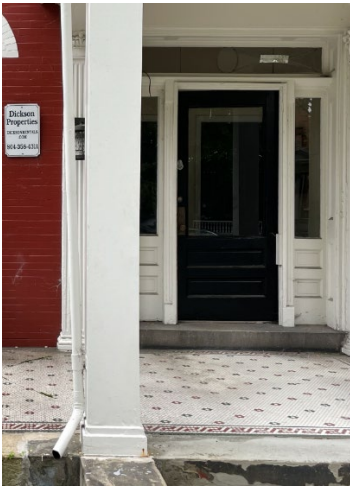
Figure 1. 2609 W. Grace Original Front Porch Floor

<b>Previous Reviews</b>	None.
<b>Conditions for Approval</b>	<ul style="list-style-type: none"> <li>Denial of the use of concrete for the new porch floor.</li> <li>The front porch floor be replaced in-kind, or with a material that conveys the same appearance of the historic front porch floor; material submitted to staff for review and approval.</li> </ul>

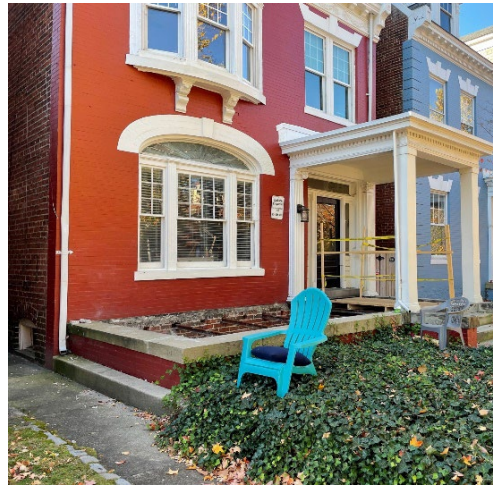
Figure 2. 2609 W. Grace Street Front Porch Floor Removed

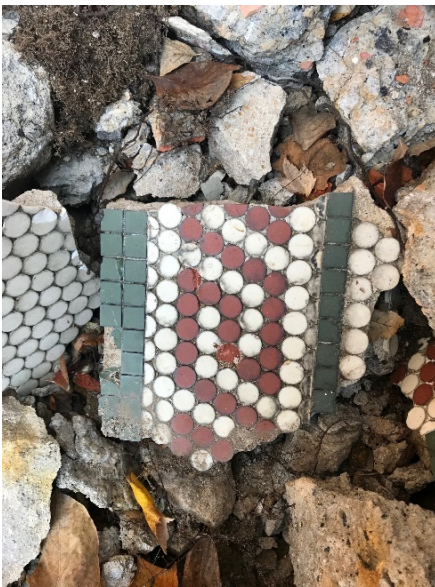
Figure 3. Remnants of Original Tile Removed from Porch Floor

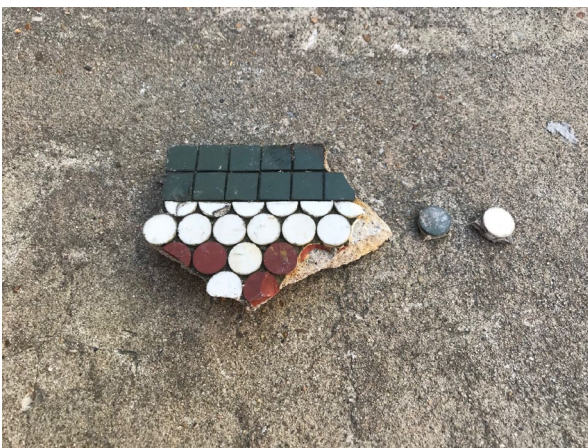
Figure 5. Remnants of Original Tile Removed from Porch Floor

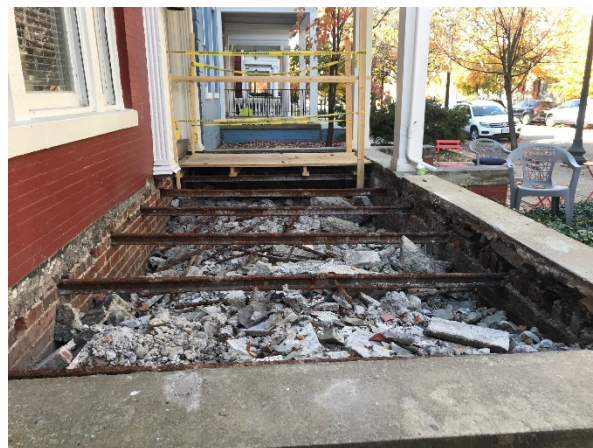
Figure 4. 2609 W. Grace Street Front Porch Floor Removed
