Commission of Architectural Review

7.COA-132790-2023	Final Review	Meeting Date: 7/25/2023
Applicant/Petitioner	JP DiMarco	
Project Description	Remove a deteriorated front porch; reconstruct to match using substitute materials.	
Project Location		
Address: 2210 Jefferson Avenue		
Historic District: Union Hill		
<p>High-Level Details:</p> <p>Applicant proposes to remove deteriorated portions of a semi-original front porch on a detached, frame, heavily altered Italianate dwelling ca. 1895.</p> <p>The porch decking, railings, and square posts are not original to the building; however the porch cornice and roof do appear to be original. The Union Hill National Register Nomination Form describes the building as having a, “one-story, 2-bay porch” that, “has sawn brackets and a circle motif in the frieze.</p> <p>The applicant will replace existing wooden square posts with new pressure treated square posts clad in a PVC wrap. Railings will be replaced with composite wood railings of a similar design, and the decking will be replaced with composite wood decking boards.</p> <p>Existing metal roof will be removed and replaced with a similar design and material.</p>

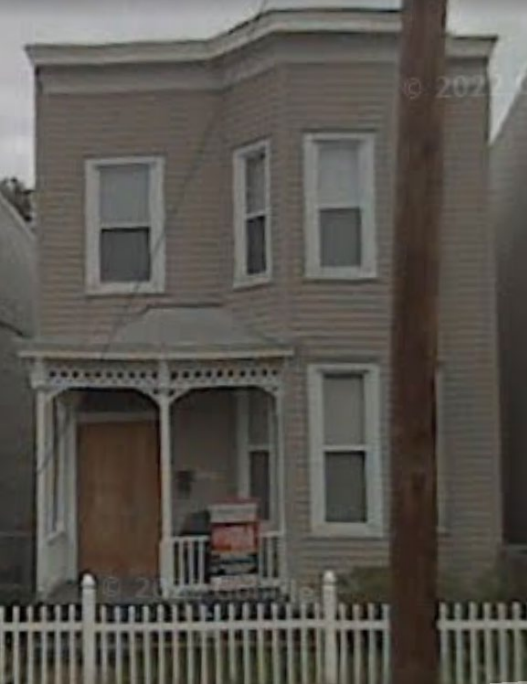
Figure 1. Image of original front porch (2007) with circle motifs in the frieze. Sawn pickets appear to have been removed by this time. *Google street view, accessed 7/12/2023*

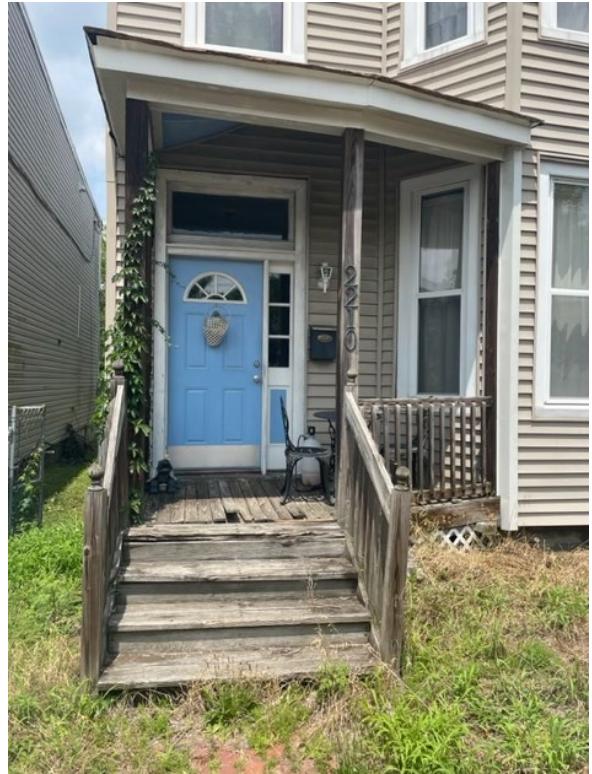
Building Elements, Porch and Entrance Repair, pg. 71	<i>1. Elements that are damaged or loose should be repaired to match the detail of the existing original fabric.</i>	<p>The applicant has expressed that the front porch decking, wooden posts, railings and stairs are deteriorated beyond repair and are in need of replacement. The applicant proposes to demolish these deteriorated elements and reconstruct in-kind; however with substitute materials for some elements.</p> <p>The existing 4x4 wooden posts will be replaced with 6x6 pressure treated wooden posts and wrapped with a paintable PVC material. Staff supports this alteration.</p> <p>Front porch wooden decking will be replaced with 1"x 3" tongue and groove composite decking with a light texture. The existing decking isn't original and is not tongue and groove. Staff finds that the design of the composite decking will be more</p>

Figure 2. Existing porch.

<p>compatible with the historic decking found in the Union Hill district. Furthermore, the Administrative approval guidelines for front porch decking allows for the installation of synthetic decking when the original is missing or deteriorated beyond repair. Staff recommends approval of the composite decking with the condition that <u>the composite decking boards be installed perpendicular to the face of the building.</u></p>
<p>Building Elements, Entrance and Porch Removal, Replacement and Reconstruction, pg. 71</p>	<p><i>4. Do not remove or radically change entrances and porches important in defining the building's overall historic character. Front and side porches are architecturally more ornate than utilitarian back porches.</i></p> <p><i>5. The entire porch should only be replaced if it is too deteriorated to repair or is completely missing; replacements should match the original as much as possible.</i></p> <p><i>6. When restoring a railing or balustrade there may be difficulty in maintaining the original height while meeting current building code. Always consult with the building department.</i></p> <p><i>7. When replacing a railing on a historic building which has lost its railing, the first step is to look for documentary evidence which records the appearance of that railing. If no documentary evidence survives, look for physical evidence (this may benefit from the help of a design professional).</i></p> <p><i>8. Do not strip entrances and porches of historic material and details that should be retained in any repair or partial replacement.</i></p> <p><i>9. Existing entrances or porches should not be removed when an historic structure has been reoriented to accommodate a new use.</i></p> <p><i>10. The addition of a new entrance to a primary dwelling elevation is strongly discouraged.</i></p> <p><i>11. A primary entrance should not be altered to give an appearance that was not originally intended, such as adding a pediment to a simple vernacular entrance.</i></p>	<p>The front porch of 2210 Jefferson has been radically altered over the years. Very little original fabric remains. The only original element of the front porch is the roof structure. The applicant proposes to retain the roof structure and install a new metal roof. <u>Staff recommends that the original roof structure be retained and its form not be altered.</u></p> <p>The applicant proposes to remove the non-original wooden front porch railings and to replace them with the “grab-and-go deckorators composite railings.” Staff supports the use of a composite railing in this location, however is concerned about the visual appearance of the brackets that will be used to join the railings together, as they appear quite bulky. The applicant did not provide specific detail on the connector pieces/brackets, but staff was able to find images online (see figure 5). Bulky connectors do not adequately resemble historic railing configurations. <u>Staff recommends that a composite front porch rail be used that does not feature bulky connectors. Staff recommends that the applicant work with staff on choosing an appropriate substitute rail material and design.</u></p>

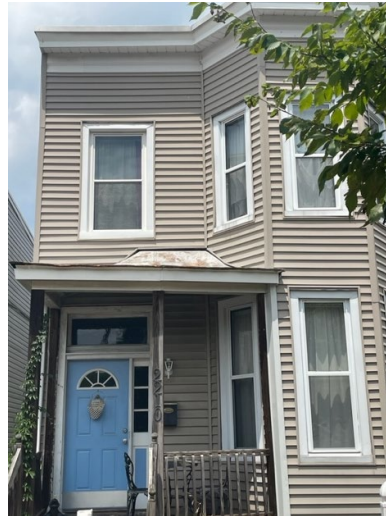
Figure 4. Existing porch roof condition.

Guideline Reference	Reference Text	Analysis
Roofs, Roof Replacement/ Reconstruction, pg. 66	<i>5. The historic front and rear porches of many historic Richmond houses -particularly in the Jackson Ward and St. John's Church Old and Historic Districts- have shallow pitched metal roofs with flat seams (also called flat-lock seams). Flat seam metal roofs have a more homogenous appearance than the more typical standing seam metal roofs found on steeper slopes of the main roof.</i>	While a majority of the existing front porch is not original to the dwelling, the front porch roof and cornice are original. The applicant proposes to replace the existing roof in-kind. Staff supports this alteration. <u>Staff recommends that the new metal roof be flat-lock and be painted a color found on the Commission's approved color pallet; final materials and color submitted for administrative review and approval.</u>
