# COMMISSION OF ARCHITECTURAL REVIEW

## APPLICATION FOR CERTIFICATE OF APPROPRIATENESS

**Renovation of existing garage, rear yard parking surface, and main house back deck**

PROJECT	20-037	3303 MONUMENT
BY	SK	DATE 7.2.20
SUBJECT	EXIST. CONDITION	
		SHEET SK-1

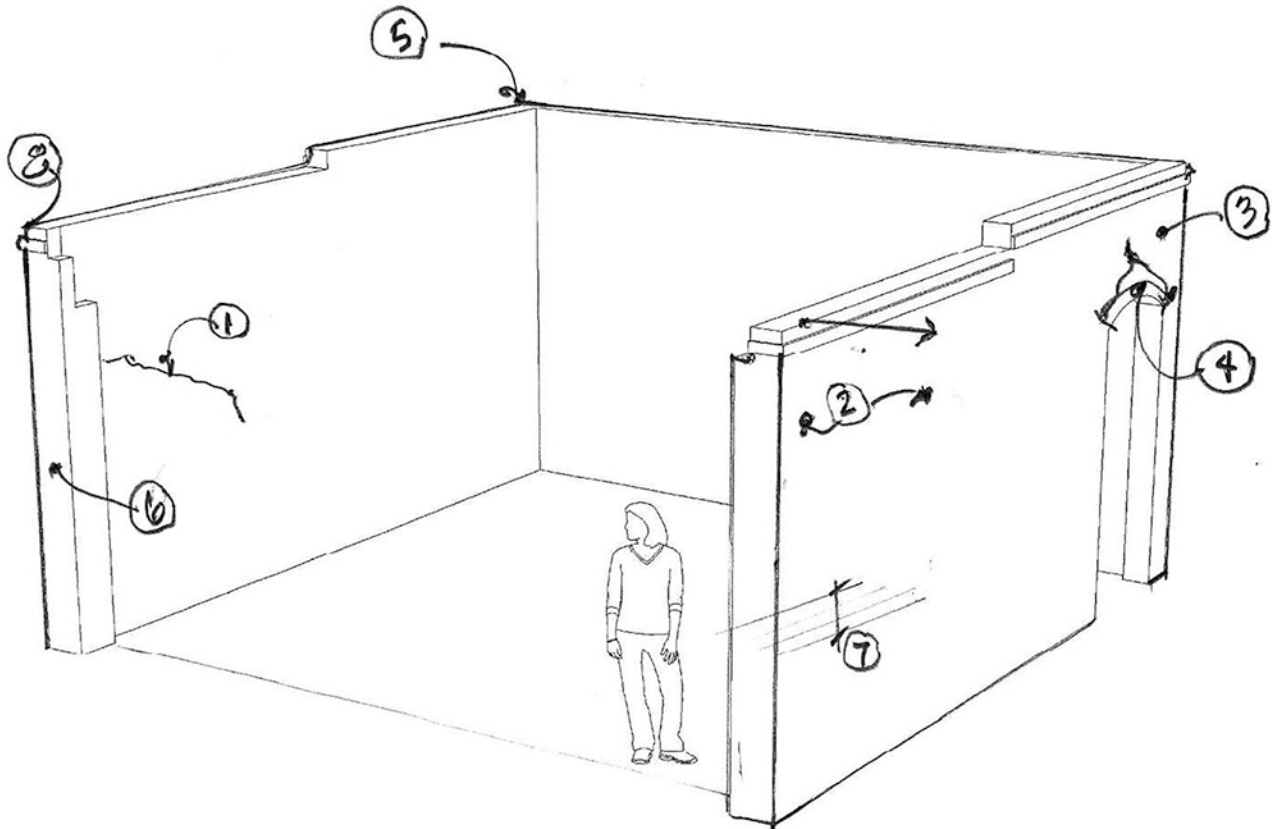
The condition of the masonry and mortar overall is sound, though there has been significant movement of the east wall. Its lean is enough that puts its stability in question, so I agree with your proposal to remove this wall as part of the studio design.

The roof has been replaced, so it's not clear how deterioration of the previous framing may have contributed to the lean of the east wall. The drainage around the garage is impeded by the raised alley surface, so it's possible that water in the soil has contributed to rotation of the base of the wall on the east side.

1. A hairline crack at this corner extends about 5' north and steps through brick. It doesn't follow a normal settlement pattern, but rather shows signs of a slight horizontal movement or is the result of overall movement of the masonry walls. I didn't find it on the outside wythe of brick.

2. The outward movement of this area of wall is most pronounced. It's out of plumb at about 1" in 4'. The shape of this wall is not uniform; it seems to get progressively worse toward the south.

3. This corner is nearly plumb.
4. The failed masonry arch seems to be the spring point of the movement of the east wall. The original cause of the arch failure was likely water infiltration at this corner.

5. The west side wall leans slightly east at this corner, about 1/4" in 4 feet.
6. There was some repointing done at the piers on the south side using hard mortar. It has come loose in some joints.

7. Three courses of brick = 9 1/4" +/-, for your information
8. This corner leans slightly to the west, about 3/8" in 4'.
