6. COA-090017-2021

3225 Monument Avenue

Commission of Architectural Review

STAFF REPORT

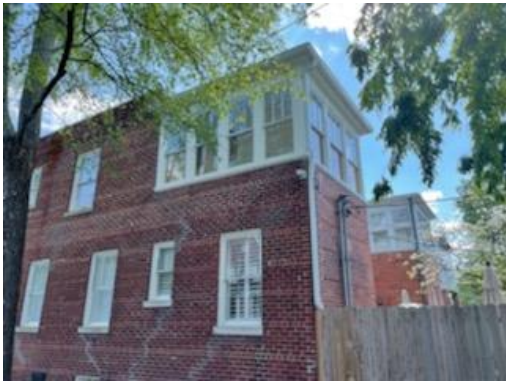
Figure 1. 3225 Monument, side and rear elevation from Tilden Street.

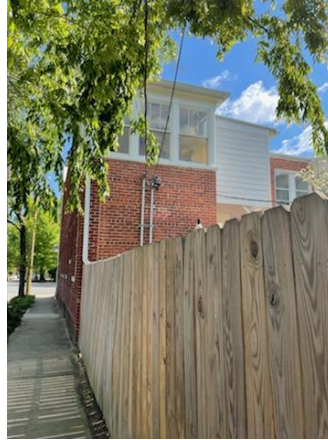
Figure 2. 3225 Monument, rear elevation from Tilden Street

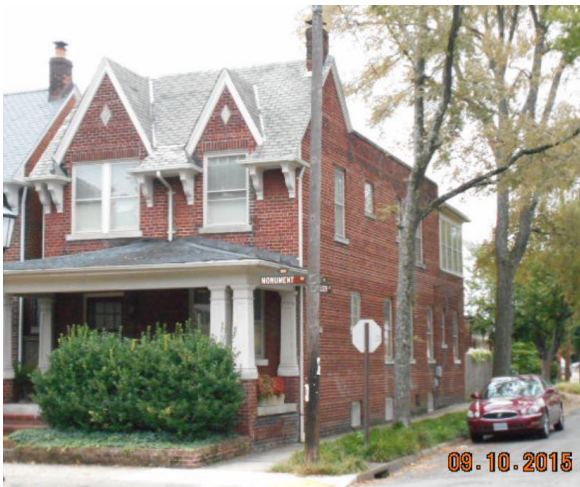
Figure 3. 3225 Monument, view of storm windows on front and side elevations. 2015, City Assessor's Image.

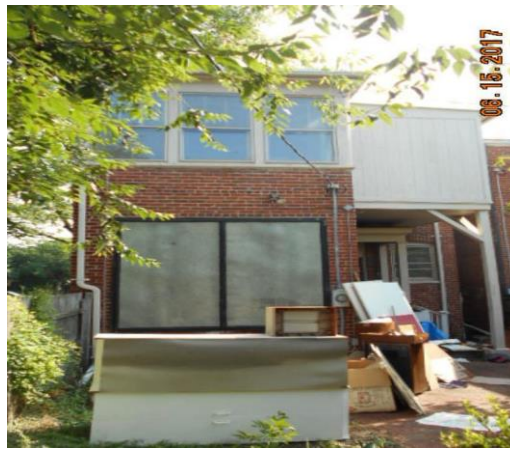
Figure 4. 3225 Monument, view of storm windows on rear elevation. 2017, City Assessor's Image.

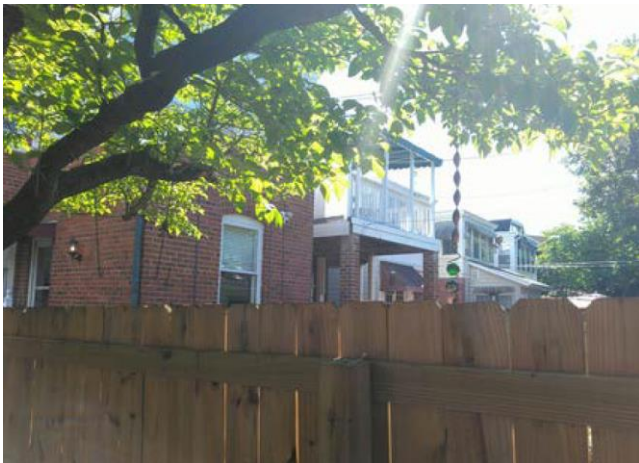
Figure 5. Commission Member site visit photo showing sleeping porches on similar properties within the district, demonstrating that the rear of 3225 Monument is not original to the building, including the associated windows.
