**Staff Report**  
**City of Richmond, Virginia**

**Commission of Architectural Review**

2.COA-163028-2025	Final Review	Meeting Date: 4/22/2025
Applicant/Petitioner	B. Tyler Sylvestro	
Project Description	Demolish an existing one- and one-half story rear portion of a building.	
Project Location		
Address: 711 North 26 <sup>th</sup> Street		
Historic District: Church Hill North		
<p>High-Level Details:</p> <p>The applicant requests approval to demolish the rear projection of a Greek Revival Style House circa 1855.</p> <p>The projection is one and a half stories with a gable roof, center chimney, and features a couple of doors and vertically aligned windows, the upper windows being smaller than the lower ones.</p> <p>Historic documentation suggests that this addition may have been constructed between 1889 and 1905.</p>		
Staff Recommendation	Approval, with Conditions	
Staff Contact	Alex Dandridge, alex.dandridge@rva.gov, (804) 646-6569	
Previous Reviews	<p>The Commission reviewed this application at their March 2025 meeting. The Commission supported the demolition of the rear addition for the reasons stated in the staff report. Ultimately, the Commission deferred the demolition, ag

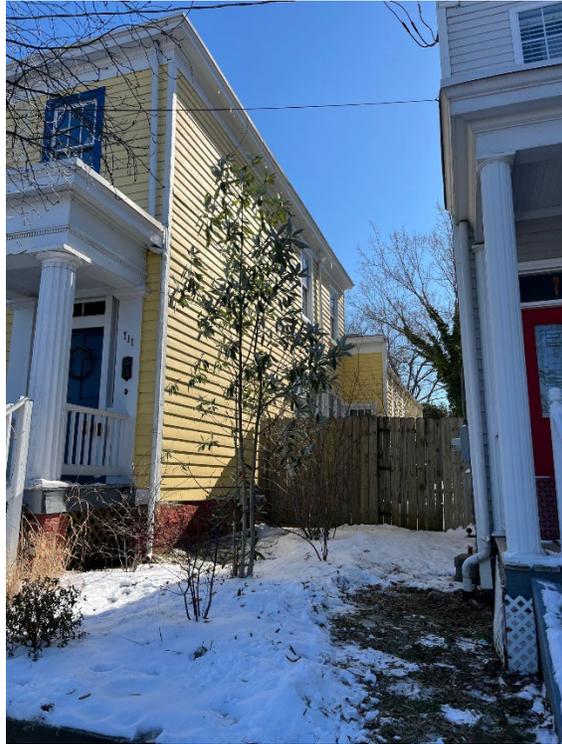
Figure 2. View of existing rear addition from North 26<sup>th</sup> Street.

The addition is in fair condition and has undergone many alterations overtime. It appears to have inherent construction flaws that make maintenance and repair difficult. A structural engineer’s report demonstrates that rehabilitation would require disturbing and replacing more of the little historic material that is left. While the building’s scale, massing, and roof form contribute to the character of the Church Hill North City Old and Historic District, its overall integrity has been diminished. The demolition would not have a major impact on the North 26<sup>th</sup> Street streetscape but would change the view of the building from the rear alley, which is a secondary public right-of-way. Furthermore, the applicant is proposing to construction a new addition that references the design of the existing addition.

For these reasons, staff recommends approval of the demolition of the rear addition.

Staff recommends the demolition approval should be contingent on the approval of the new construction to take its place.

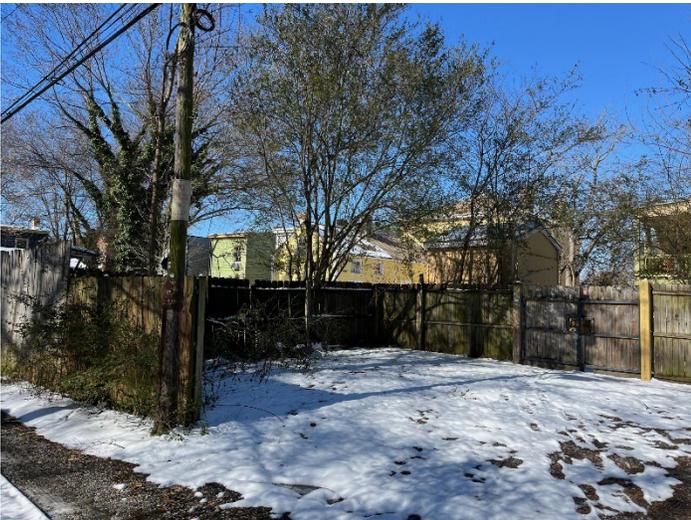
Figure 3. View of existing rear addition from the rear alley.

**demolition would have an impact on the views of the property from the rear alley.**
