INTRODUCED: September 13, 2021

A RESOLUTION No. 2021-R072

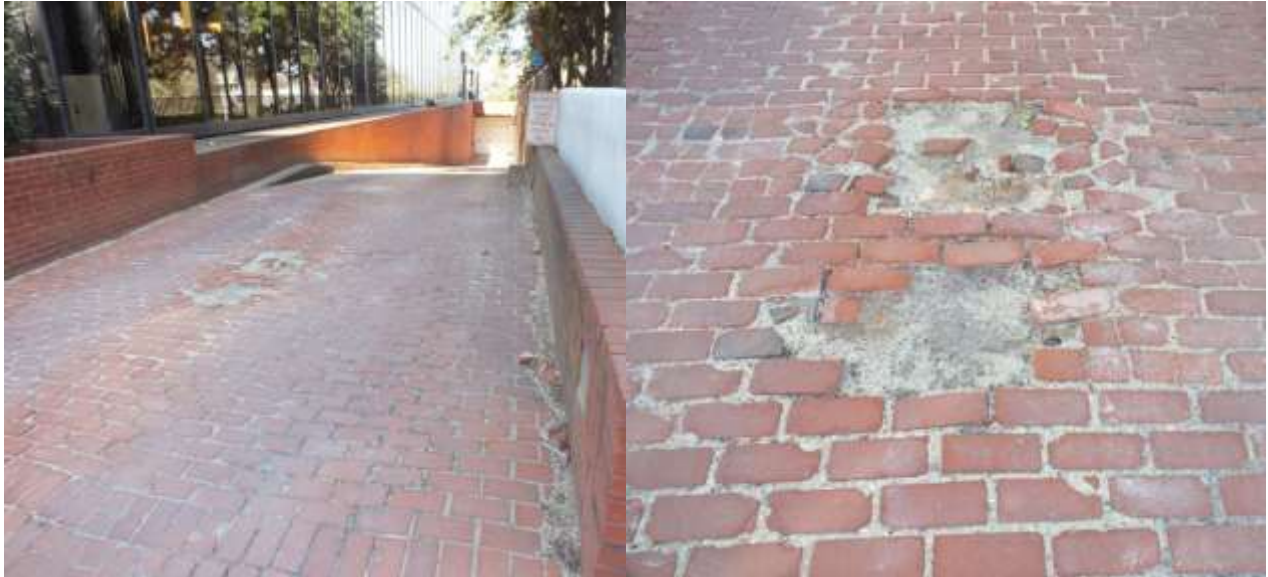
LOADING DOCK RAMP - UNEVEN AND MISSING PAVERS

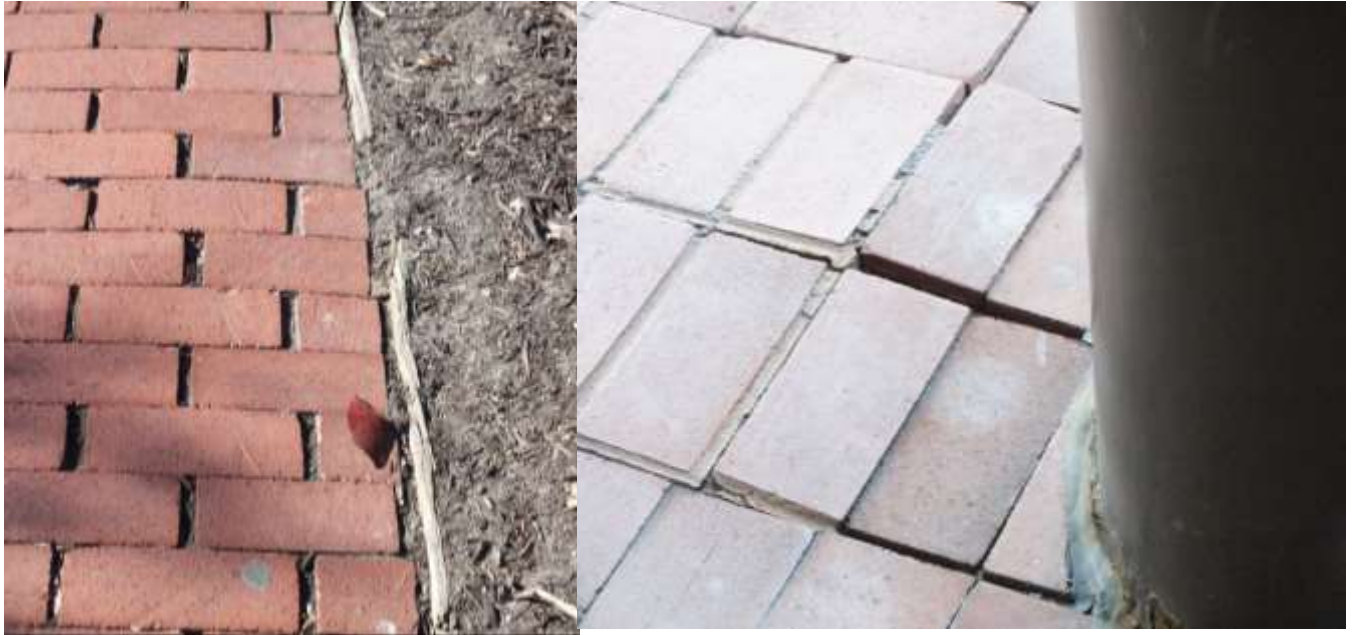
BRICK JOINT SEPARATION

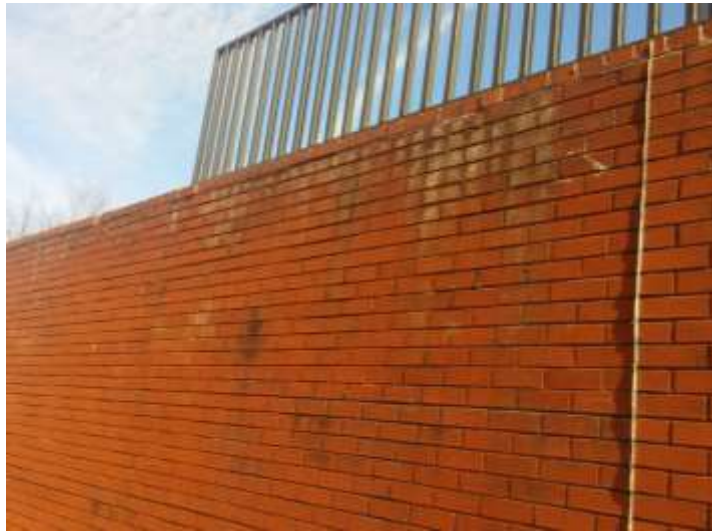
The majority of the brick masonry is located on the west side of the building for the onsite retaining walls. There are signs of efflorescence and staining on the brick. There is also extensive organic material growing at the brick mortar joints. There are no major signs of cracks that may represent any major failures in the masonry.

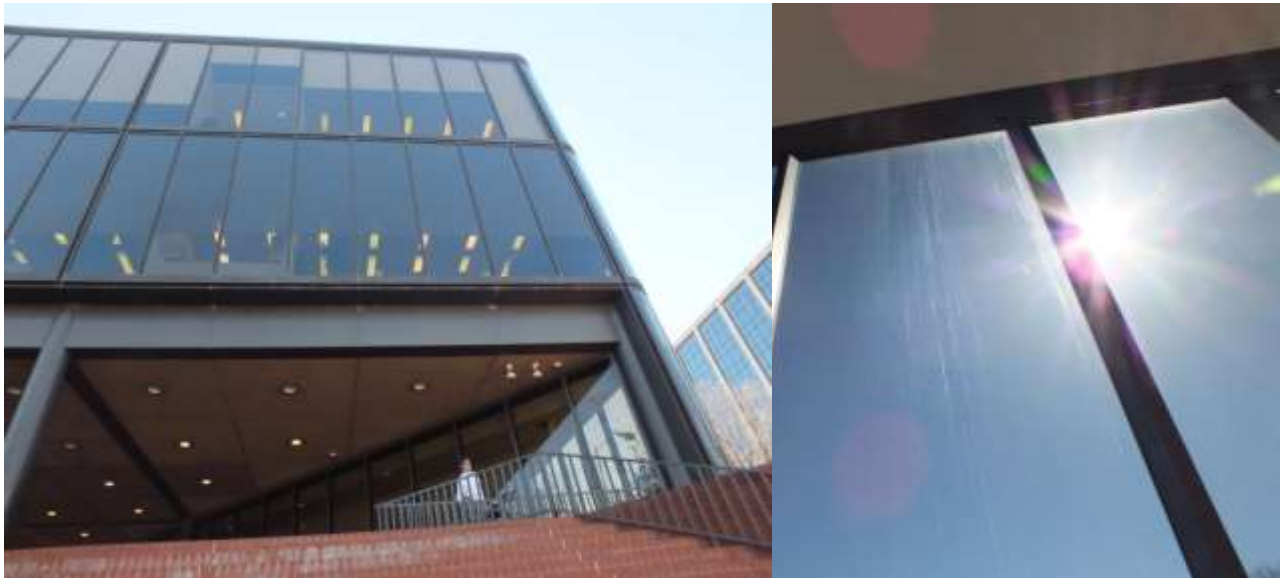
EXTERIOR CURTAIN WALL SYSTEM

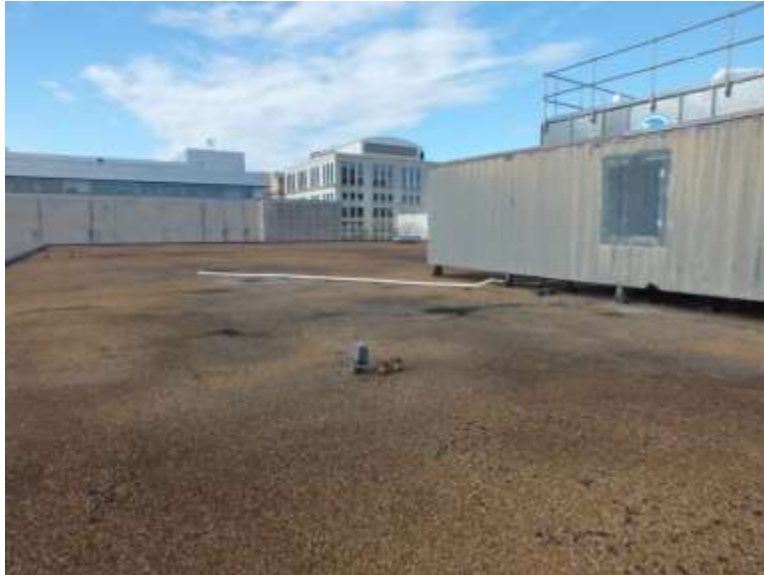
EXISTING ROOFING SYSTEM

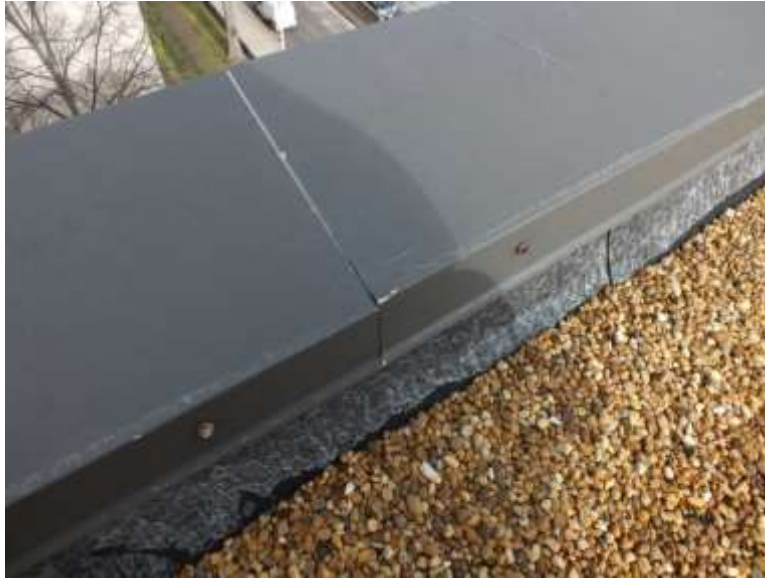
EXISTING PARAPET CAP

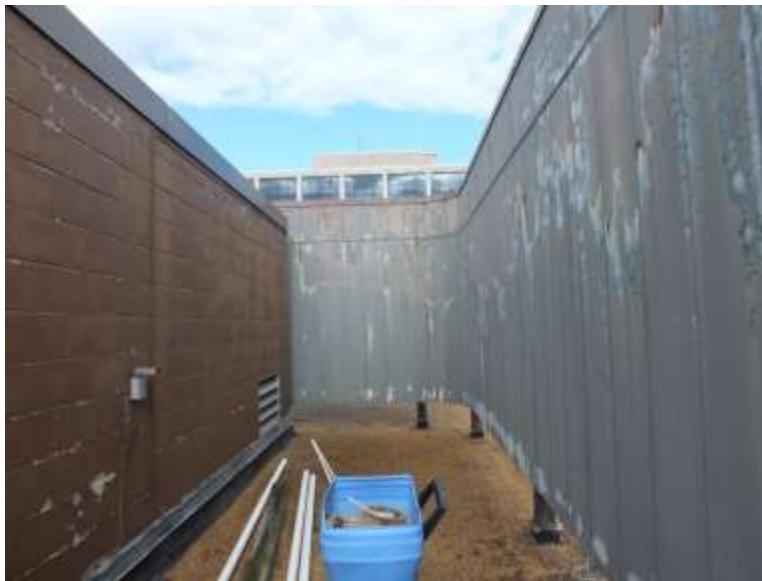
PEELING PAINT ON EQUIPMENT SCREEN AND PENTHOUSE

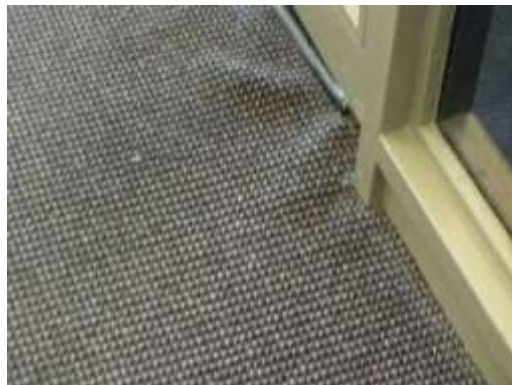
**BROADLOOM CARPETING BUCKLING**

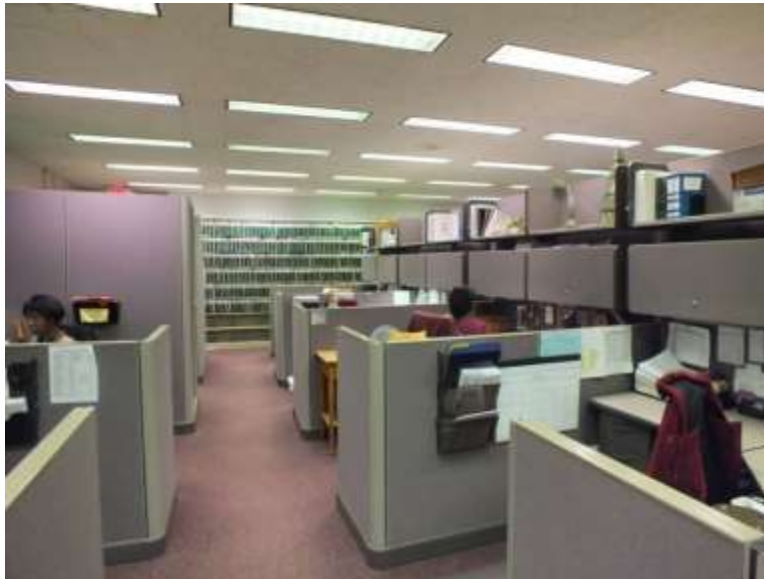
2<sup>ND</sup> FLOOR OFFICE

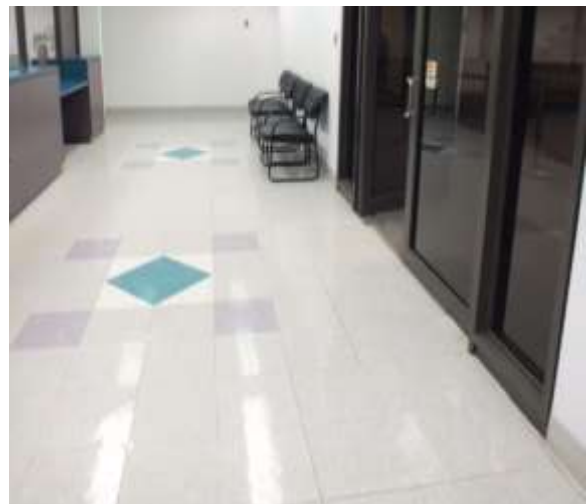
Vinyl flooring is used sparingly in the building. The existing VCT and vinyl flooring are in good condition and appear to be well maintained.

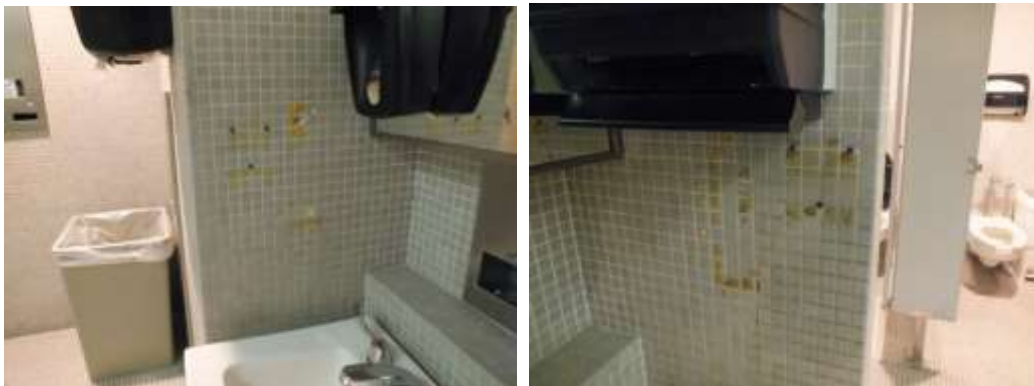
JOHN MARSHALL COURTS BUILDING  
Richmond, Virginia

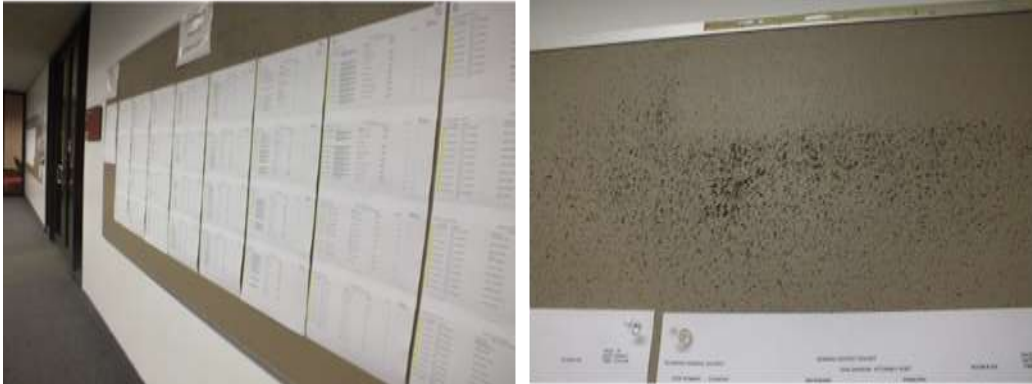
SECOND FLOOR BULLETIN BOARDS

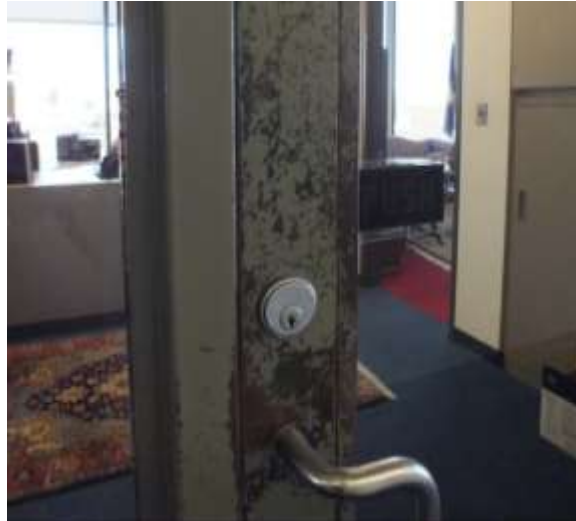
DAMAGED FINISH ON DOORS

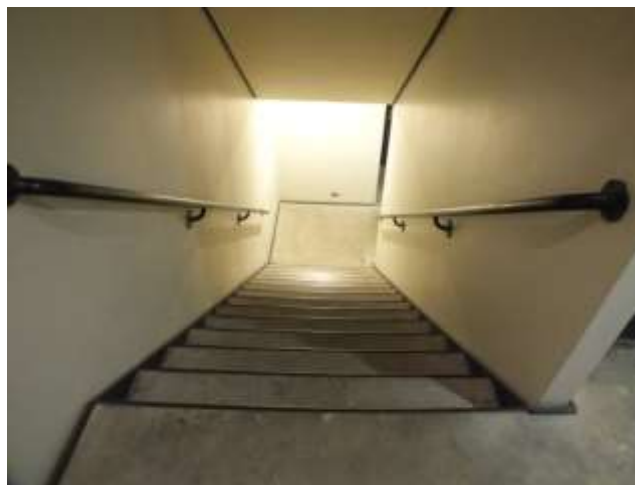
The interior exit stairs are in good condition; however, the existing handrails do not comply with ANSI A117.1 505.10 and VCC 1012.6 for extension at the top and bottom of stairs.

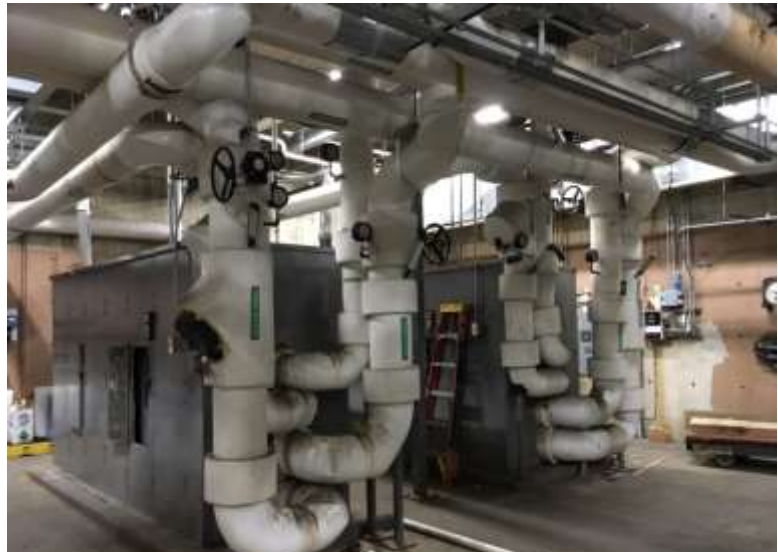
CHILLERS, INSTALLED 2008

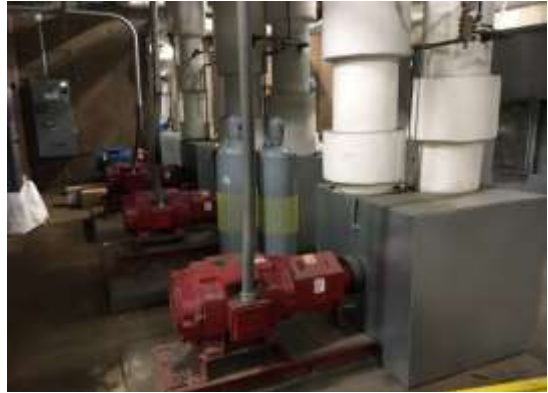
CHILLED WATER & CONDENSER  
WATER PUMPS

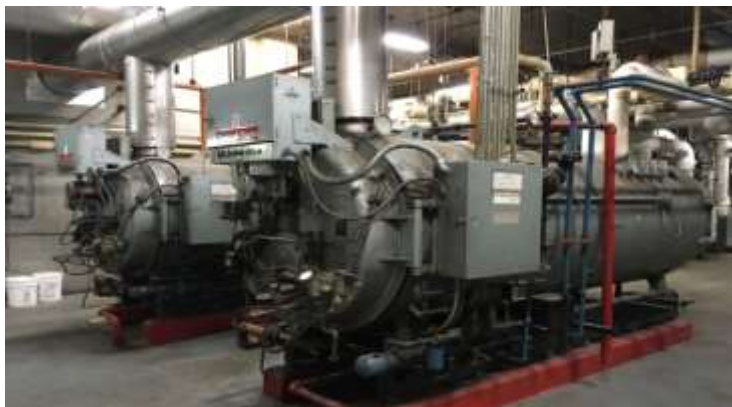
BOILERS, INSTALLED IN 1975

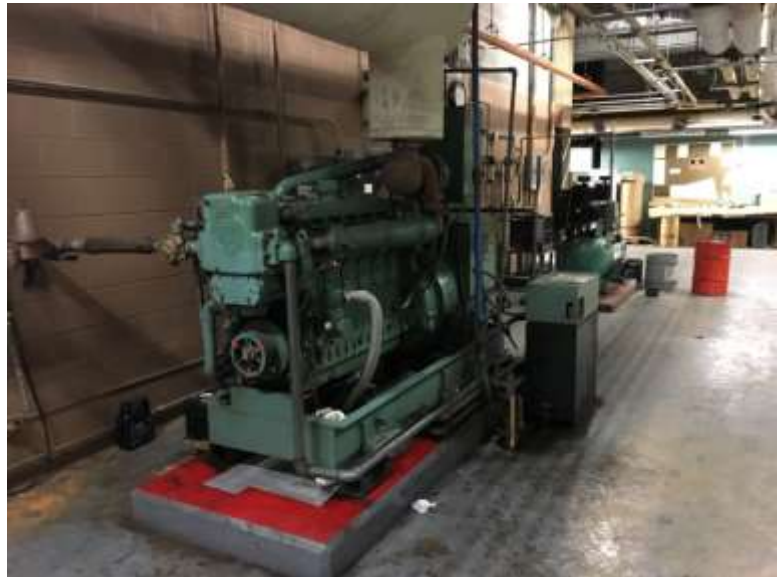
Life safety loads (lighting and fire alarm) as well as miscellaneous non-life safety loads are adequately provided by a 175 KW (219 KW @ 0.8 PF) water cooled, oil-fired diesel generator. Power is transferred from the switchboard to the generator upon a loss of utility power by a 300A transfer switch. The generator and transfer switch are located in the lower level,

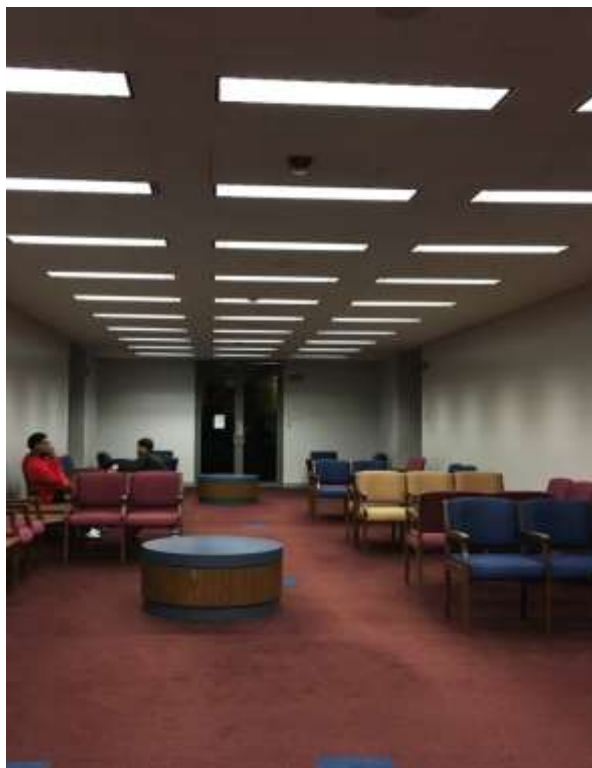
THIRD FLOOR LIGHTING

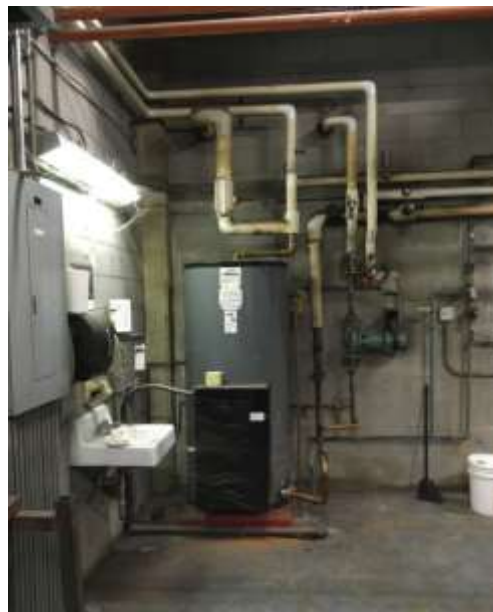
ELECTRIC DOMESTIC WATER  
HEATER

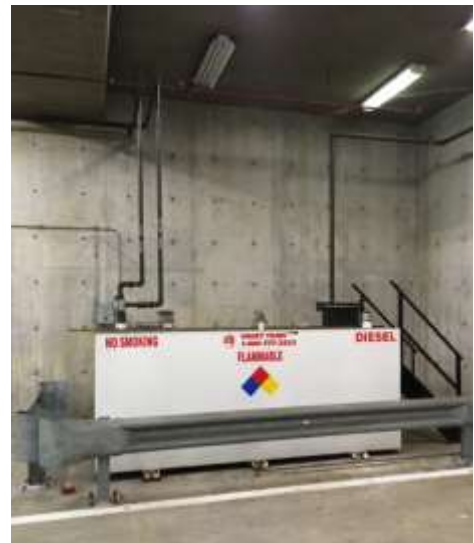
FUEL OIL STORAGE TANK

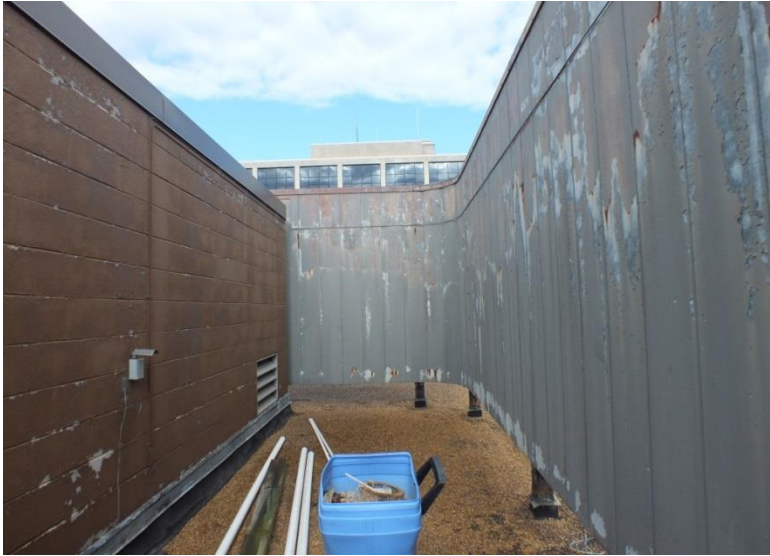
Reference:	Estimated Cost: <span style="float: right;">\$2,976</span>

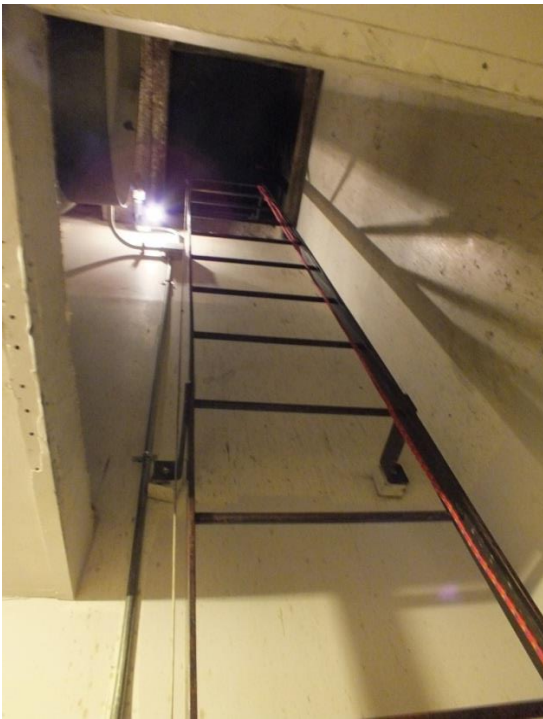
Reference:	Estimated Cost:     \$96

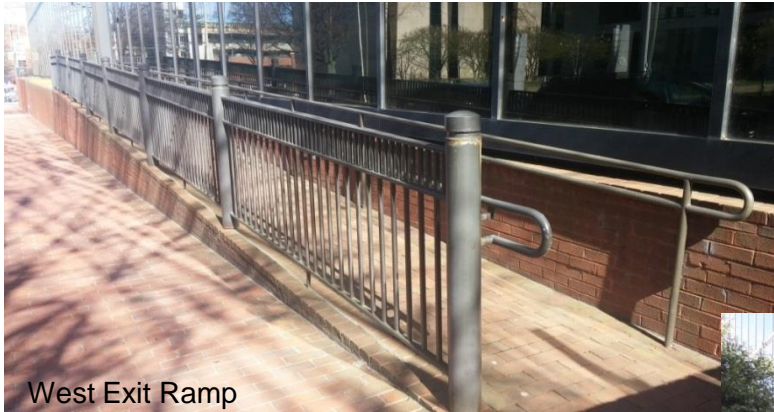
<p style="margin-top: 5px;">West Exit Ramp</p>

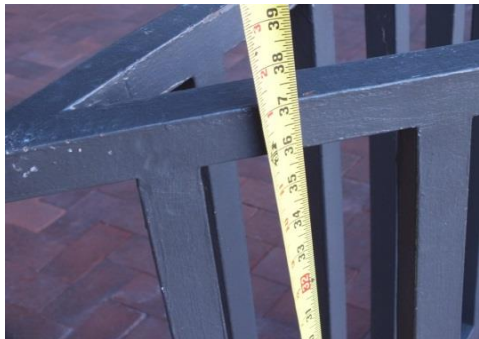
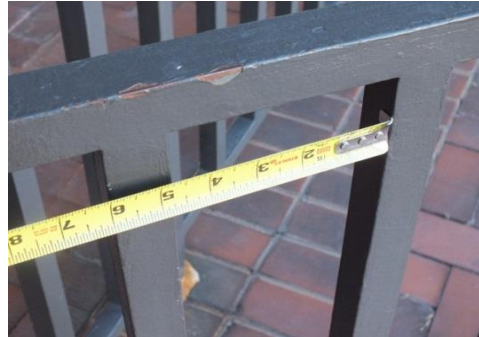
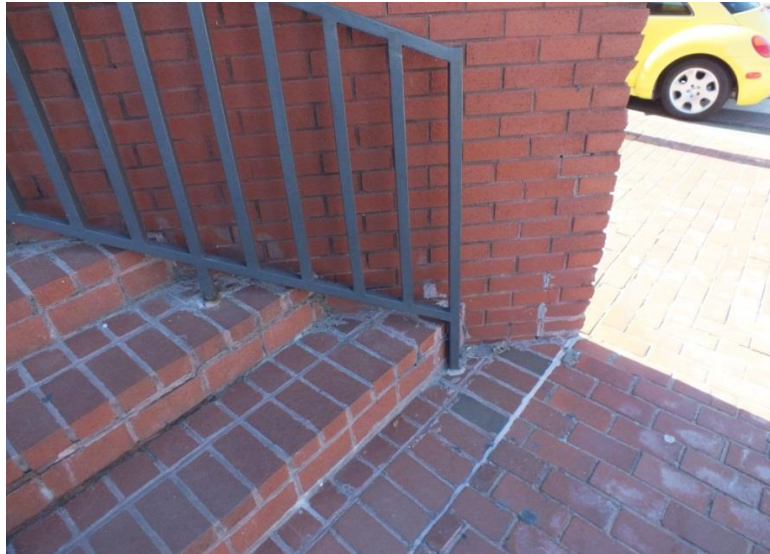
Deficiency Evaluation Location: Exterior Plaza	Deficiency No. <span style="float: right;">A05</span> Category <span style="float: right;">Life Safety</span>
Description	Recommended Action
<p>The square profile railings do not comply with the requirements for accessible handrails at ramps or stairs (ANSI A117.1 405.8 &amp; 505).</p> <p>The railings at the upper plaza are less than 42" in height (VCC 1013.3) and have a picket spacing greater than 4" (VCC 1013.4) as required for guardrails. The paint finish is starting to peel.</p>	<p>Remove existing rails at stairs and install new aluminum railings that match existing aluminum railings on steps.</p> <p>Remove existing guardrails and install new metal guardrails, minimum 42" high.</p>

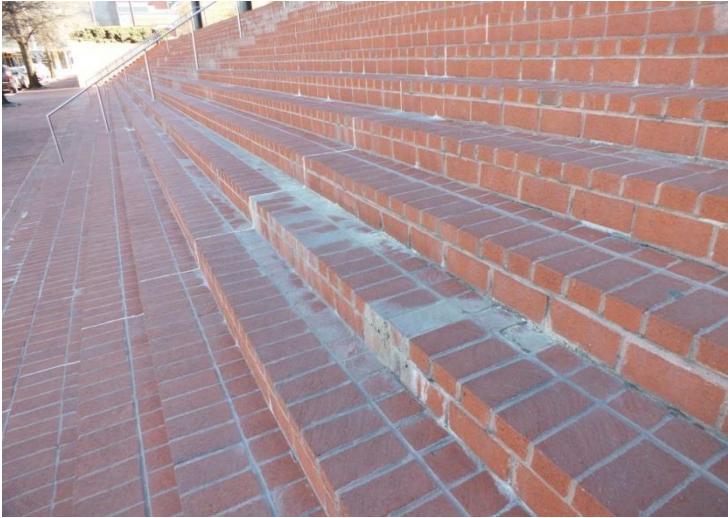
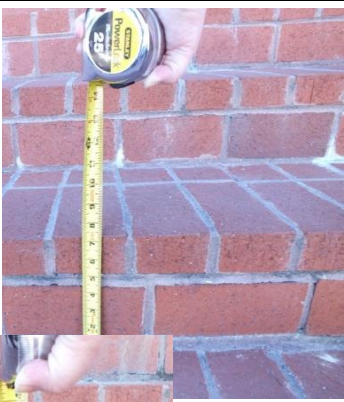
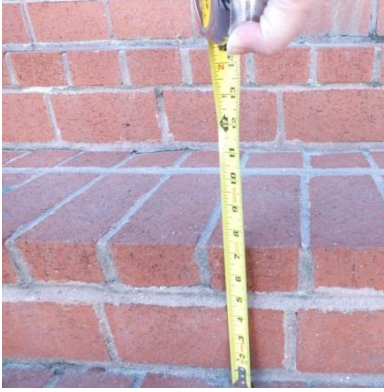
Reference:	Estimated Cost: <span style="float: right;">\$68,622</span>

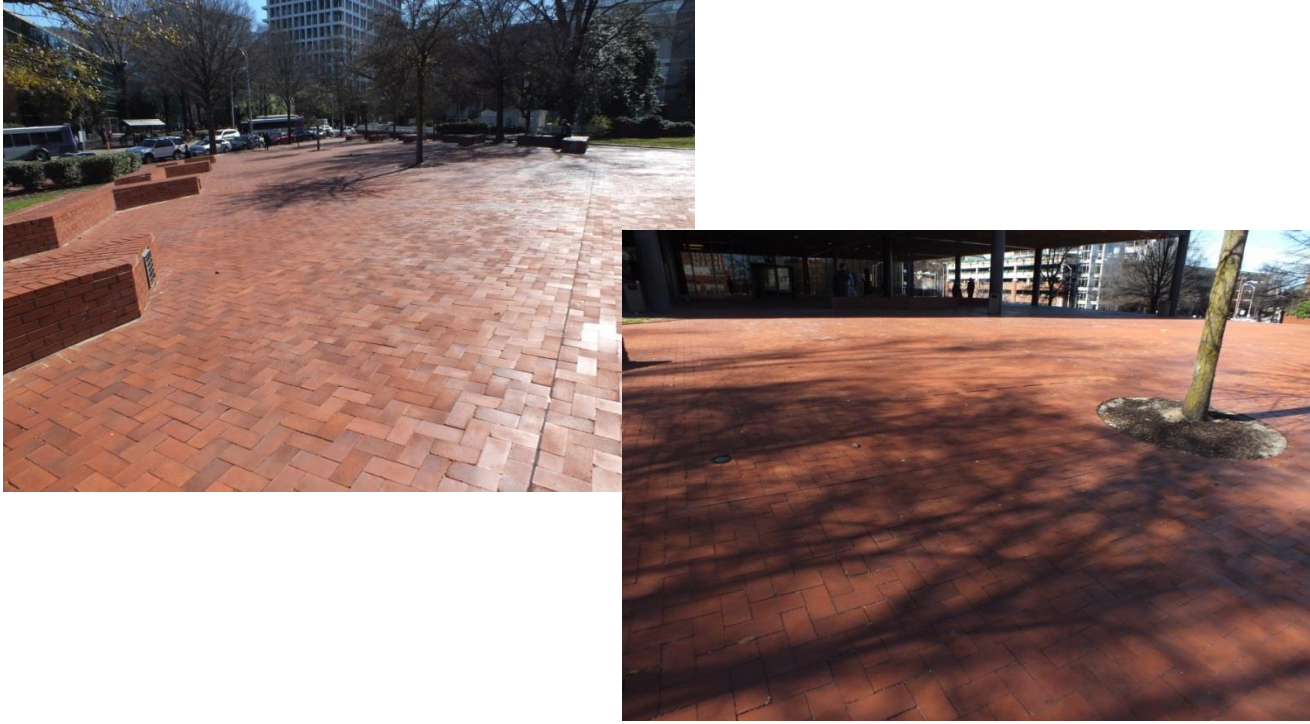
Reference:	Estimated Cost: <span style="float: right;">\$81,021</span>

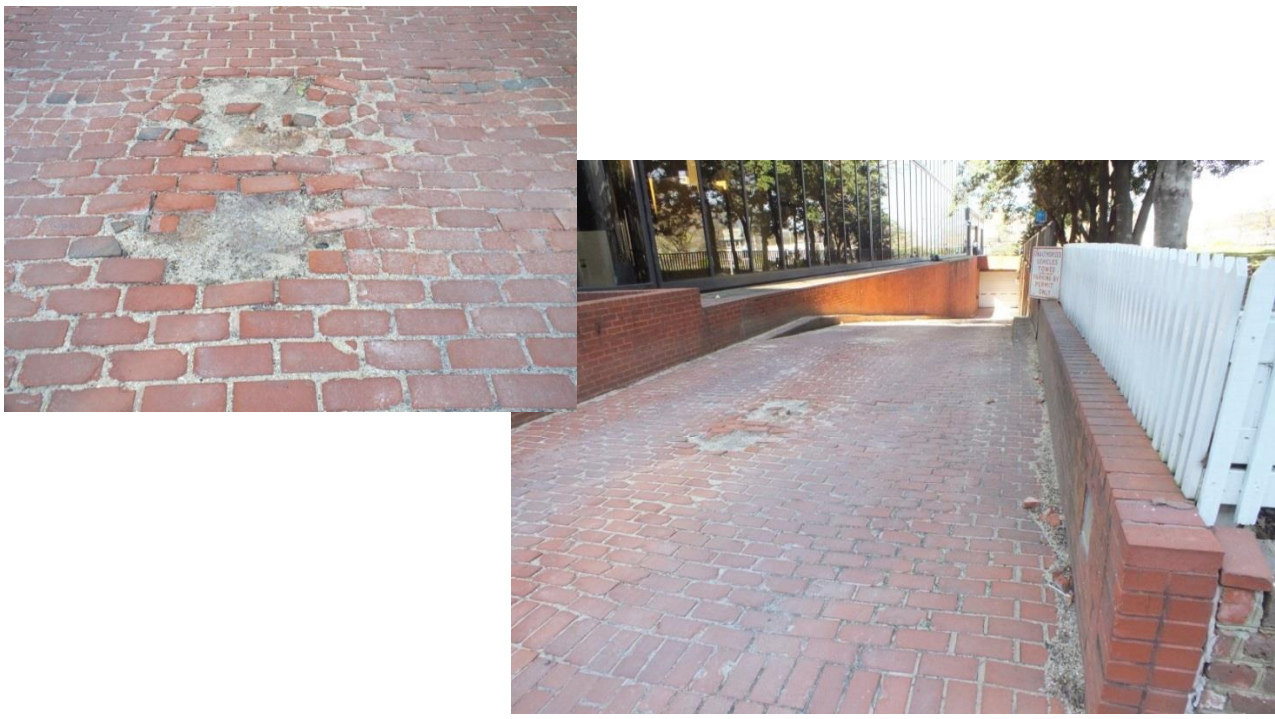
Reference:	Estimated Cost: <span style="float: right;">\$67,359</span>

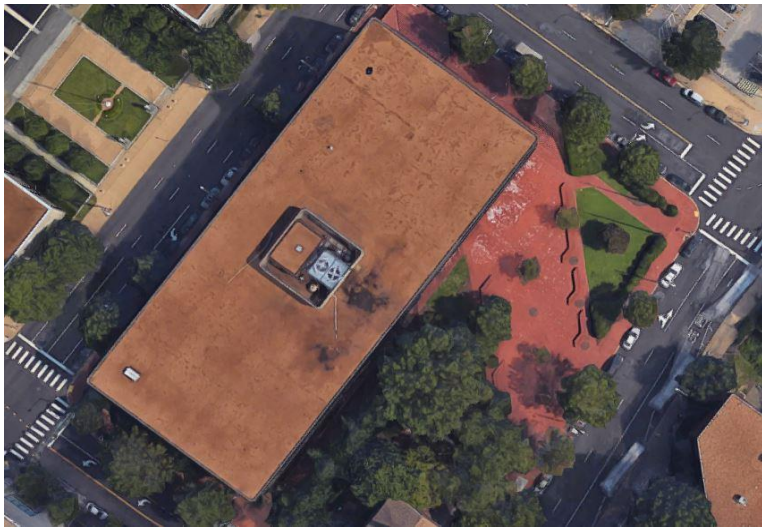
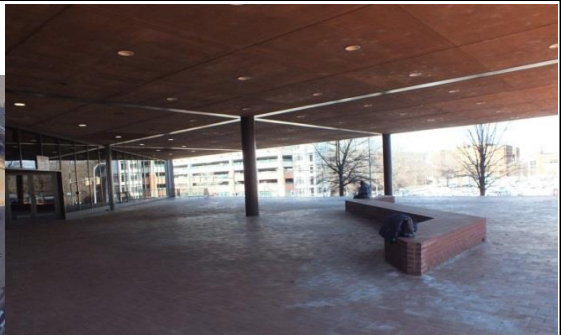
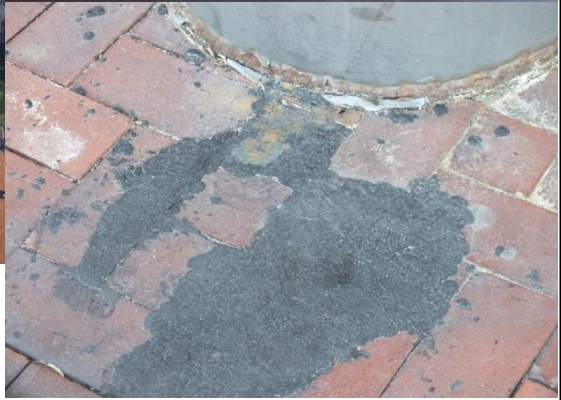
Deficiency Evaluation Location: Exterior Plaza	Deficiency No. <span style="float: right;">A09</span> Category <span style="float: right;">Repair</span>
Description	Recommended Action
The paver conditions vary from poor to good based on exposure and location. Significant portions of the brick, located primarily under the building overhang, have effloresced, discoloring the brick.	Clean plaza brick pavers and replace damaged pavers. A detailed survey of the plaza pavers would need to be conducted to determine the extent plaza repair and replacement.  A/E has assumed 30% of pavers to be cleaned and 25% to be replaced.

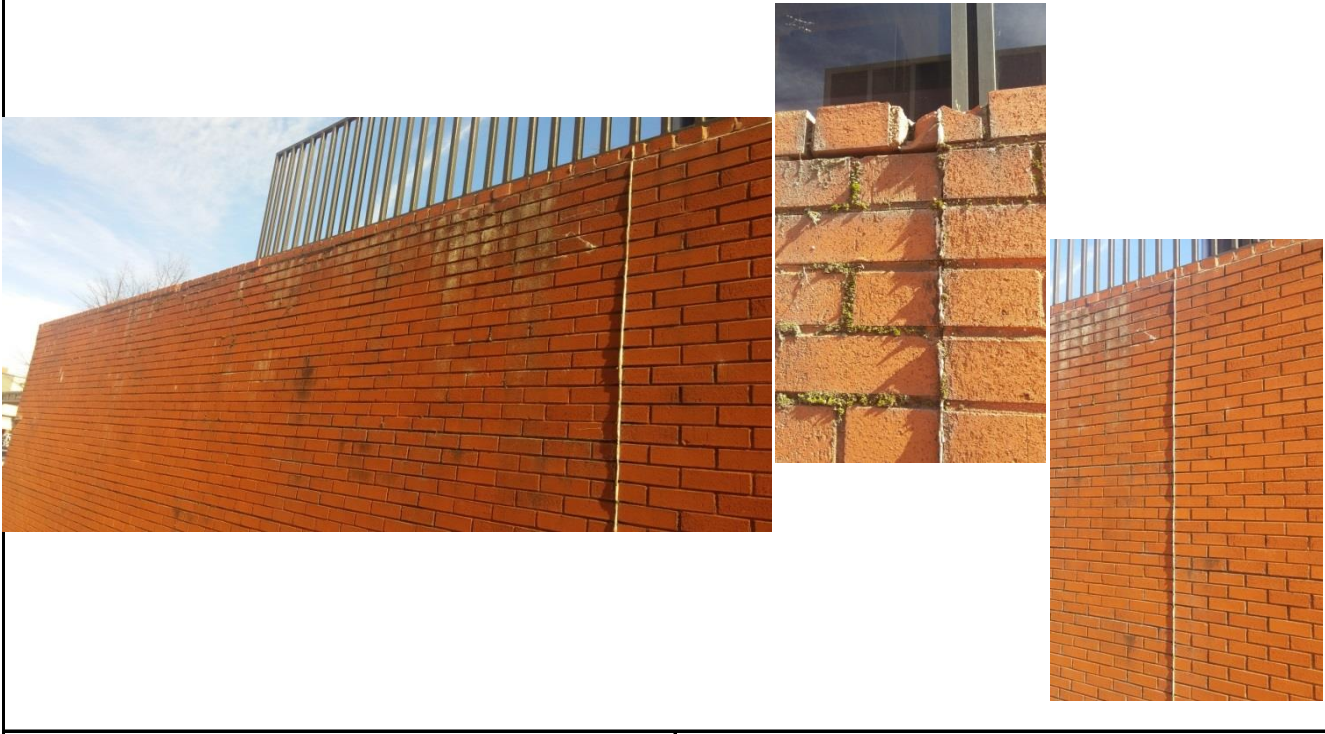
<p>The image block contains three photographs of a brick wall. The leftmost photo shows a wide view of a red brick wall with a metal fence in the background. The middle photo is a close-up of the brickwork, showing significant white efflorescence and green organic growth in the mortar joints. The rightmost photo shows a vertical control joint in the brick wall where the sealant has been pushed out and hardened.</p>

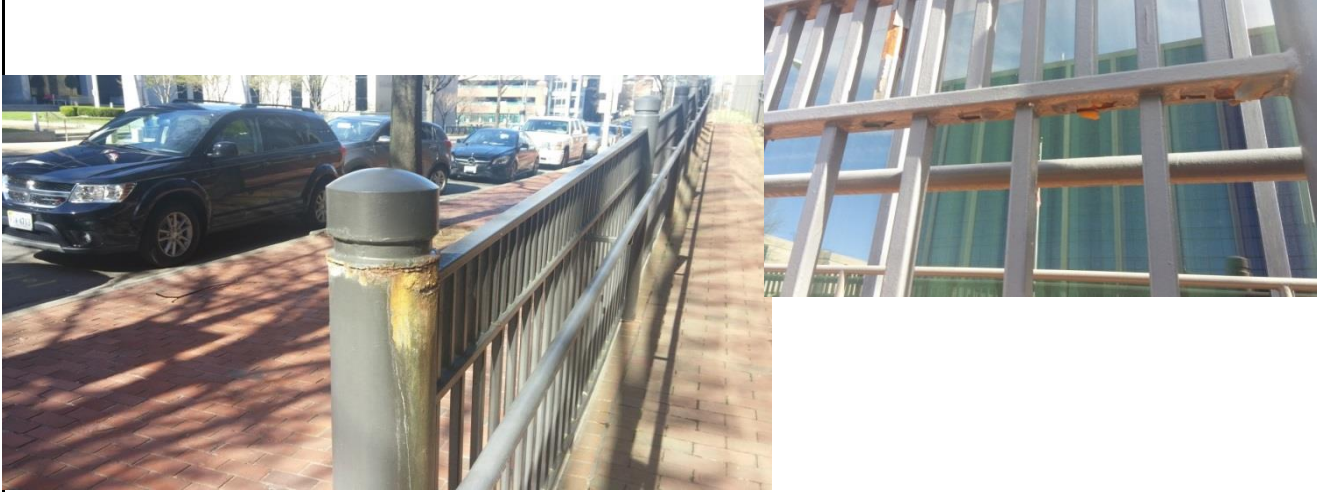
Reference:	Estimated Cost: <span style="float: right;">\$1,215</span>

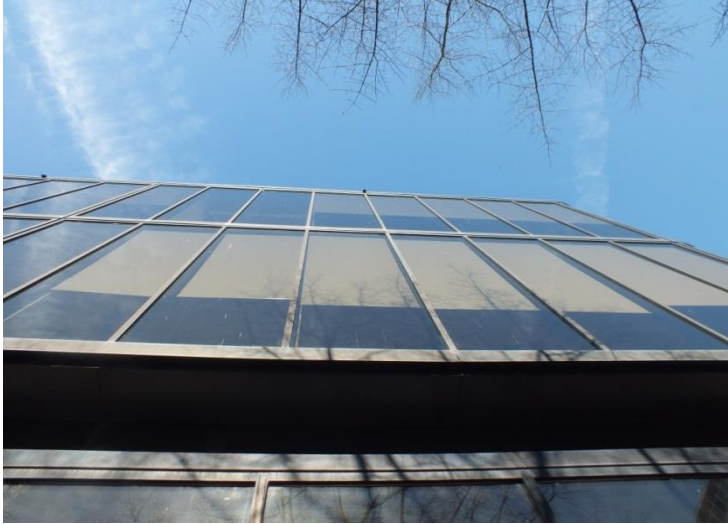
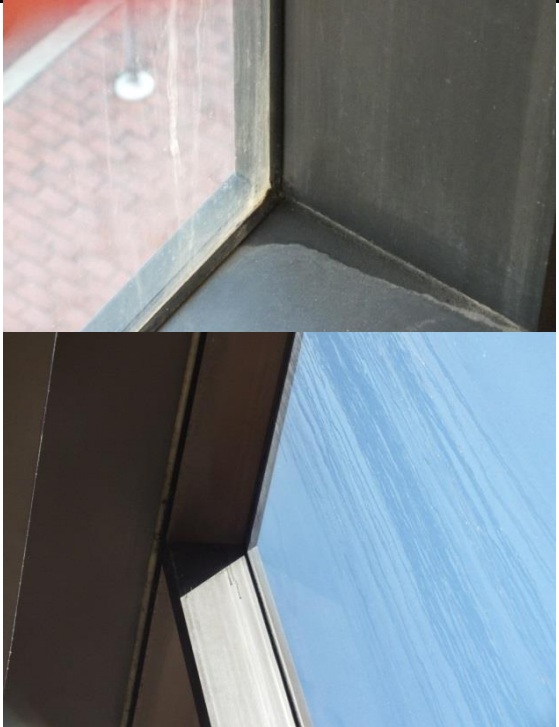
Reference:	Estimated Cost: <span style="float: right;">\$5,040,000</span>

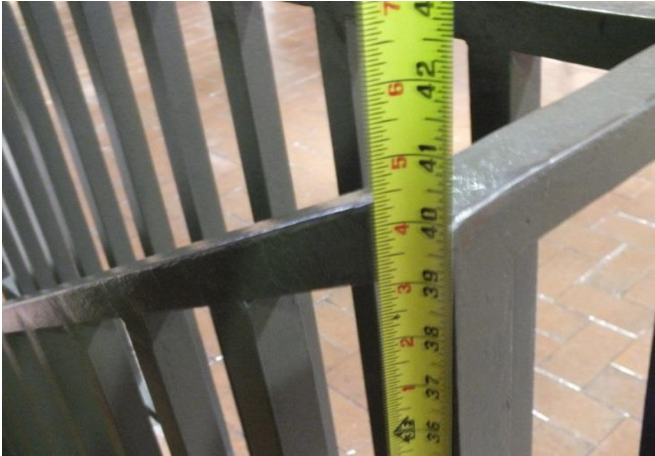
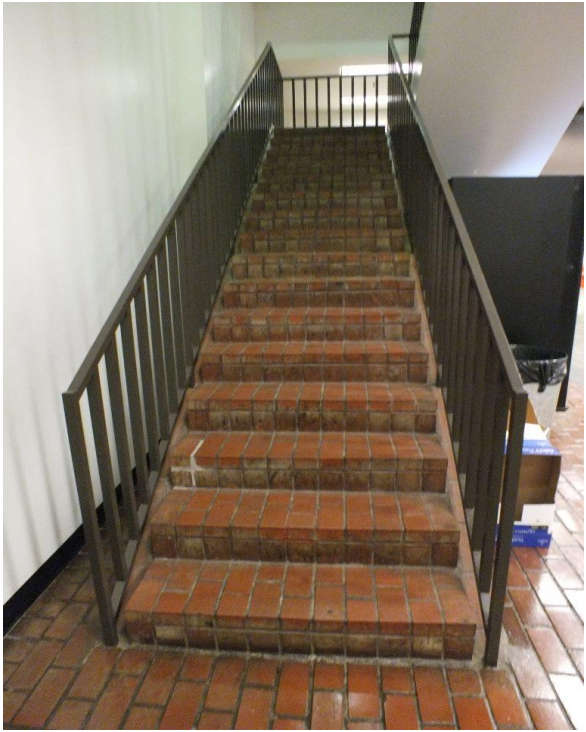
Reference:	Estimated Cost: <span style="float: right;">\$35,645</span>

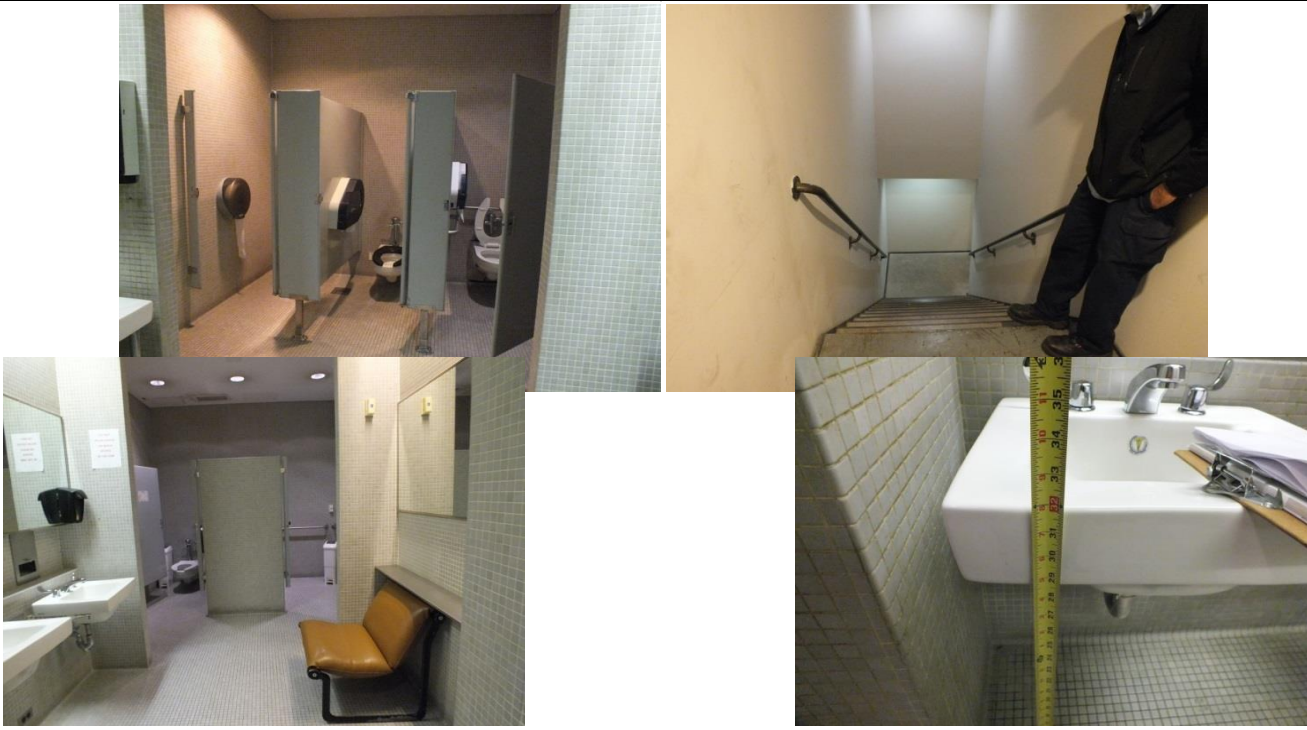
Reference:	Estimated Cost: <span style="float: right;">\$1,239,914</span>

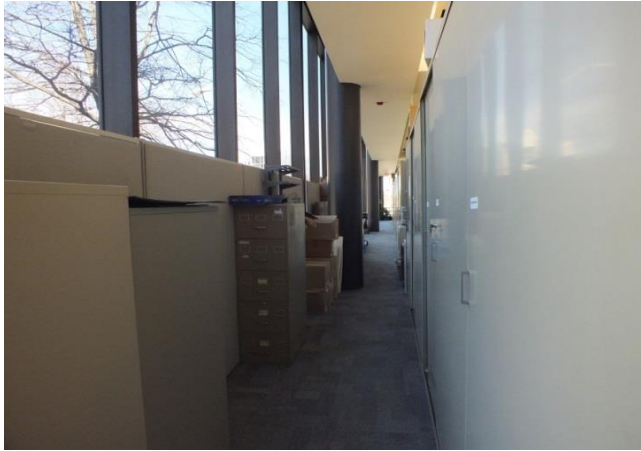
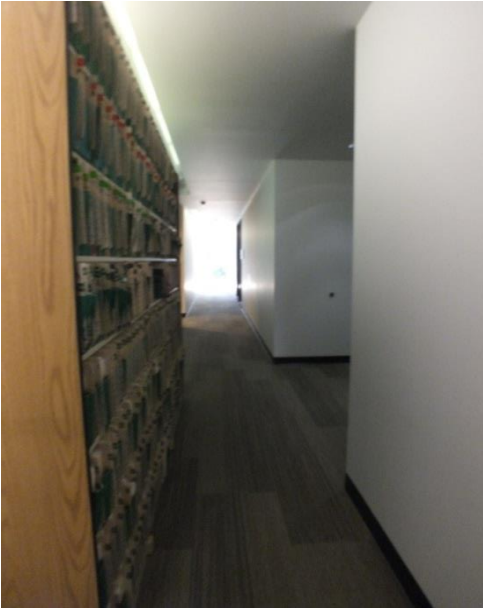
</div>	
Reference:	Estimated Cost:    \$0

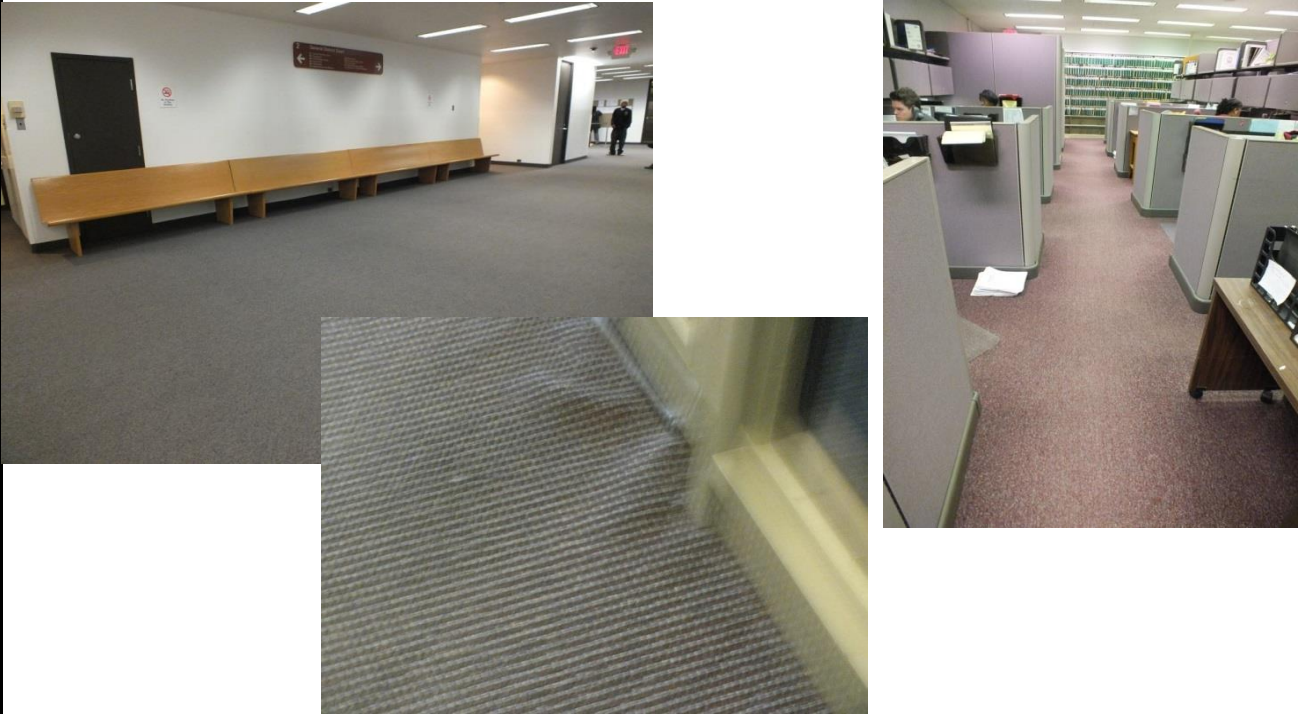
Reference:	Estimated Cost: <span style="float: right;">\$797,364</span>

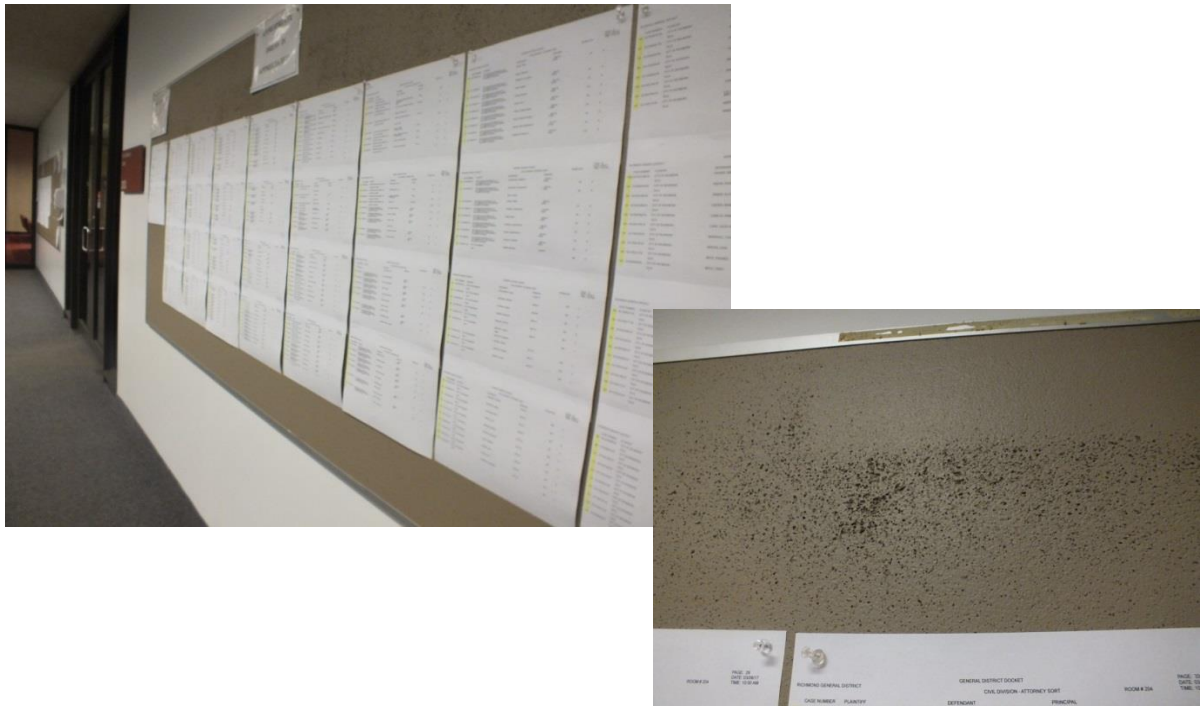
Reference:	Estimated Cost: <span style="float: right;">\$2,218</span>

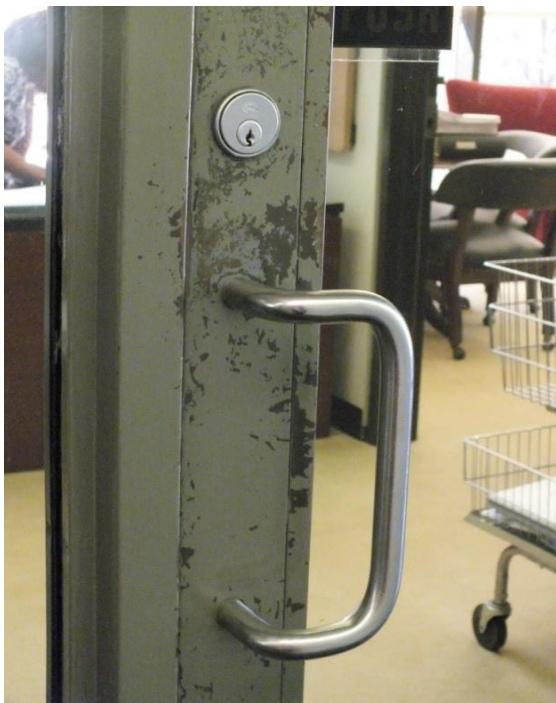
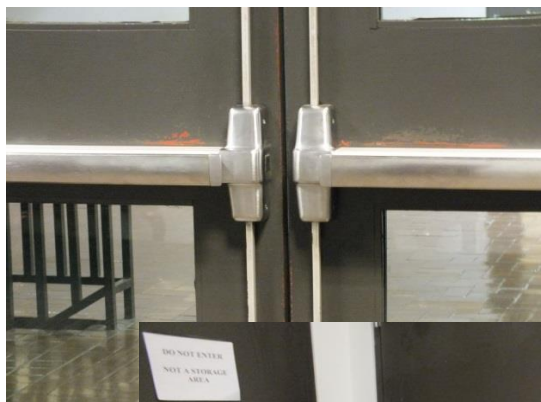
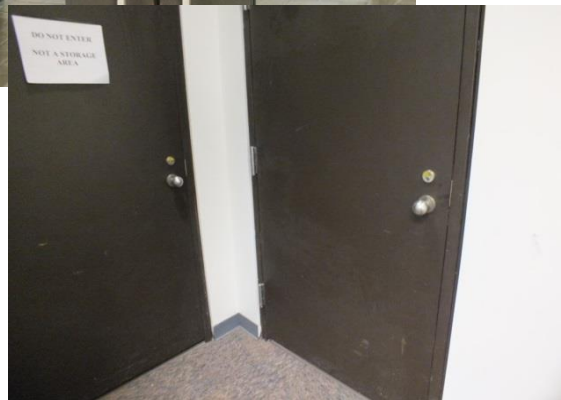
Deficiency Evaluation Location: Building interior-All floors	Deficiency No. <span style="float: right;">A18</span> Category <span style="float: right;">Maintenance</span>
Description	Recommended Action
The paint on the doors in public areas are chipped and peeling.	Repaint existing doors and frames through out building

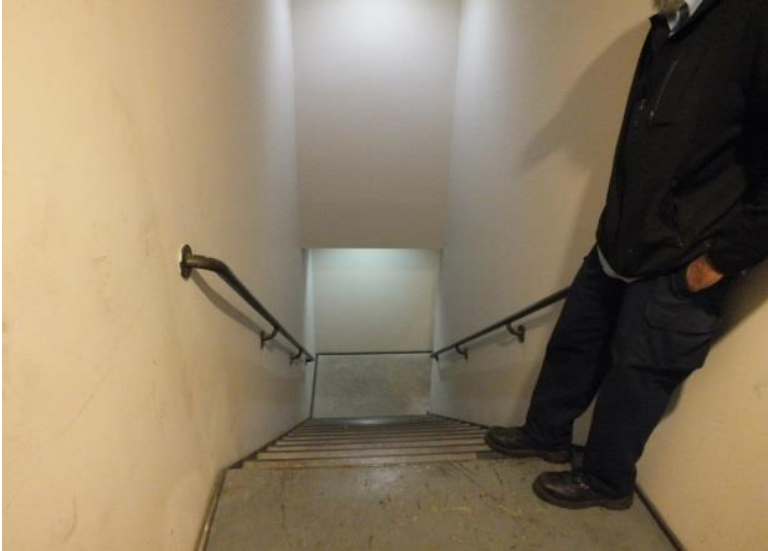
Reference:	Estimated Cost: <span style="float: right;">\$24,122</span>
