INTRODUCED: September 13, 2021

A RESOLUTION No. 2021-R072

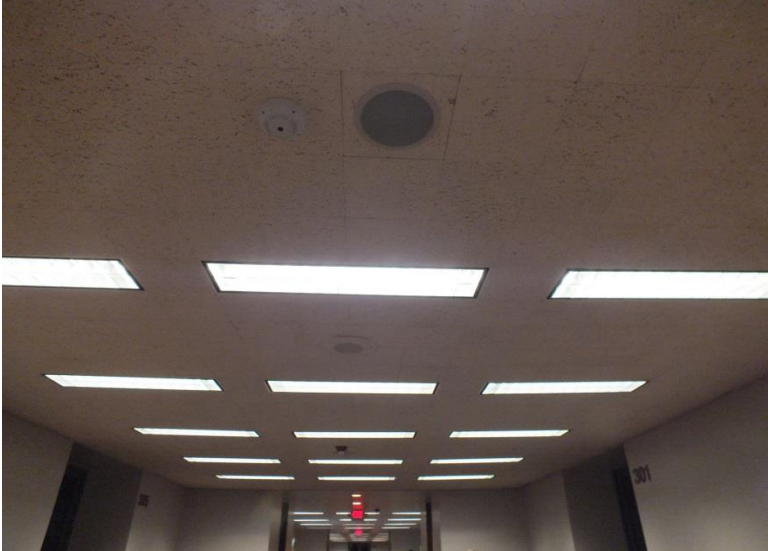
Reference:	Estimated Cost: <span style="float: right;">\$311,425</span>

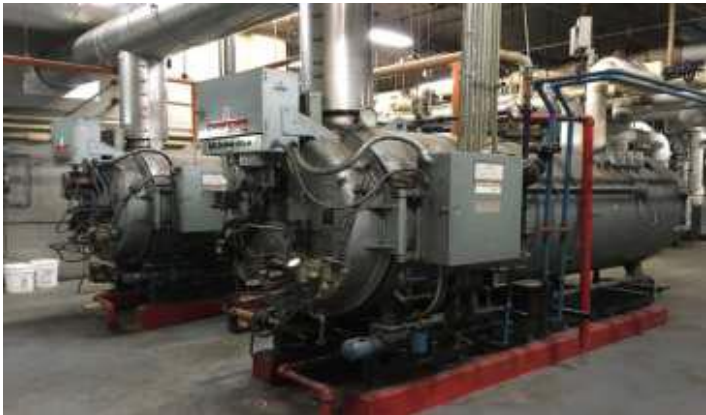
Reference:	Estimated Cost: \$336,444

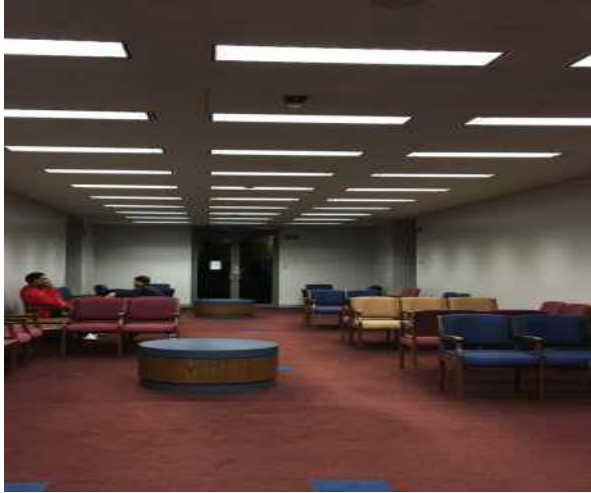
Reference:	Estimated Cost: <span style="float: right;">\$133,308</span>

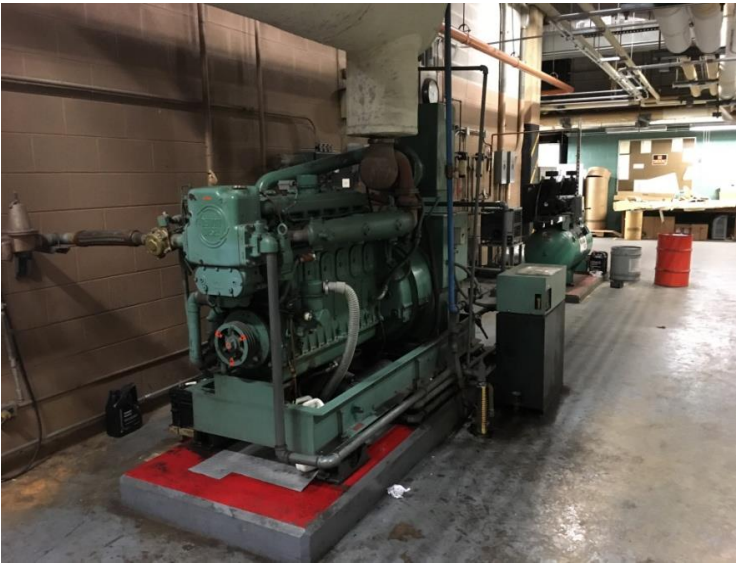
Reference:	Estimated Cost: \$119,025

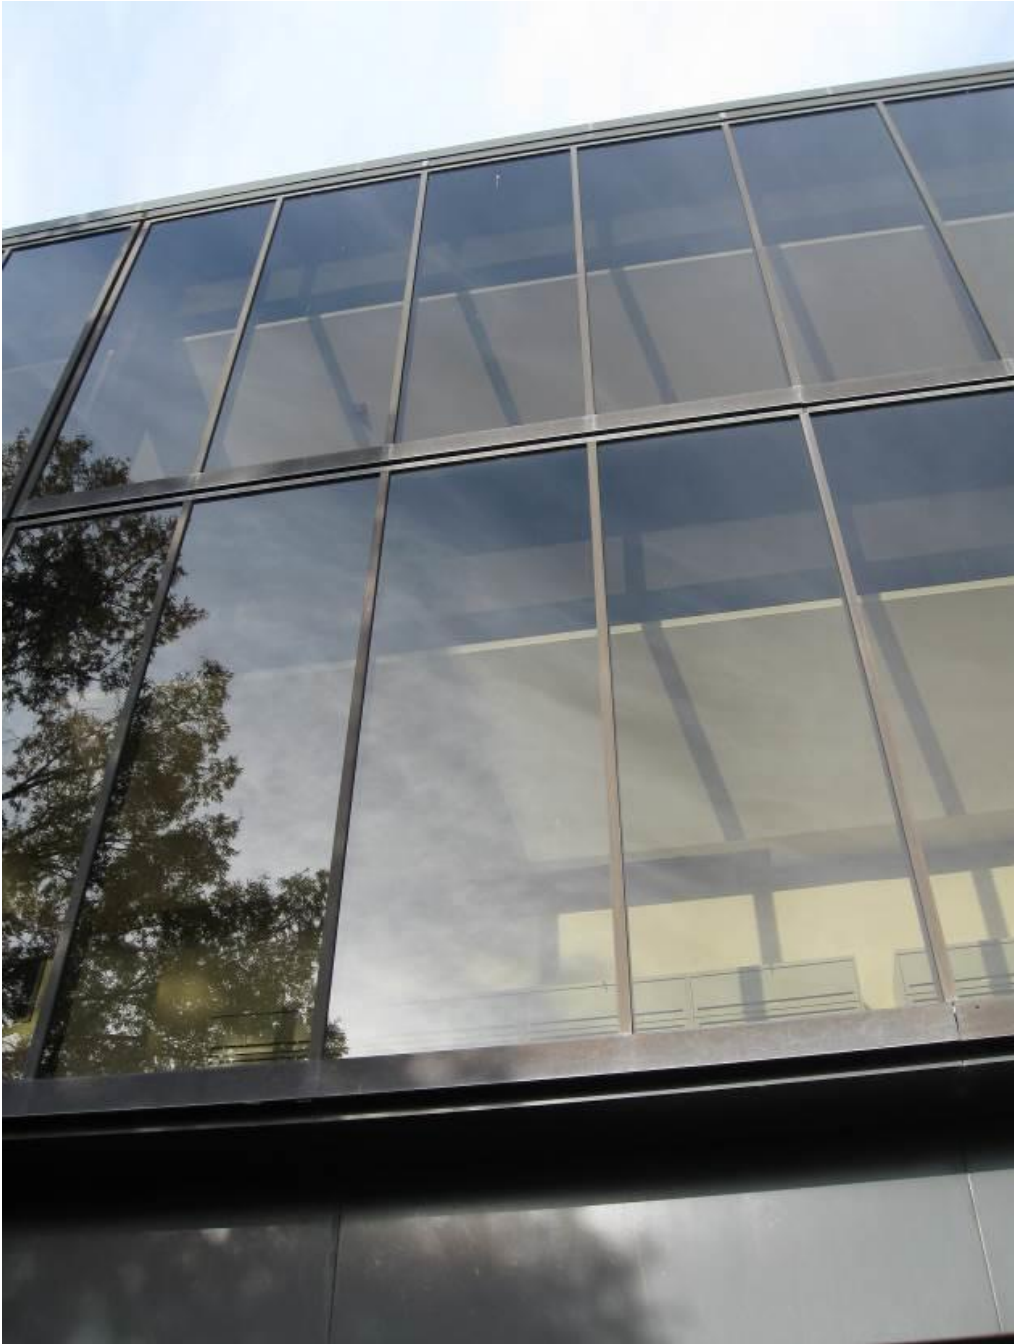
**Figure 1:** The existing curtain wall window system is an outside glazed system with a prefinished metal face cap.

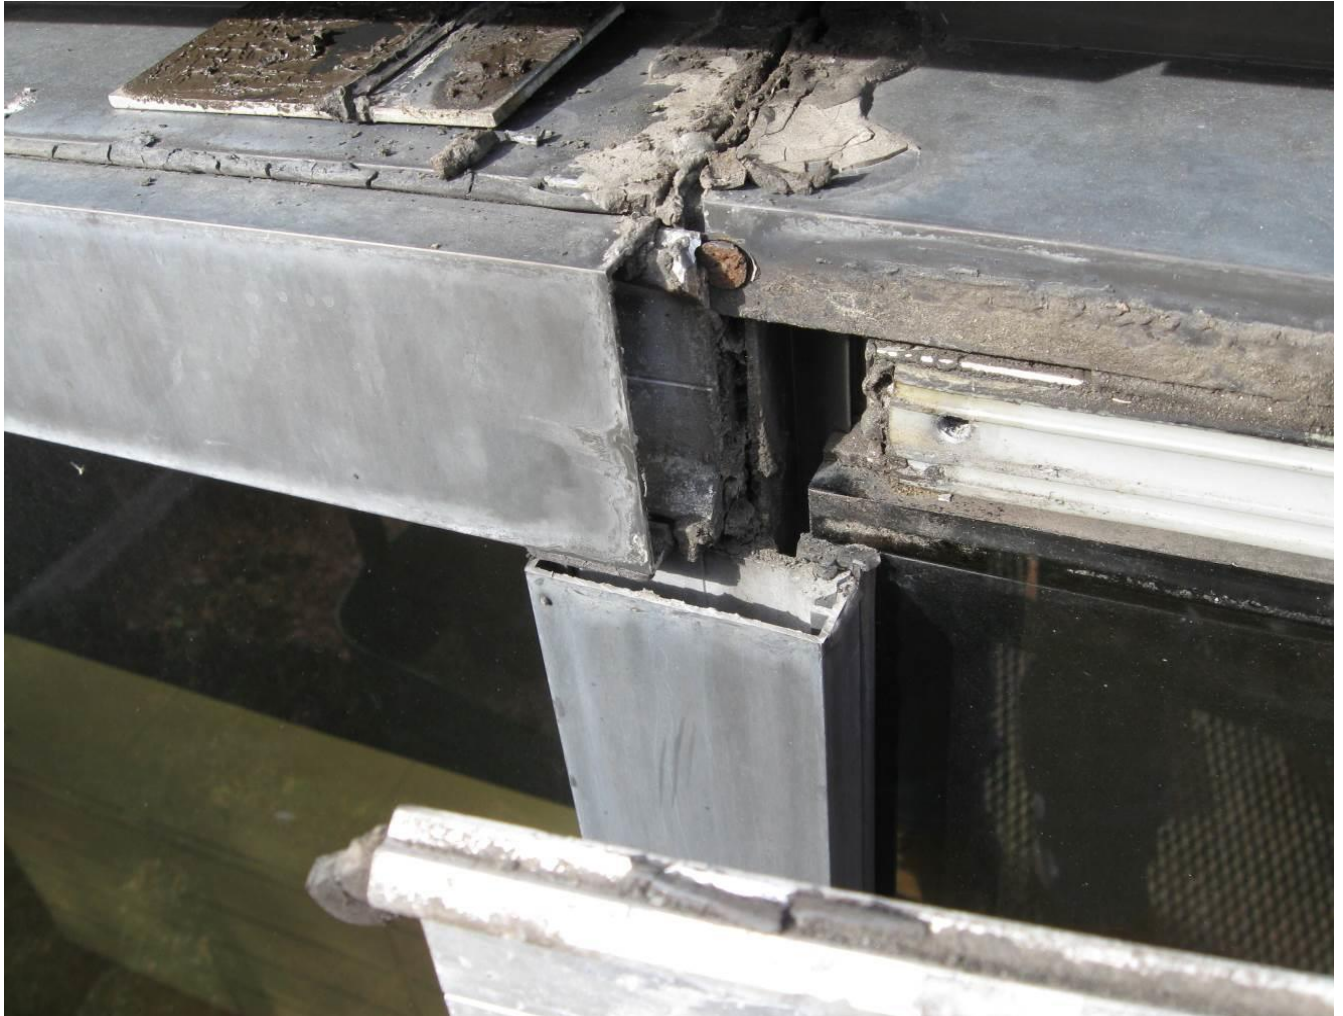
**Figure 3:** This close-up view of the exterior horizontal and vertical frames with one of the face caps removed provides a good view of the sealant. Note its condition: All the rubber and butyl tapes/seals and caulk/sealants are quite deteriorated.

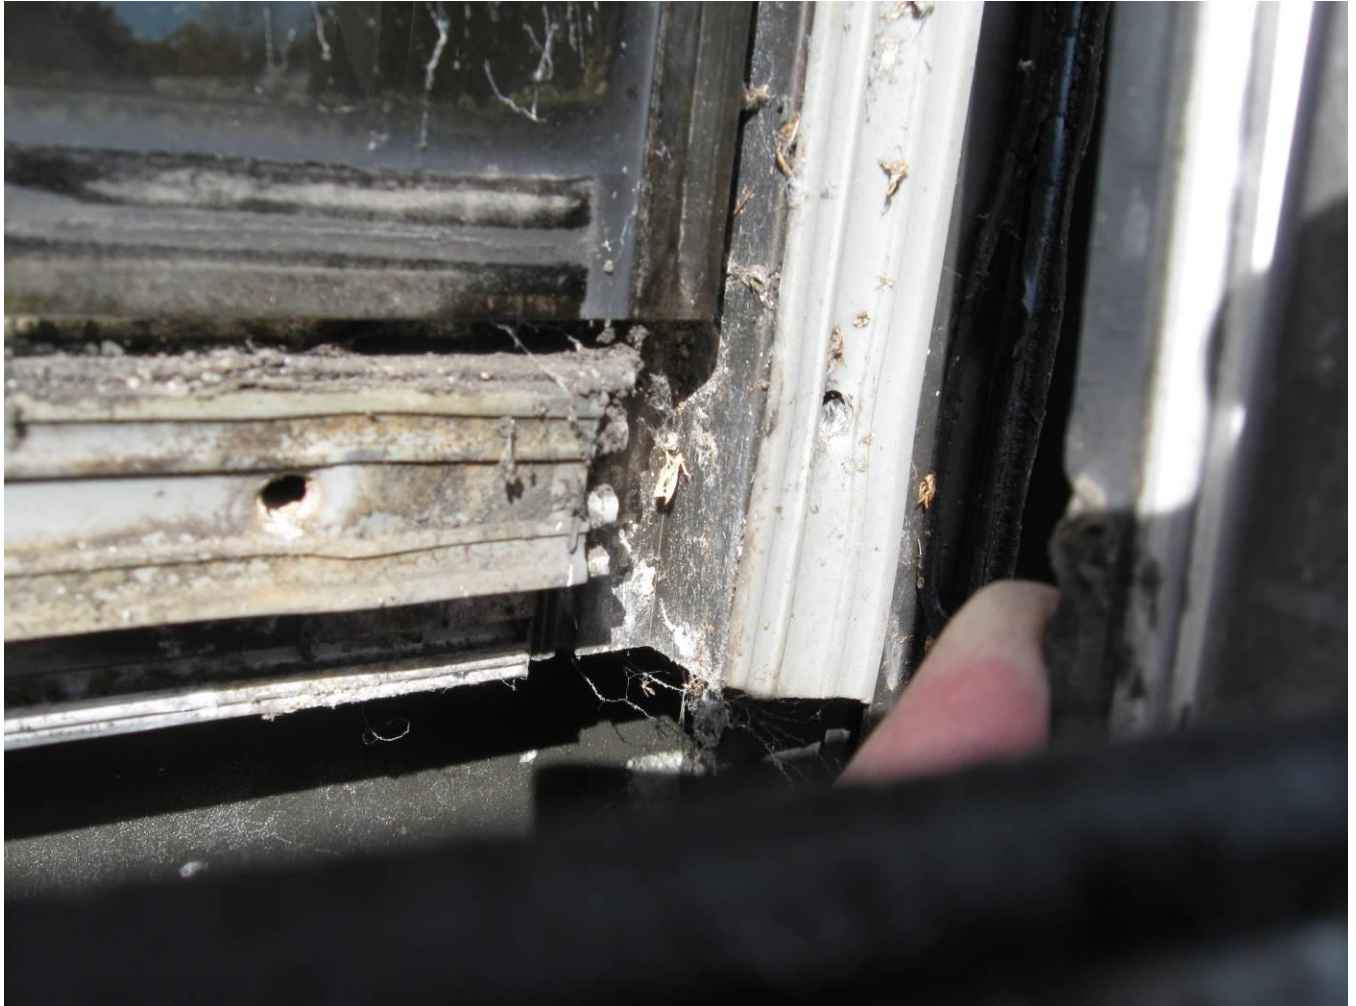
**Figure 4:** This is another view of a window at the expansion joint with the exterior face caps removed. Note that all the rubber and butyl tapes/seals and caulk/sealants were quite deteriorated.

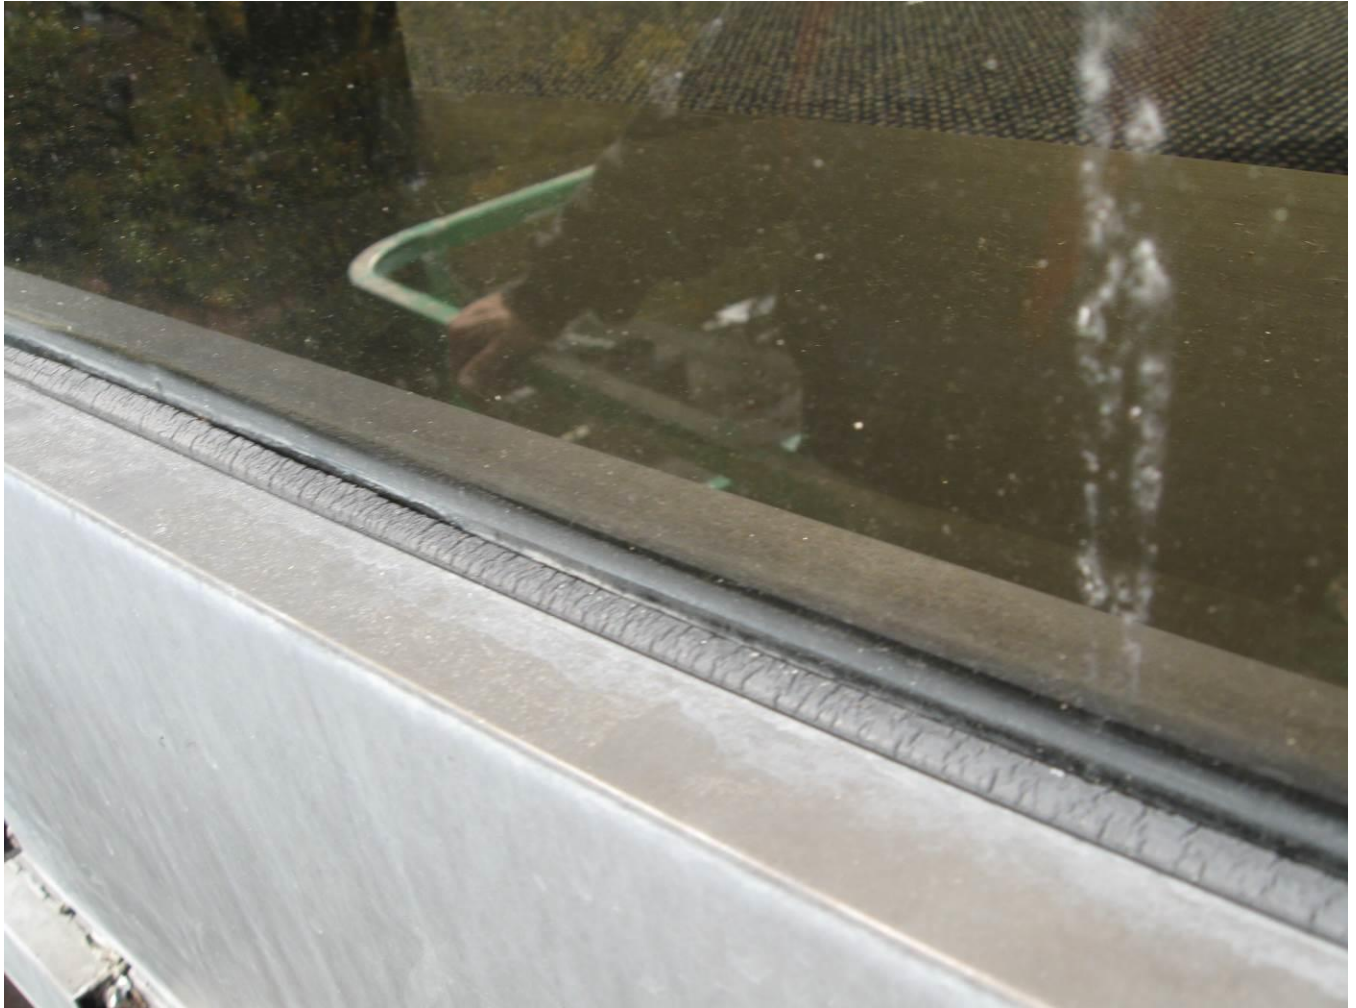
**Figure 5:** As this typical exterior picture reveals, the existing window gasketing/seals show deterioration, cracking, and exposure.

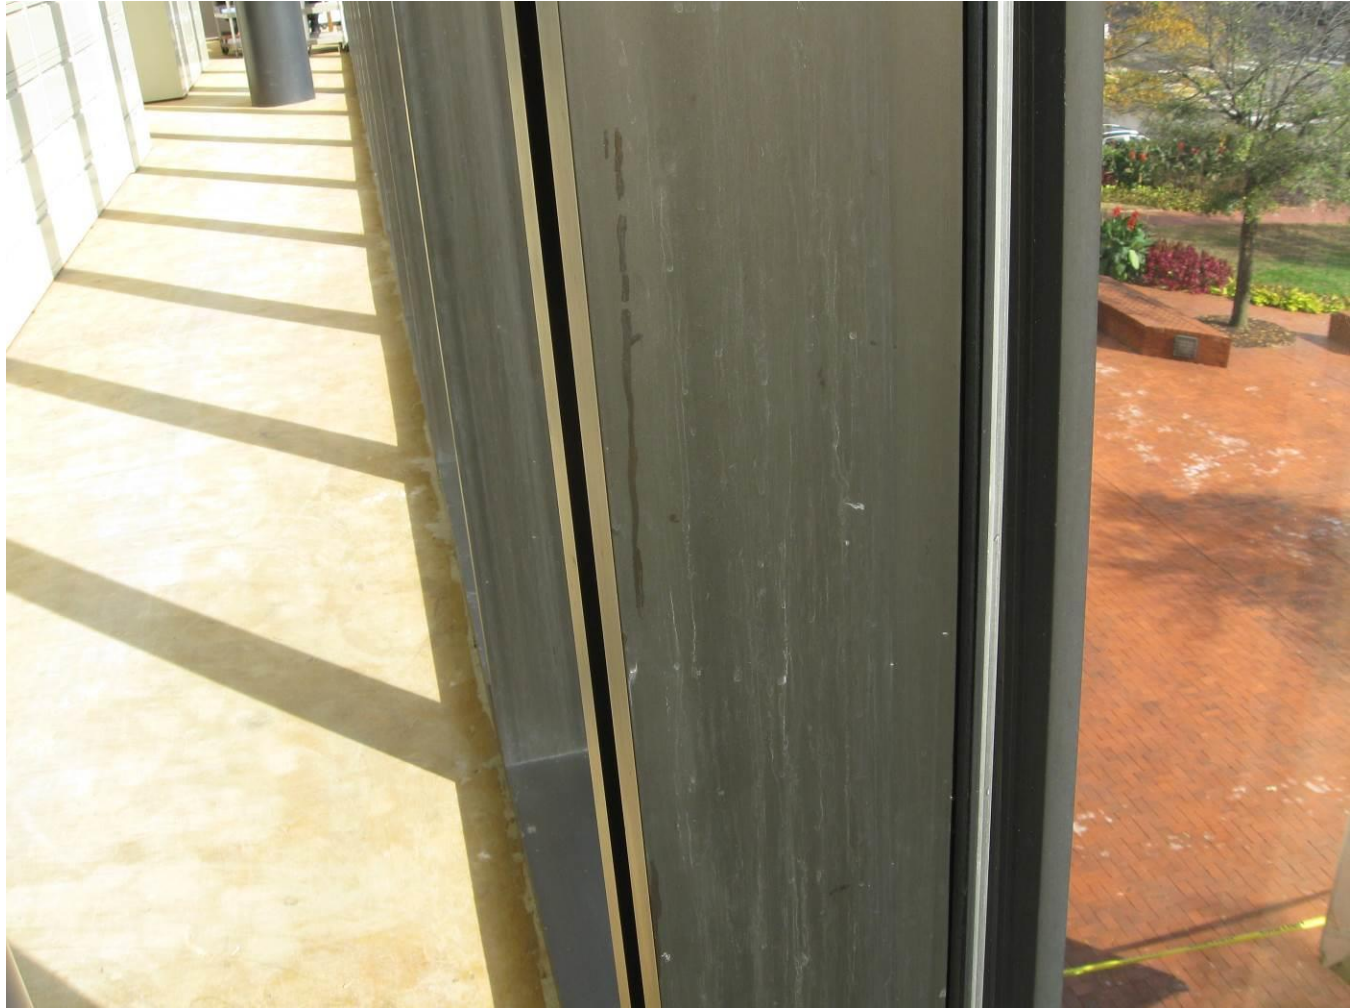
**Figure 6:** This interior picture shows that the existing window frames have water streaks and water stains.

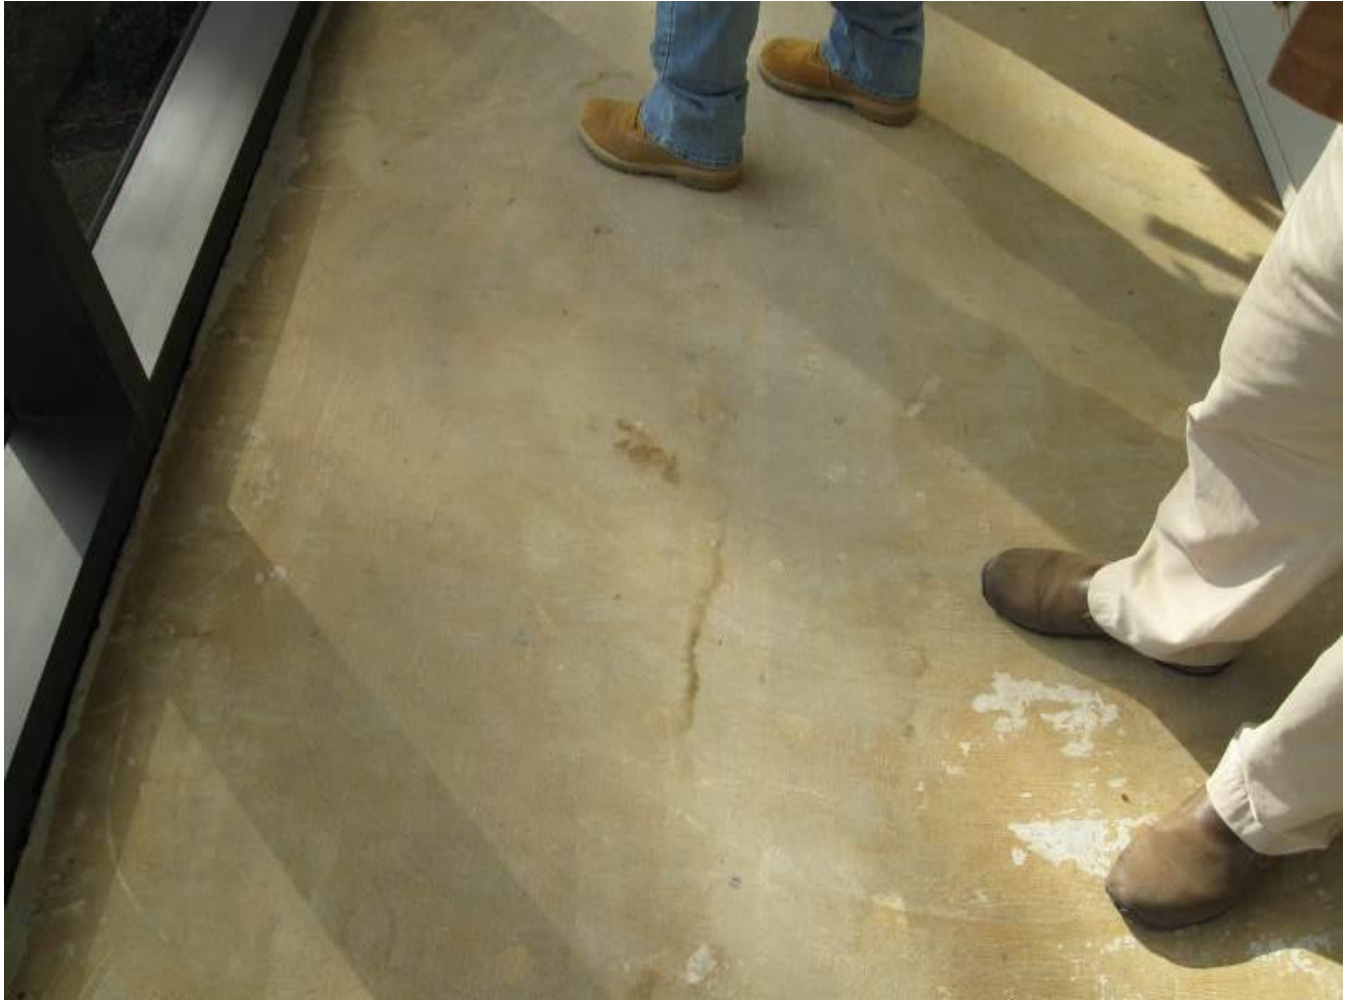
**Figure 7:** This interior picture shows water stains and water spots on the floor.

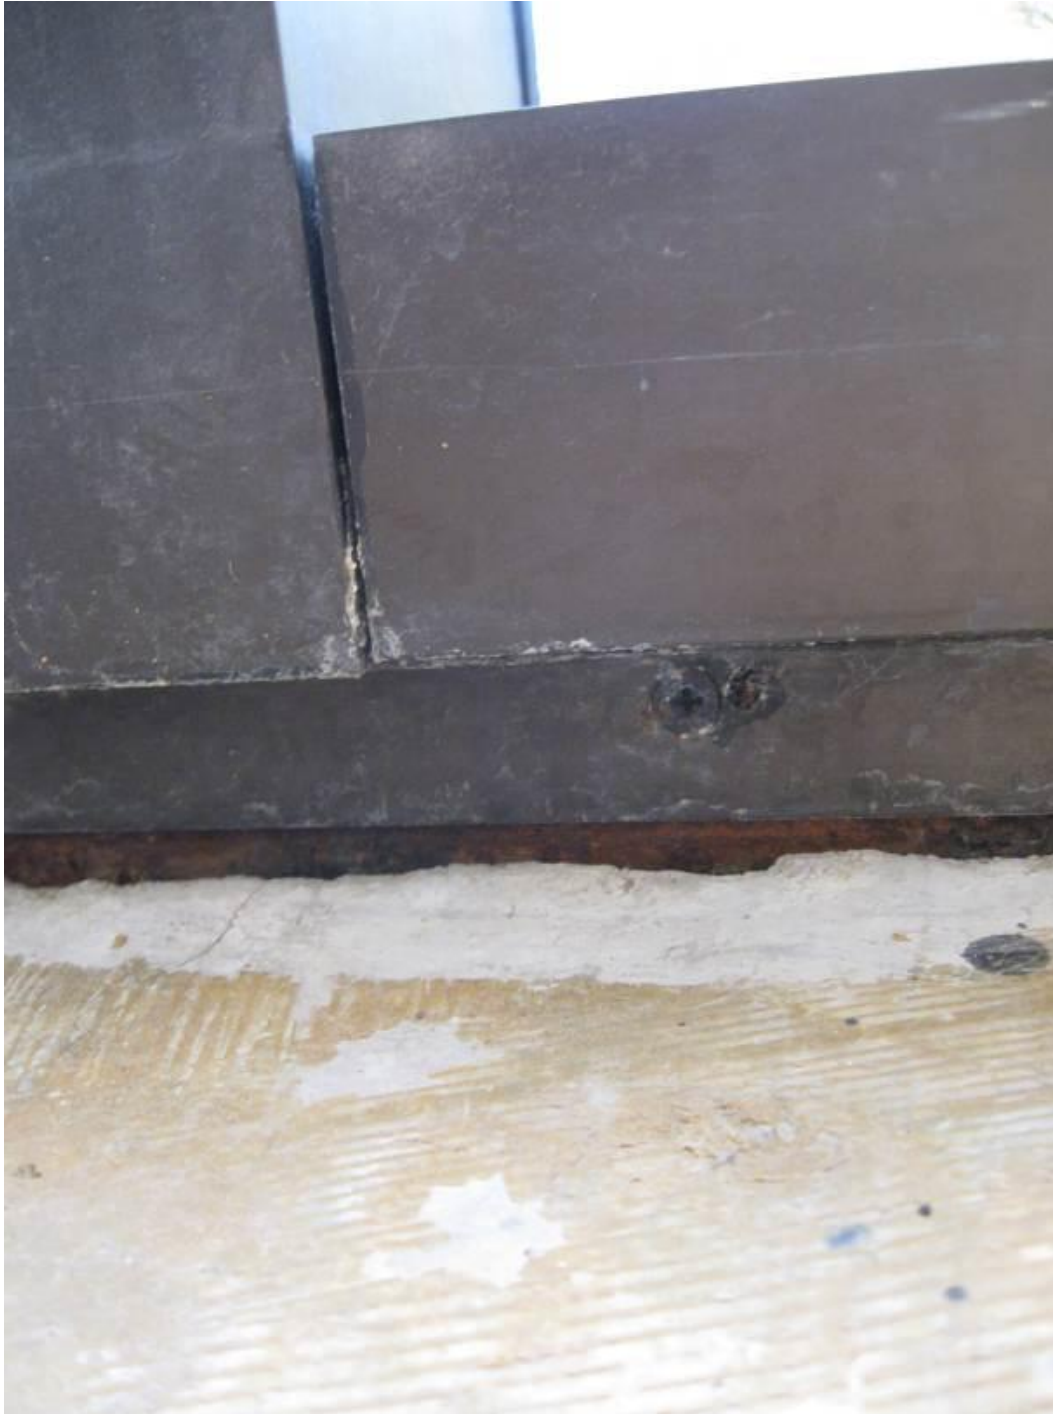
**Figure 8** – This image shows the window sill at the floor slab as well as evidence of the structural member's rusting

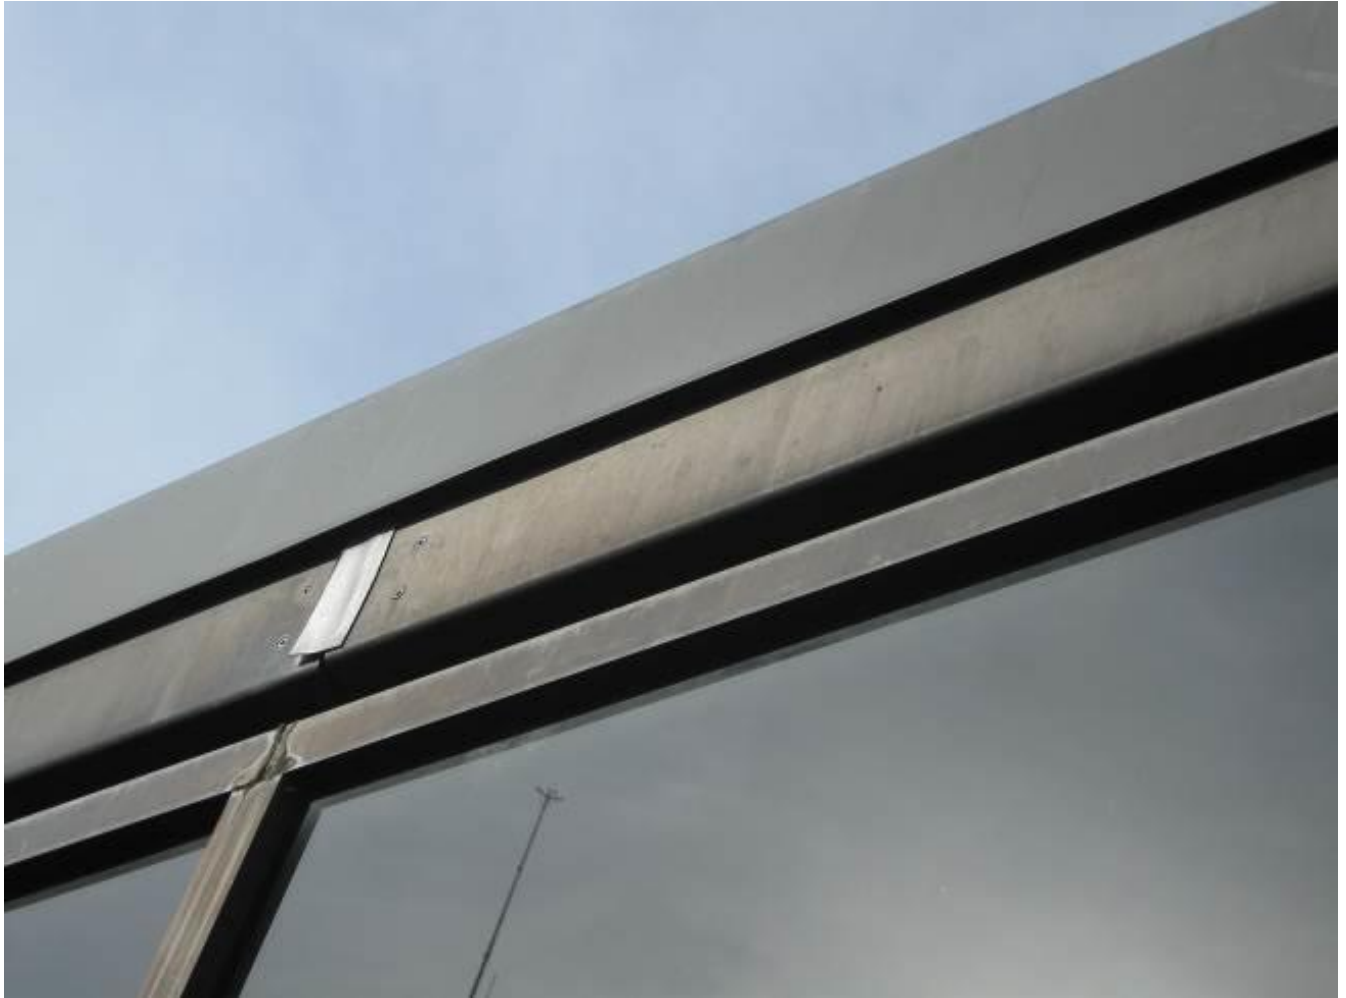
**Figure 9:** The metal coping shown is typical for the perimeter of the building. The upper most band is the metal coping (vertical leg). The band below that coping is most likely a prefinished metal panel covering the structure, which may be part of the window system. Below that is a gap and then the window frame.

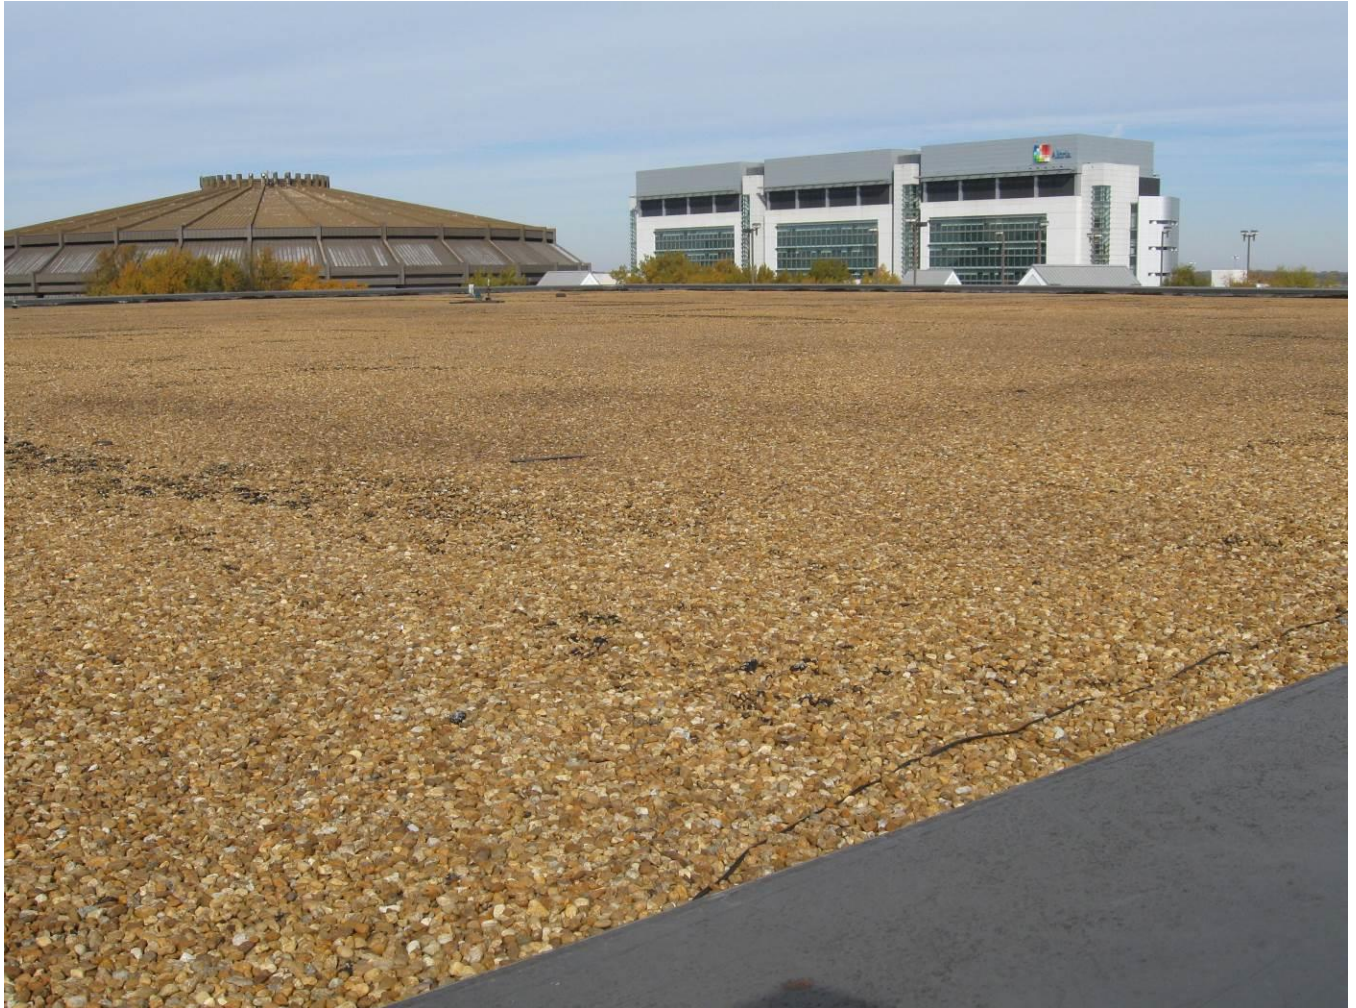
**Figure 13:** The 40-year-old roof appears to be in fairly good condition despite its age.

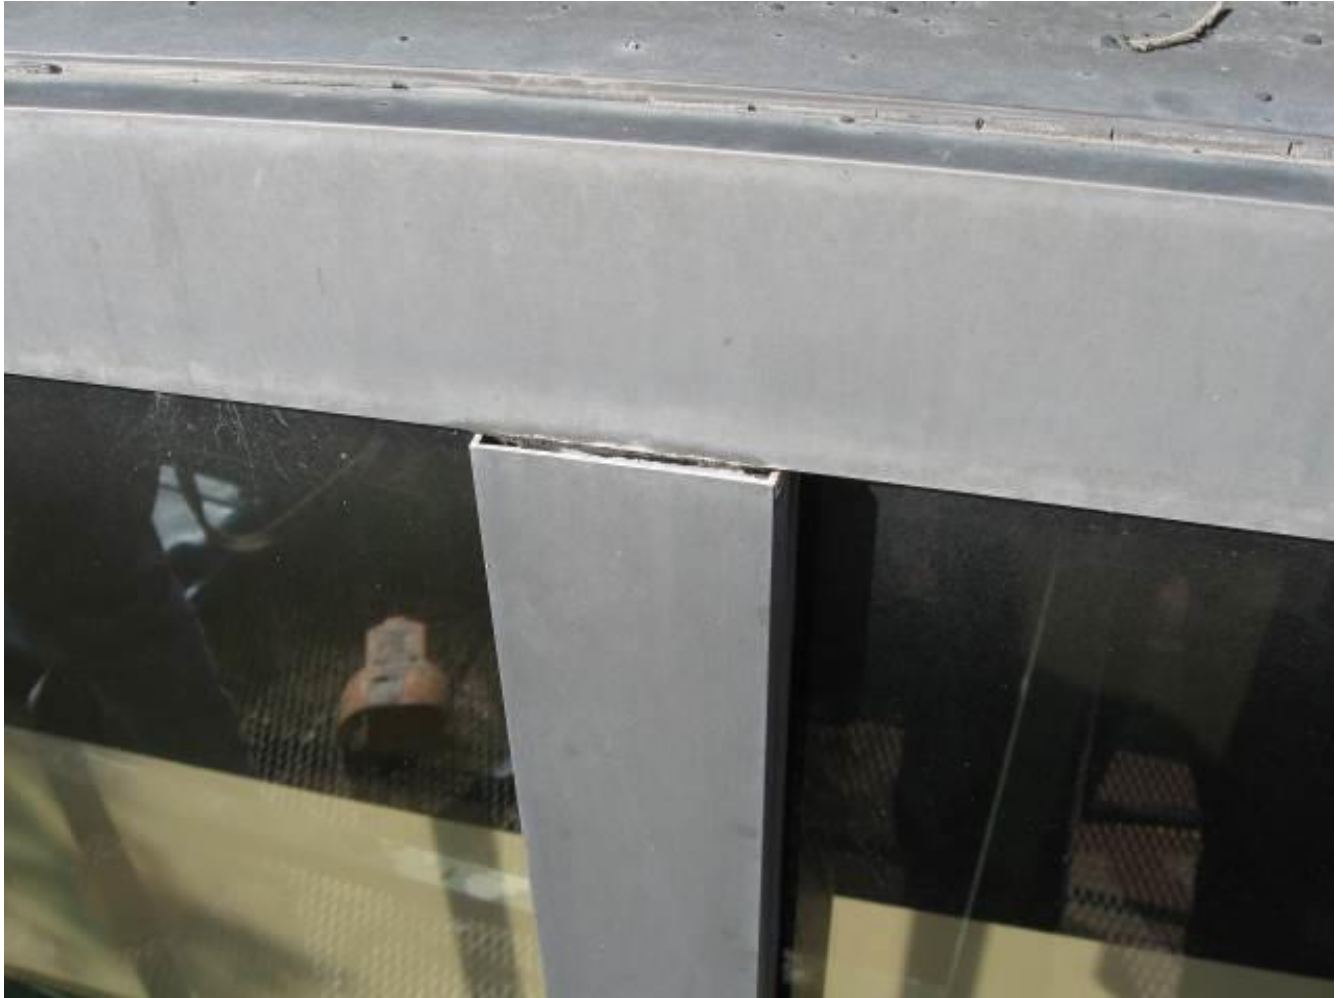
**Figure 14:** The face cap is pulled away from the window. The resulting gap exposes the interior to the elements, if the seals and flashing have failed underneath.

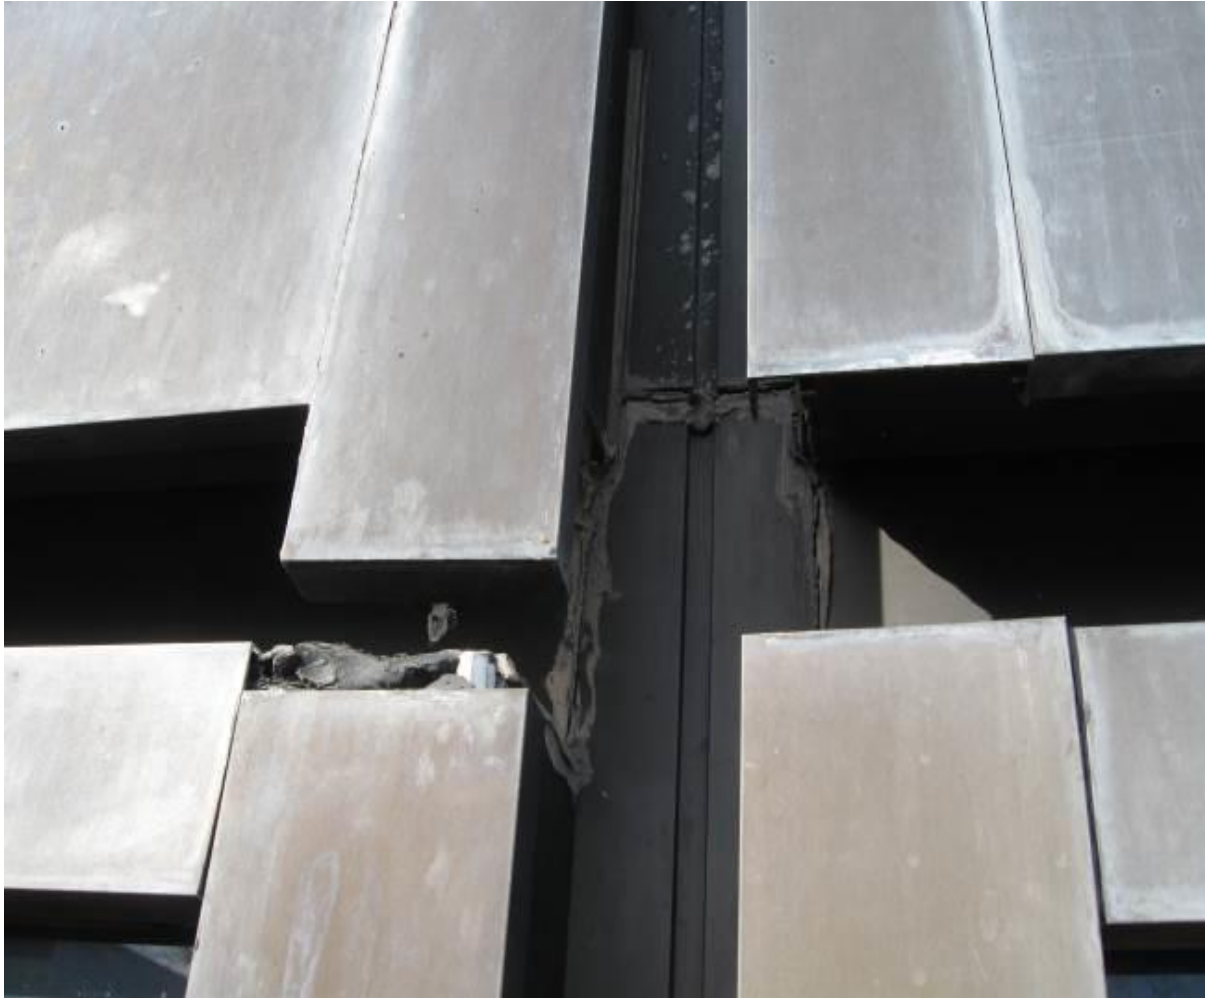
**Figure 15:** The vertical face caps are dropping downward and it can be seen where repeated attempts at caulking may also be directing water into the interior space.

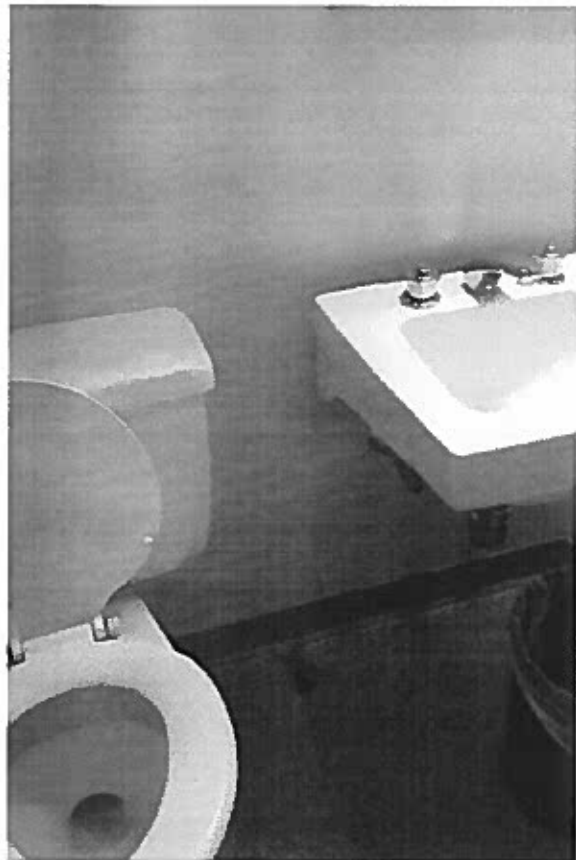
Faucet handles incorrect, sink clearance violation, uninsulated  
Pipes, no grab bars.

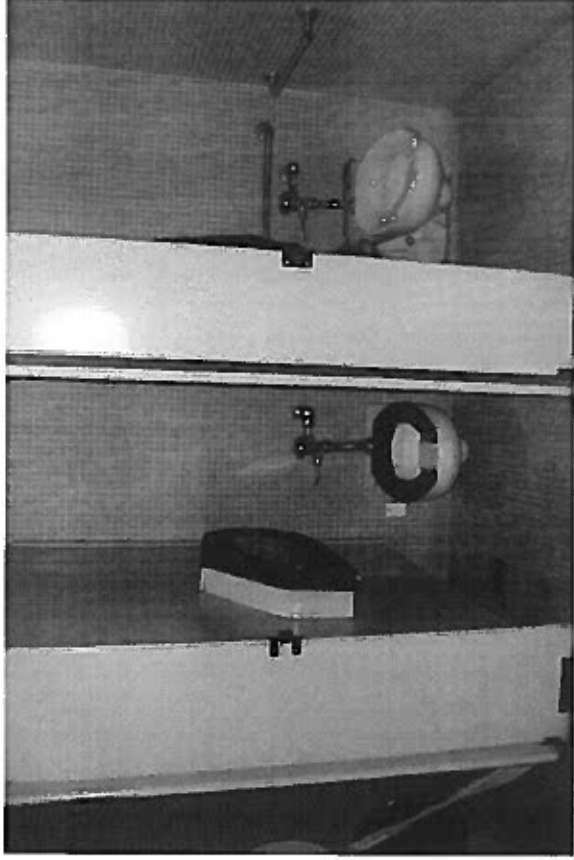
John Marshall Courts Building  
ADA Survey - 2015

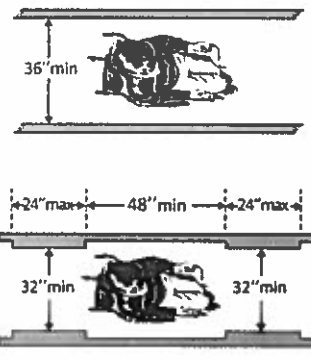
<p>Photo #:</p>	<ul style="list-style-type: none"> <li>• Widen route</li> <li>•</li> <li>•</li> </ul>

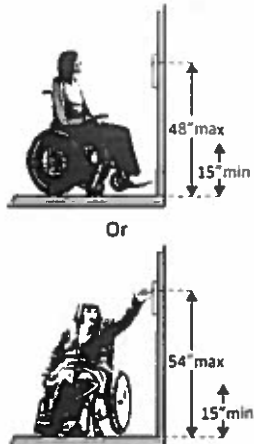
<p>Photo #:</p>	<ul style="list-style-type: none"> <li>• Change control height</li> <li>•</li> <li>•</li> </ul>

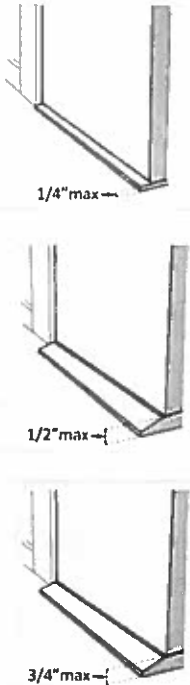
<p>1/4" max →</p> <p>1/2" max →</p> <p>3/4" max →</p>	<p>Photo #:</p>	<ul style="list-style-type: none"> <li>• Remove or replace threshold</li> <li>•</li> <li>•</li> </ul>

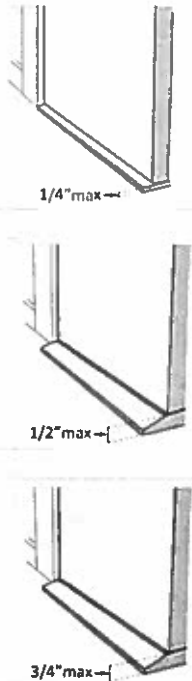
<p>1/4" max</p> <p>1/2" max</p> <p>3/4" max</p>	<p>Photo #:</p>	<ul style="list-style-type: none"> <li>• Remove or replace threshold</li> <li>•</li> <li>•</li> </ul>

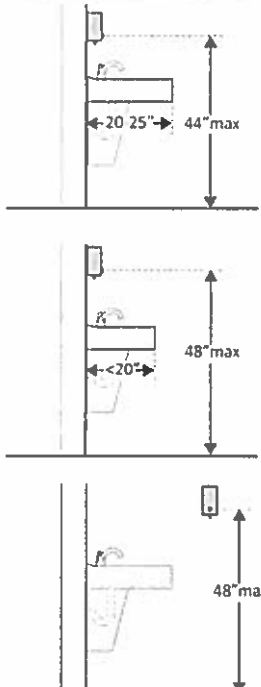
<p>Photo #:</p>	<ul style="list-style-type: none"> <li>• Adjust dispensers</li> <li>• Replace with or provide additional accessible dispensers</li> <li>•</li> </ul>
<p><b>3.29</b> Are the operable parts of the hand dryer or towel dispenser within one of the following reach ranges:</p> <p>Above lavatories or counters no less than 20 inches and no greater than 25 inches deep: no higher than 44 inches above the</p>	<p><input type="checkbox"/> Yes <input checked="" type="checkbox"/> No Measurement:</p>

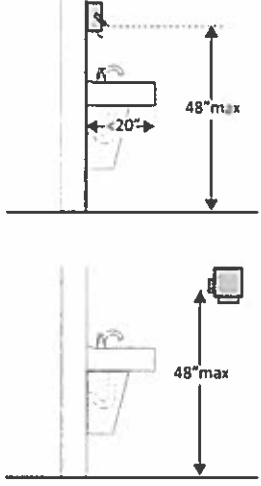
<p>Photo #:</p>	
<p><b>Water Closets in Single-User Toilet Rooms and Compartments (Stalls)</b> The 2010 Standards refer to toilets as water closets.</p>

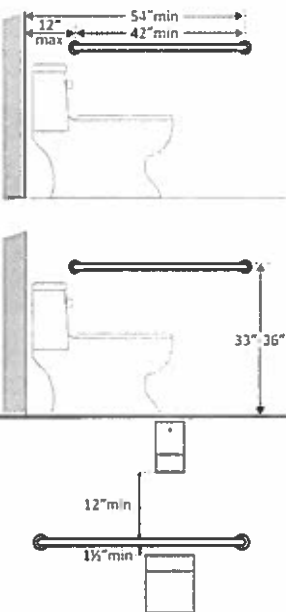
<p>Photo #:</p>	<ul style="list-style-type: none"> <li>• Install grab bar</li> <li>• Relocate grab bar</li> <li>• Relocate objects</li> <li>•</li> </ul> <p>* If constructed before 3/15/2012 grab bars do not need to be relocated; there are no space requirements above and below grab bars in the 1991 Standards</p>

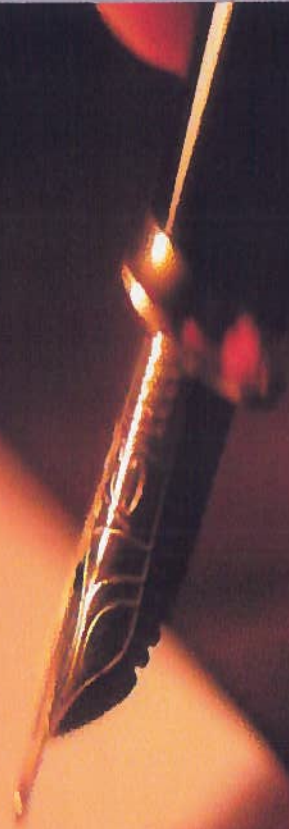
## SUMMARY OF RECOMMENDED PROJECT

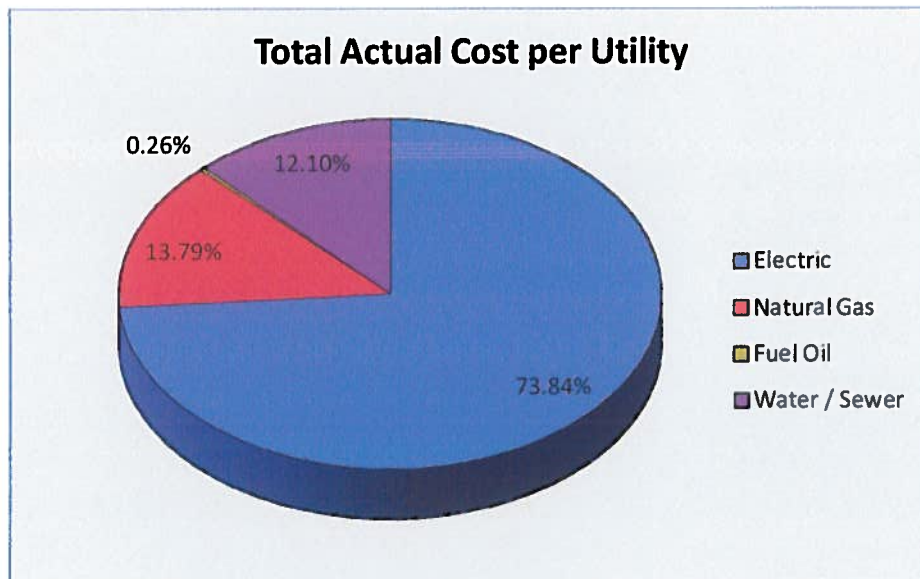
### Recommended Project

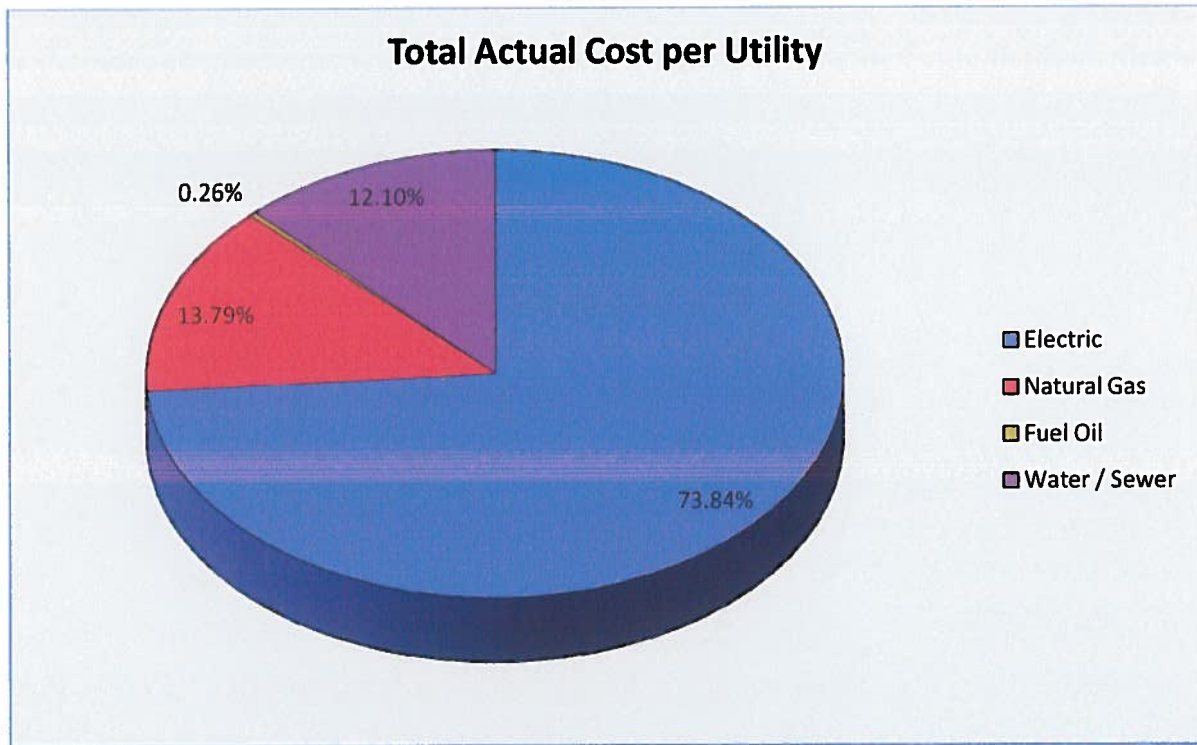
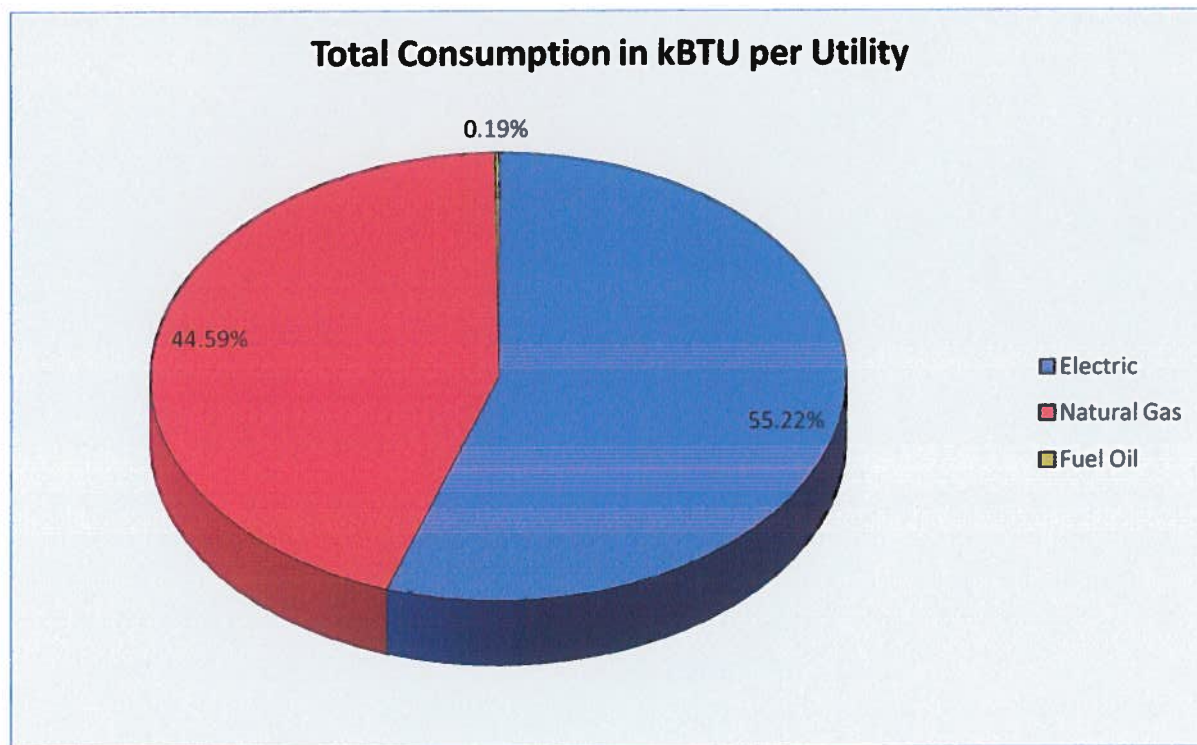
Actual Cost	Percent of Total
Total Energy Cost	\$2,469,375	
Electric Cost	\$1,894,476	76.72%
Natural Gas Cost	\$567,663	22.99%
Fuel Oil	\$7,237	0.29%
Energy Use	150,247 MMBTU	
Electric Consumption (kWh)	25,813,797	58.64%
Natural Gas Consumption (Mcf)	61,861	41.47%
Fuel Oil (gallons)	2,050	0.19%
Water & Sewer Cost	\$ 388,066	
Annual Water Use (ccf)	33,942

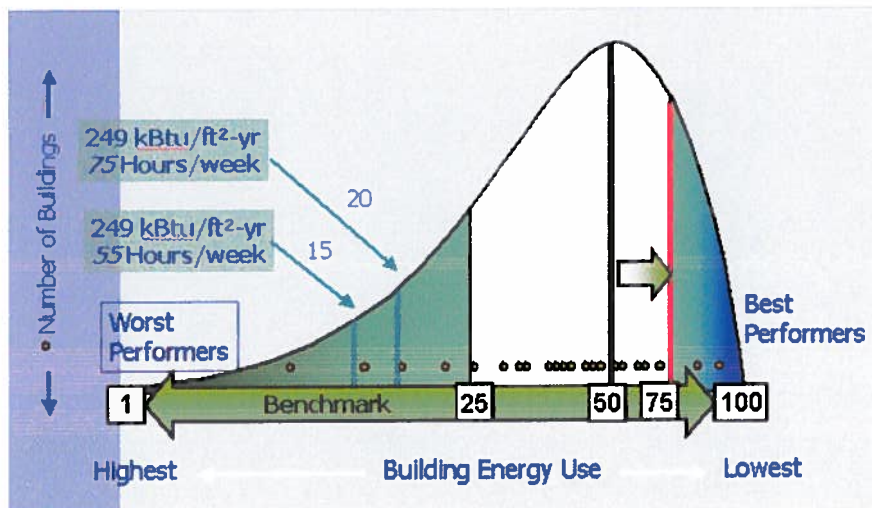
The EPA Energy Star Rating Process

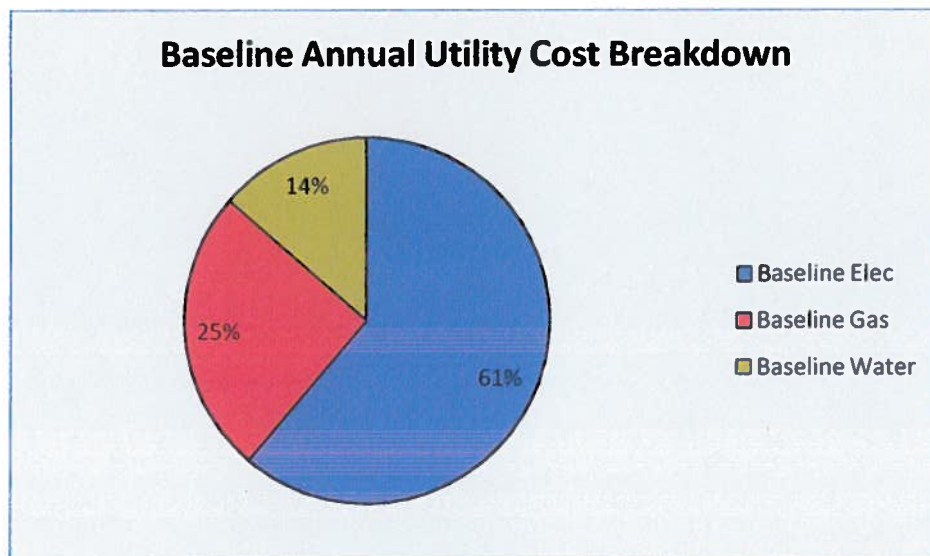
Historical trends for each of the utilities used by the facility are addressed in the specific utility sections which follow. Review of all data provided by the City for multiple years indicates that, overall, utility use is relatively stable with variations directly correlated to weather conditions and occupancy except for a few random variations. Some utility costs
