INTRODUCED: September 13, 2021

A RESOLUTION No. 2021-R072

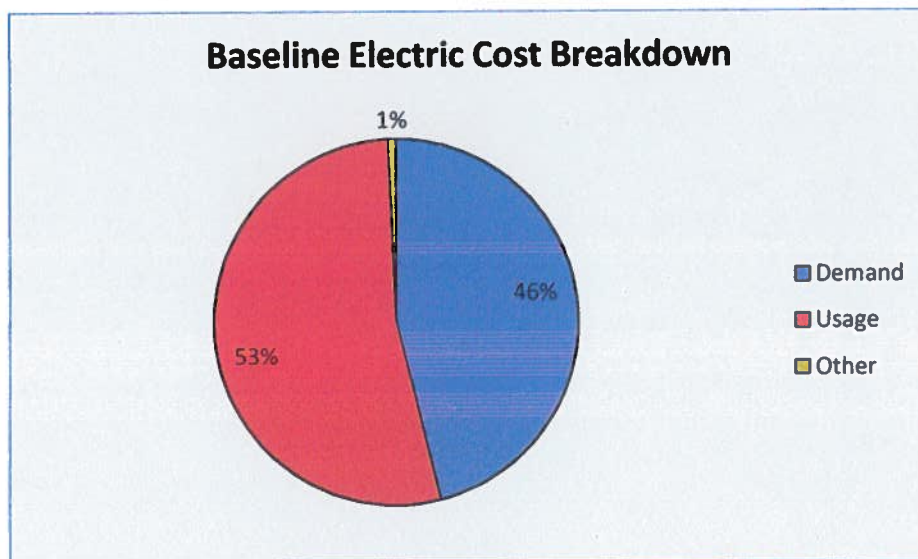
A further breakdown of electricity costs is shown in the Electric Cost Components chart below. The chart shows that electric energy costs are not strongly correlated to seasonal cooling needs, and that electricity costs tend to remain relatively the same throughout the year due to the rate structure and the consistent operation of air handling/cooling equipment. As can be seen, the highest cost percentage is due to energy use, showing how efforts to reduce energy use will be more effective in reducing cost.

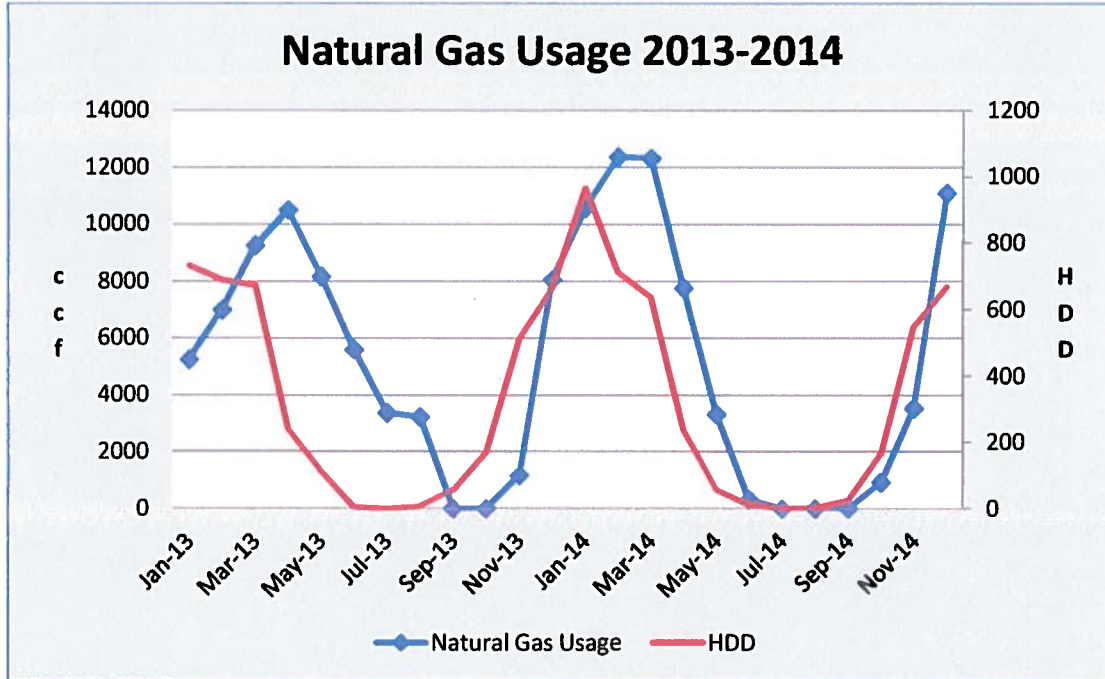
### Water & Sewer Detailed Analysis
