Commission of Architectural Review

5. COA-181523-2026	Final Review	Meeting Date: 4/28/2026
Applicant/Petitioner	Allison Wingfield	
Project Description	Replace wooden porch columns with fiberglass	
Project Location		
Address: 2735 W Grace Street		
Historic District: West Grace Street		
<p>High-Level Details:</p> <p>The applicant proposes to replace four existing wooden Corinthian columns on the front of a Colonial Revival Style, three story multifamily building circa 1927.</p> <p>The wooden columns are proposed to be replaced with new fiberglass columns.</p> <p>The extant columns are in poor condition and show evident signs of rot exacerbated by water intrusion.</p>		
Staff Recommendation		
Staff Contact	Alex Dandridge, Alex.Dandridge@RVA.gov, (804)646-6569	
Previous Reviews	<ul style="list-style-type: none"> • Review 	
Staff Recommendations	<ul style="list-style-type: none"> • Approval of the replacement of the four wooden column shafts with fiber glass. • Extant column capitals be salvaged and reinstalled. • Final dimensions of the fiberglass columns be submitted for staff review and approval prior to installation. • New bases of the columns match the original in design and dimen

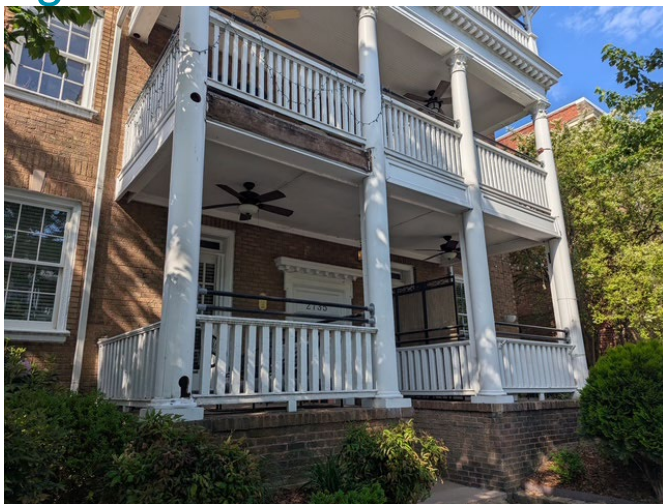
Figure 1. Existing Conditions, facade, April 2026.

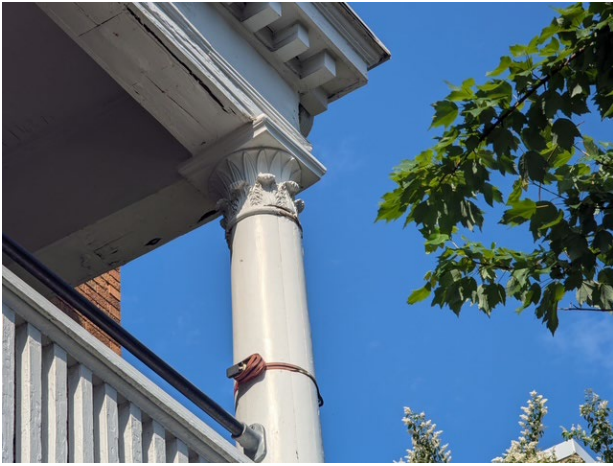
Figure 3. Existing condition of western column. April 2026.

<p>design and dimension. Additionally, the preservation of historic materials and decorative elements that are salvageable should be prioritized. The decorative column capitals appear to be in good condition without any visual indication of rot.</p> <p><u>Staff recommends approval of the replacement of the four wooden column shafts with fiber glass.</u></p> <p><u>Staff recommends the extant column capitals be salvaged and reinstalled.</u></p> <p><u>Staff recommends that the final dimensions of the fiberglass columns be submitted for staff review and approval prior to installation.</u></p> <p><u>Staff recommends the new bases of the columns match the original in design and dimension, design submitted for staff approval.</u></p>
--	--	--

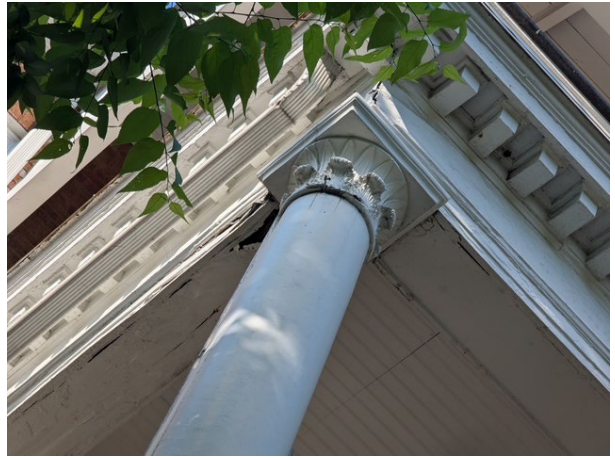
Figure 4. Existing condition of eastern column. April 2026.

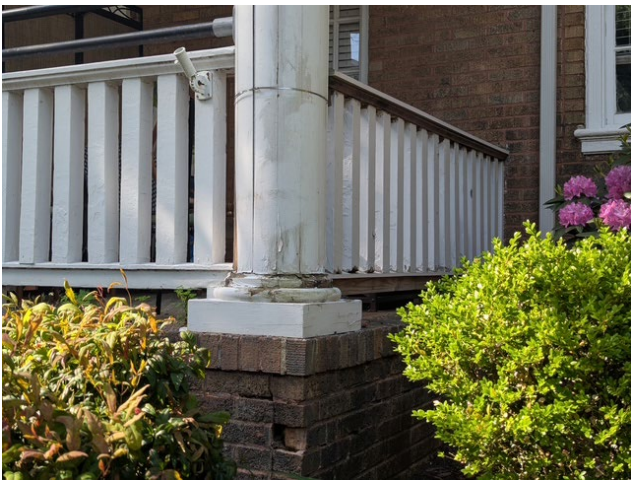
Figure 5. Existing condition of western column. April 2026.

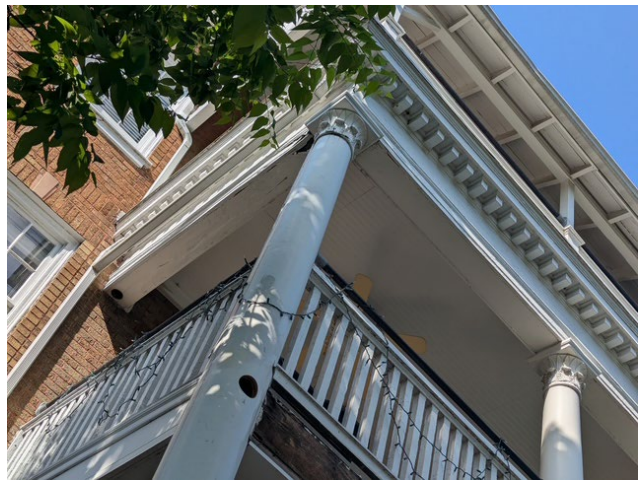
Figure 6. Existing condition of eastern column. April 2026.

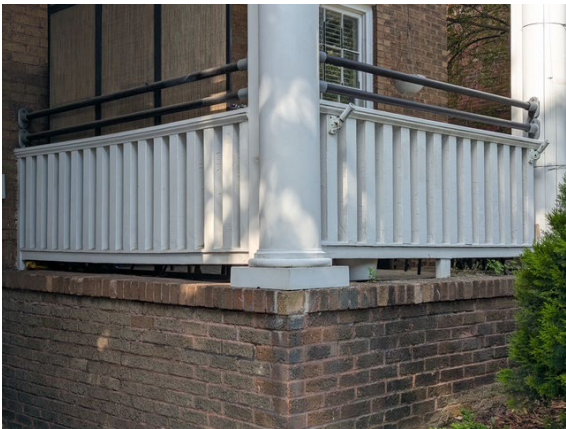
Figure 7. Existing condition of eastern column. April 2026.
