3. COA-090017-2021

3225 Monument Avenue

STAFF REPORT

PROJECT DESCRIPTION
Replace eleven windows.

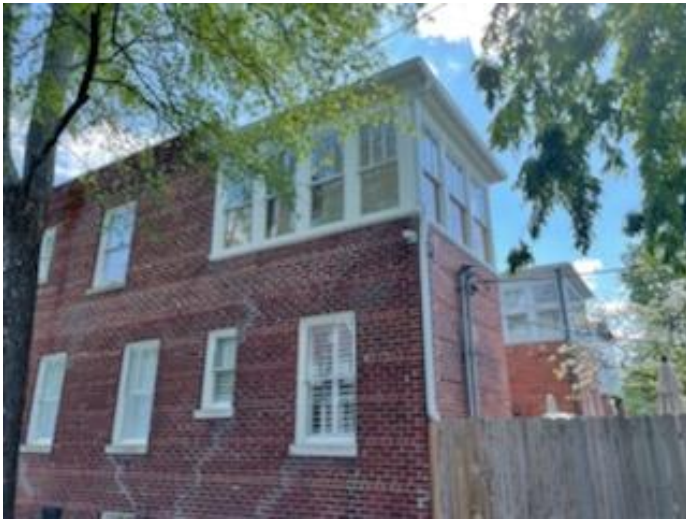
Based on the information submitted by the applicant, staff finds the windows proposed for replacement are not deteriorated beyond repair. Staff recommends that the existing wooden windows be retained and repaired as necessary.

Figure 1. 3225 Monument, side and rear elevation from Tilden Street.

- Staff recommends that the existing wooden windows be retained and repaired as necessary
- Staff recommends the applicant consider installing interior or exterior storm windows, which can be administratively approved

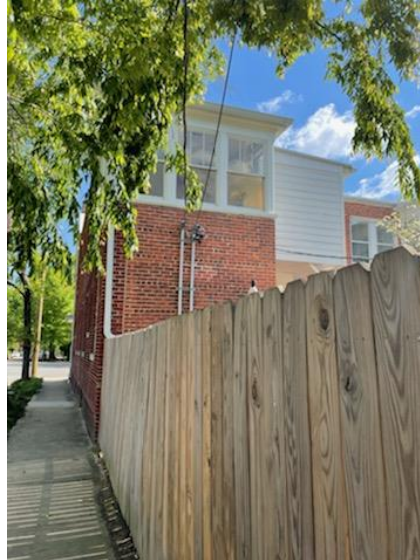
The applicant has indicated to staff that they would like to replace the rear windows because they are not thermal efficient. Staff suggests that storm windows can increase the thermal efficiency of single-pane wood windows. Staff recommends the applicant consider installing interior or exterior storm windows, which can be administratively approved. Staff notes that exterior storm windows were utilized on the residence as recently as 2017 and have since been removed.

Figure 2. 3225 Monument, rear elevation from Tilden Street

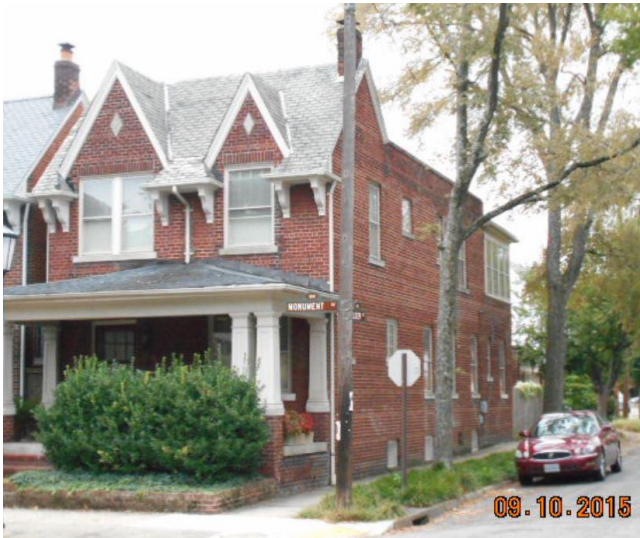
Figure 3. 3225 Monument, view of storm windows on front and side elevations. 2015, City Assessor's Image.

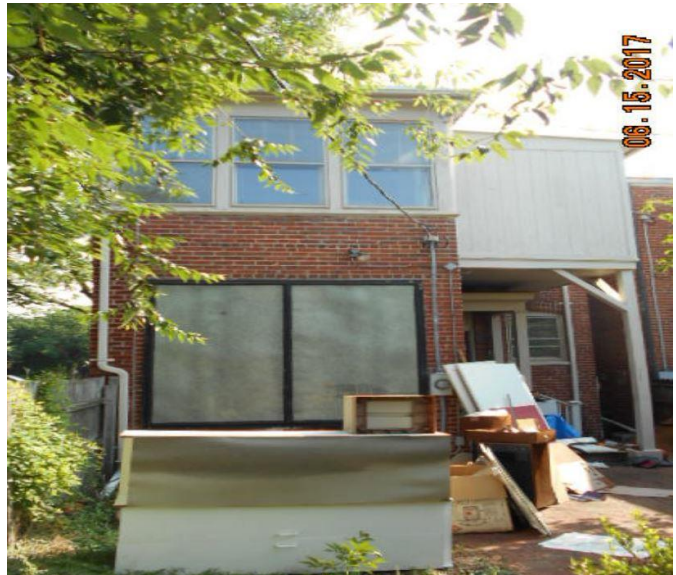
Figure 4. 3225 Monument, view of storm windows on rear elevation. 2017, City Assessor's Image.
