City of Richmond After-Action Assessment Report

HNTB

April 7, 2025

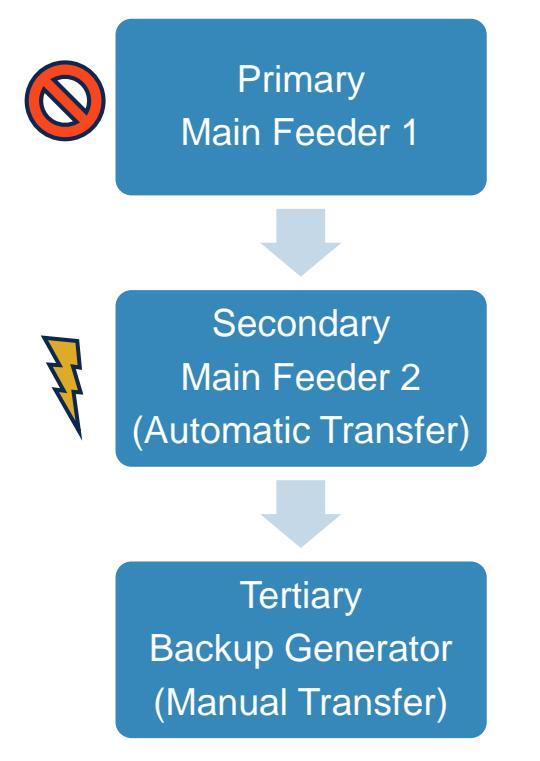
Winter Mode of Operation

- Winter Mode puts the WTP at greater risk. Bus tie in SG 6 becomes singular critical component.
- Close coil in SG 6 bus tie cabinet failed (root cause of event).
- UPS did not close filter effluent valves.
- Existing UPS units were undersized and had additional loads placed on them.

- Code requires WTP facilities have two (2) power sources, a primary and a backup.
- Richmond WTP has two (2) feeds from Dominion Energy that serve as primary and backup.
- Backup generators are a tertiary and manual power supply source.
 - Intended to be used when both power feeds are out.
 - Main Feeder 2 still had power, so first step was to transfer power to that that feed.

- Recommendations:
 - Operate the WTP in Summer Mode at all times.
 - Develop a bus tie failure plan, ensure all electrical staff are properly trained on the plan, and clearly display the plan on each bus tie cabinet.
 - Provide a filter effluent valve UPS with a parallel duplicate backup UPS in each plant; sizing and operation to meet requirements of Chapter 7 of the VA Electrical Code for legally required systems.
 - Provide automatic transfer system for the existing backup generator system.
