Commission of Architectural Review

9. COA-128330-2023	Regular Review	Meeting Date: 4/25/2023
Applicant/Petitioner	Colin Elliott	
Project Description	Renovation of the existing garage, located at the rear of the property.	
Project Location

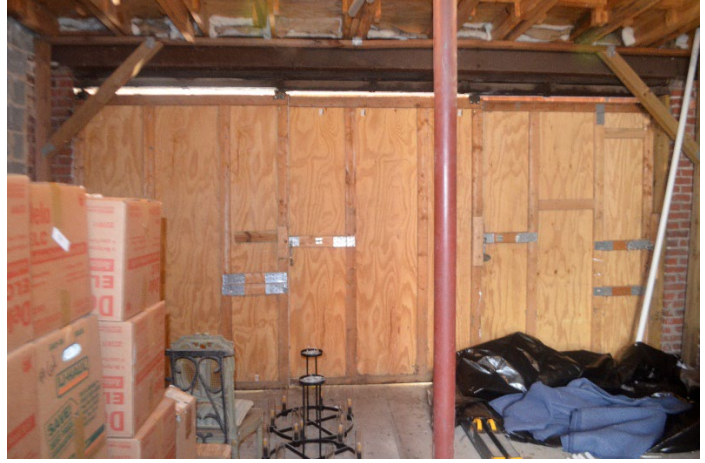
Figure 2. Interior of the garage door which will be replaced with a new, automatic door.

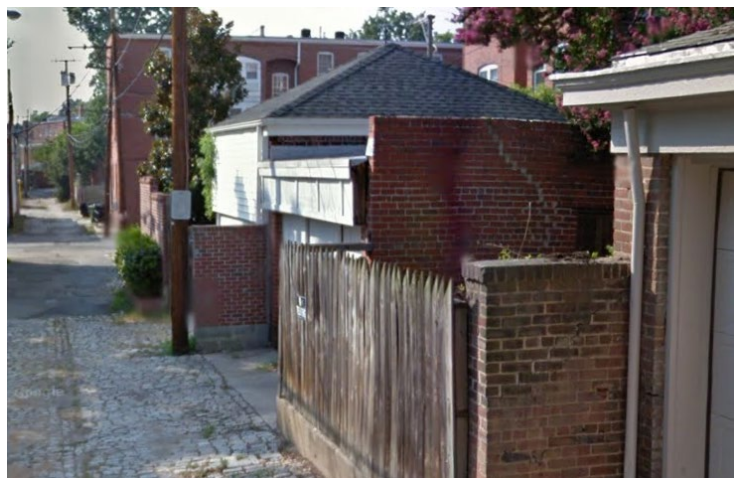
Sometime after 2011, the east wall of the garage was redone with CMU blocks and a brick veneer. A Google Maps photograph from 2011, shows the historic east wall of the garage with a window in the middle. The renovation of the garage’s east wall was not done with CAR approval and was not built soundly. The garage roof is not in good condition structurally and needs to be replaced. The applicant proposes to reconstruct the

Figure 4. View of the historic east wall of the garage from Google Street View in July 2011. This wall was replaced without CAR approval, sometime after 2011.

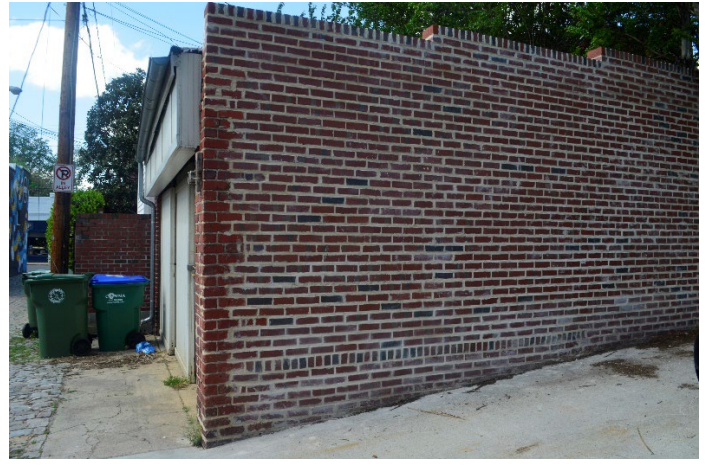
Figure 6. Existing brick veneer wall on the east side which was built sometime after 2011.

New Construction: Residential Outbuildings, page 51	<i>4. Prefabricated yard structures are discouraged. Screening will be considered as a mitigating factor for the installation of these structures.</i>	The garage will all be built of brick. The east wall was reconstructed with CMU blocks, which will be taken out. The garage width will be lengthened with the reconstruction an all-brick wall.
New Construction: Fences & Walls, page 51	<i>1. Fence, Wall and Gate designs should reflect the scale of the historic structures they surround as well as the character of nearby fences, walls and gates.</i>	The proposed brick wall will be constructed in the same massing and scale as neighboring brick walls. <u>Staff recommends that the new brick wall be constructed with similar dimensions, color and mortar joint profiles to the historic brick.</u>
New Construction: Fences & Walls, page 51	<i>2. Fence, wall or gate materials should relate to building materials commonly found in the neighborhood.</i>	The proposed wall will be built of brick similar to other walls found along the alley.

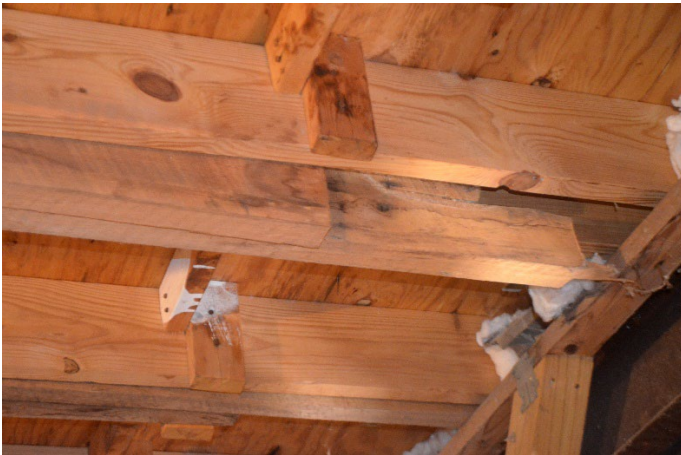
Figure 7. Interior view of the structurally unsound roof in the garage.

roof, similarly to the current roof. The east wall will be redone similarly to the rest of the garage but extended four feet farther east.

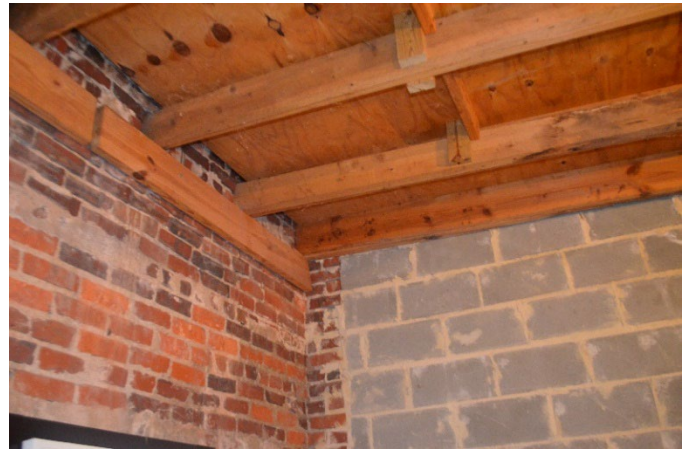
Figure 8. Interior of the garage showing the northeast corner, and the replacement east wall.

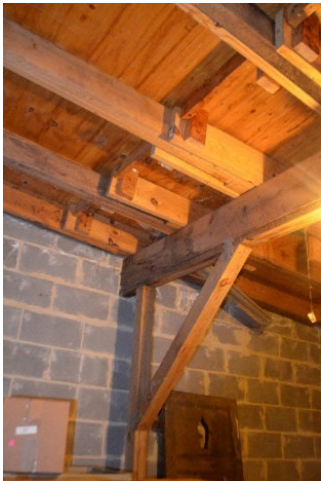
Figure 9. Interior view of the garage's east wall. The photograph shows additional wall braces added to support the unsound roof.

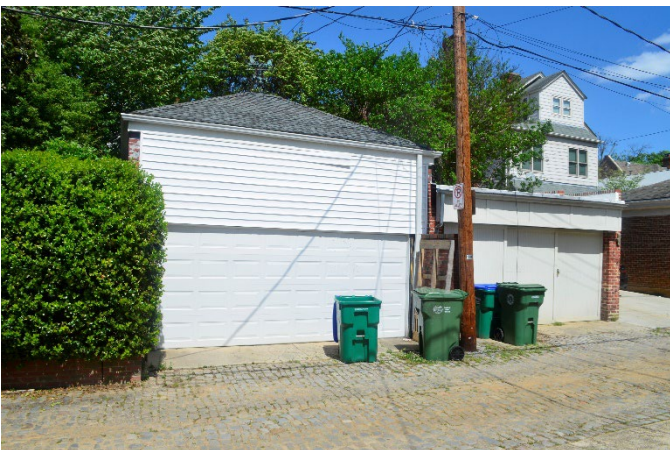
Figure 15. 2917 Monument Avenue garage. The façade of this garage appears to have been modified at some point. The 2915 Monument Avenue garage can be seen on the right side of the photograph.
