CAR SUBMISSION FOR 2114 M STREET RENOVATION & ADDITION

Prepared by LoCh Design
June 26, 2025

2114 M Street - PROJECT OVERVIEW

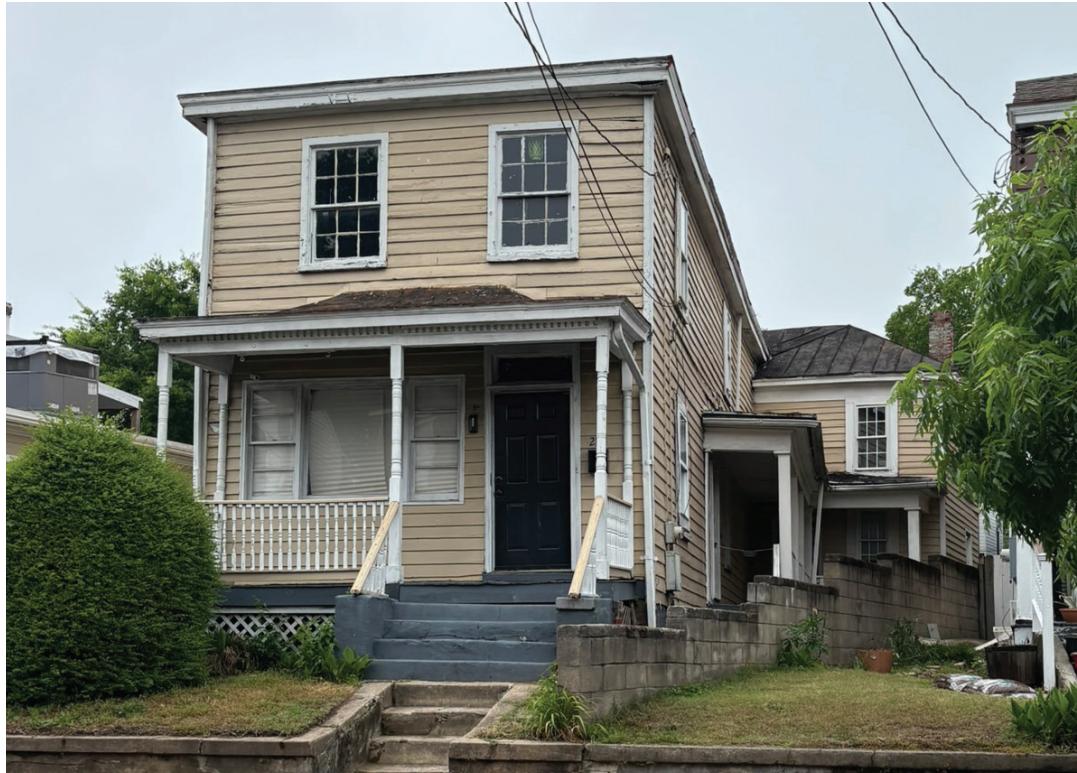
View of front and east elevations

Note: The roof structure, frieze beam, fasica, dental molding, crown, brick masonry piers, appear to be original and will be retained and restored. The remainder of the porch will be replaced as shown in the attached documents..

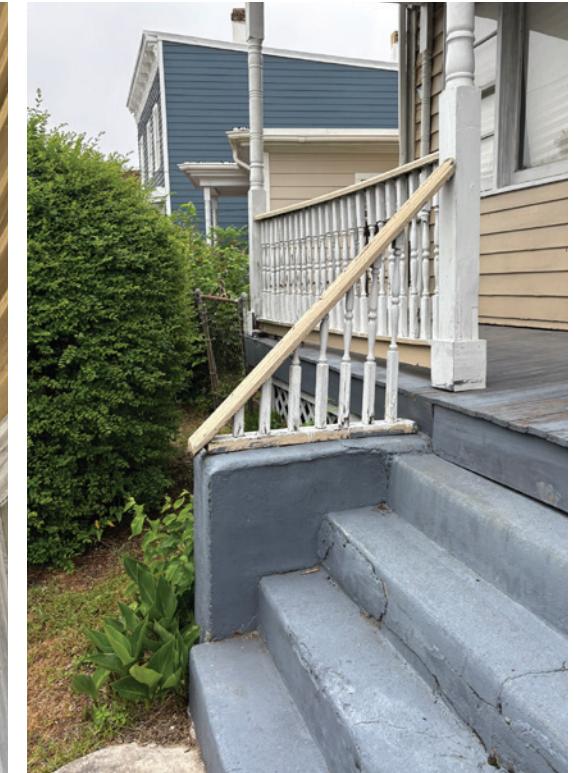
View of front porch steps and rail

Note: The stair and side wall are in disrepair. and demolition is proposed.

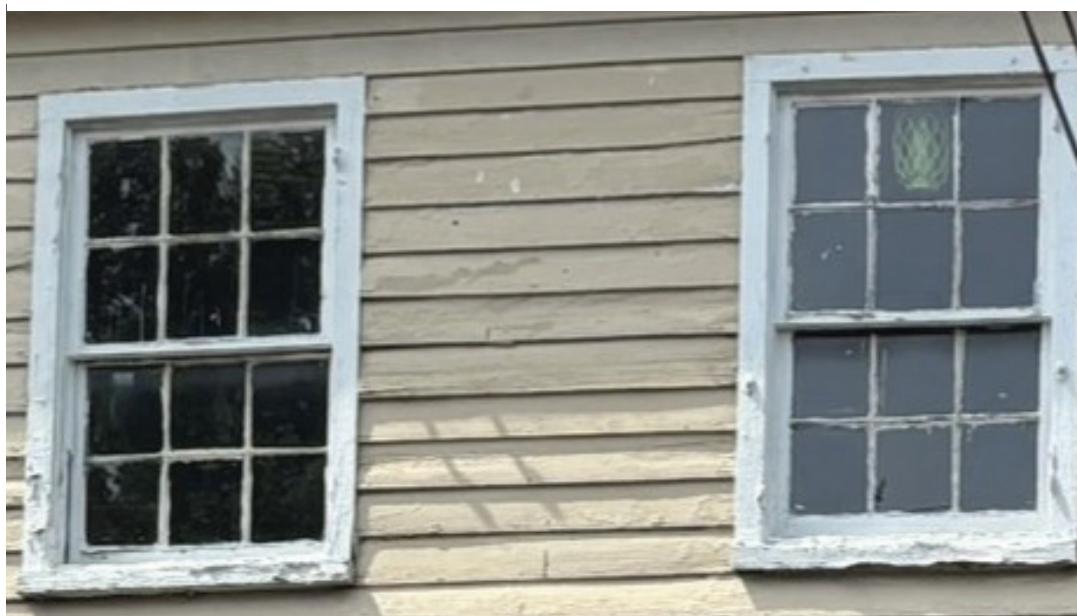
View of possible original windows on the front elevation.

Note : The sashes would need to be entirely reconstructed due to the exterior portions of the muntins are no longer in place and there is not significant material remaining for the glazing compound. The project seeks to replace with new wood double-hung windows.

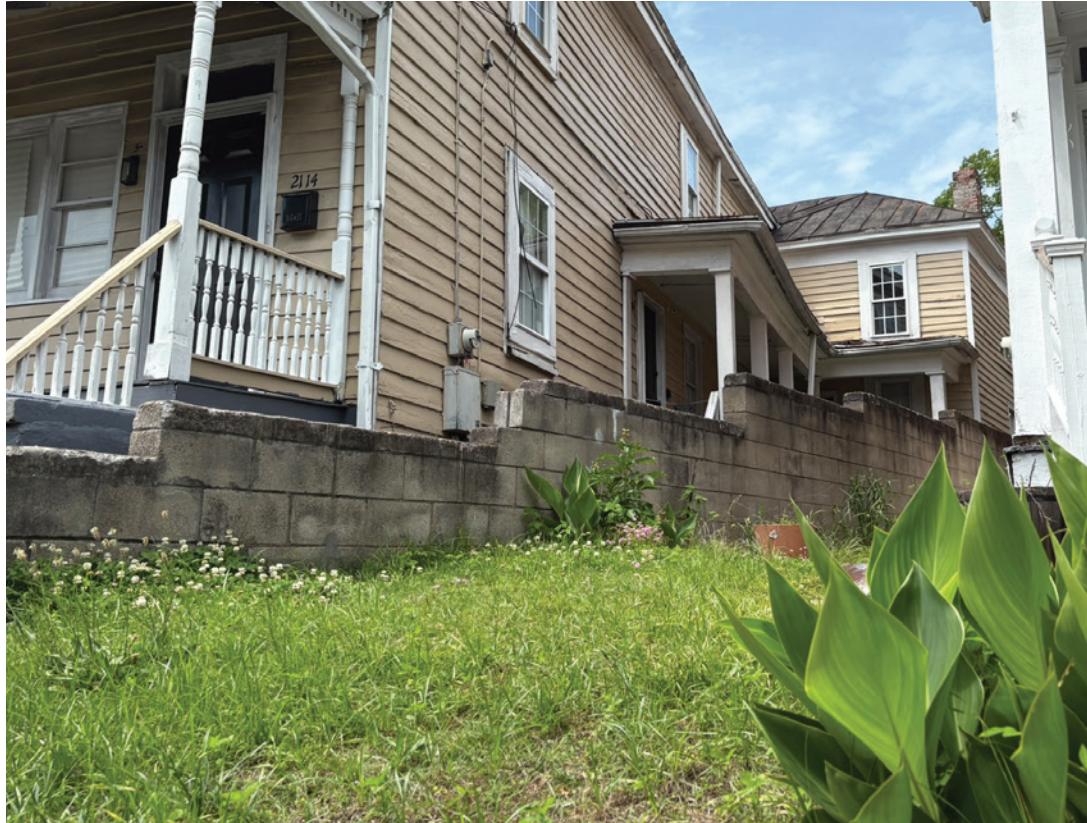
View east side

Note: The intent is to relocate the meter to the west side of the home and work with the adjacent neighbor to remove the cmu fence/wall. All windows shown are replacement windows and are smaller than original openings.

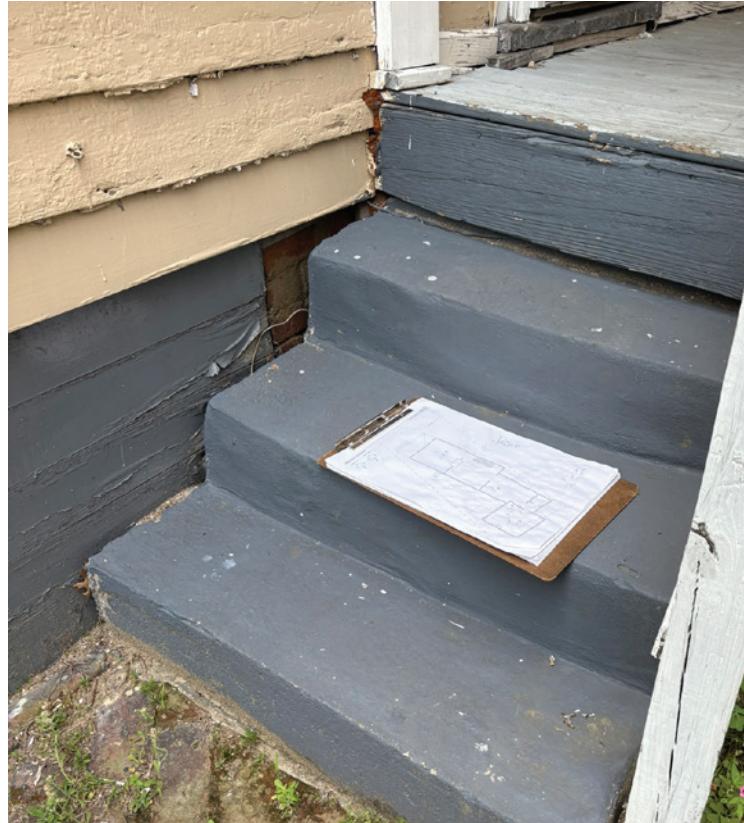
View of porch steps to be demolished

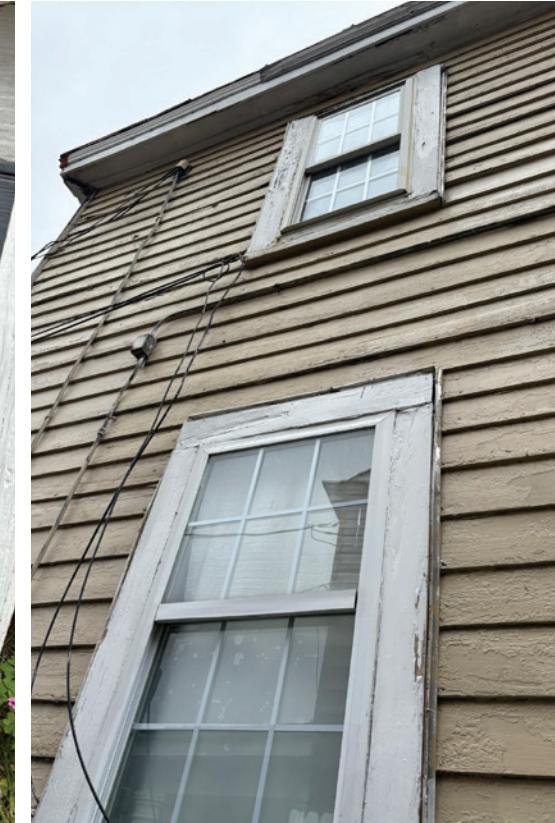
View of windows on east side

Note: These windows have been replaced and are smaller than the original.

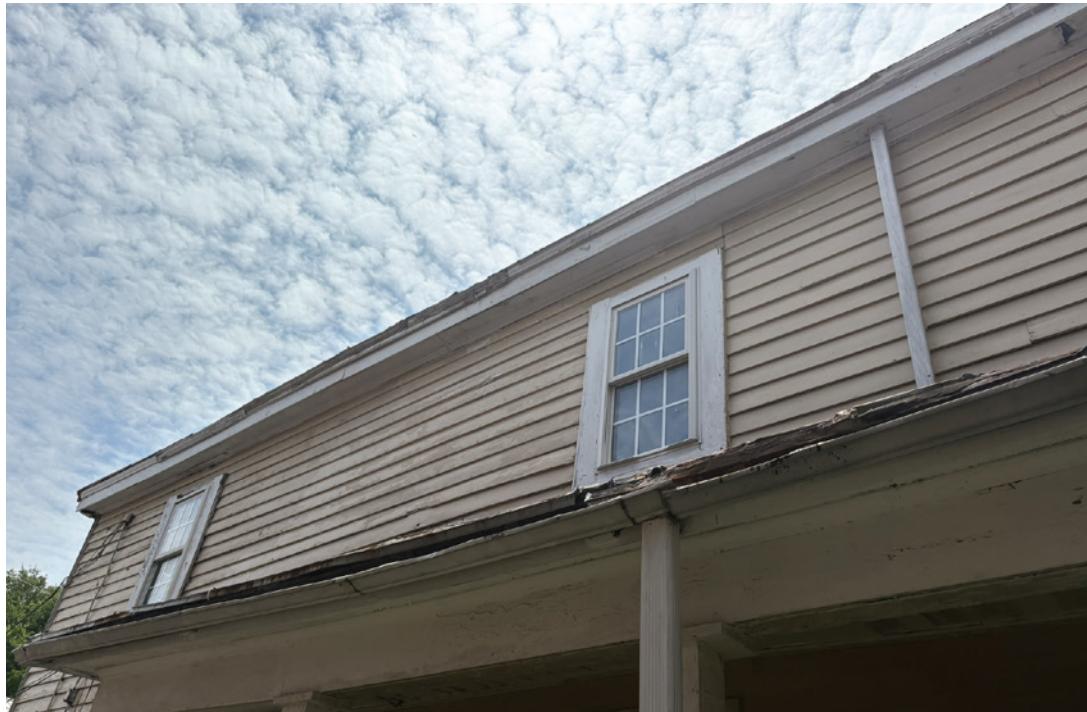
View of non-original windows on east side

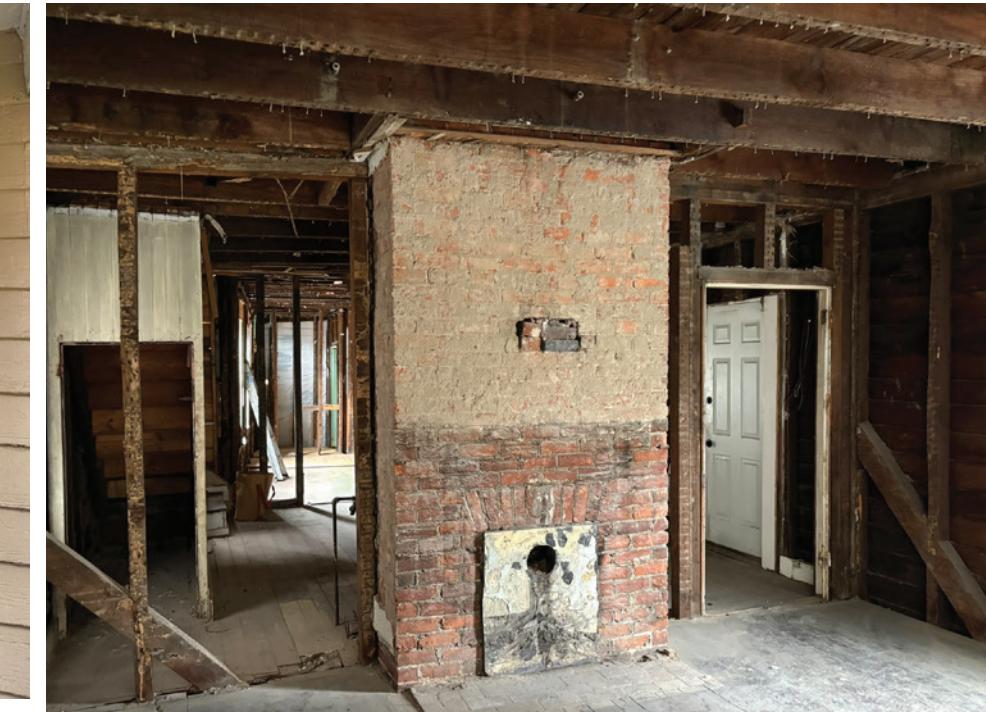
View of non-original existing door to side porch

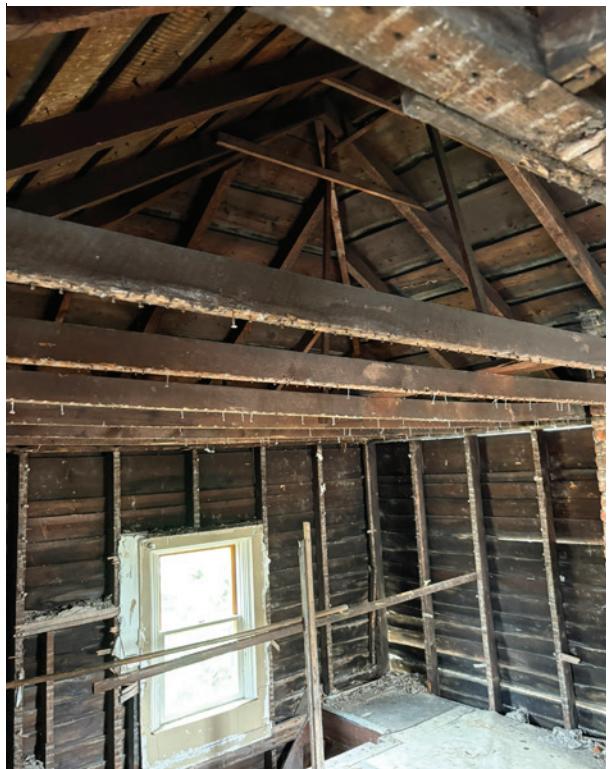
View of non-original window and original roof structure that will be maintained and relocated upwards

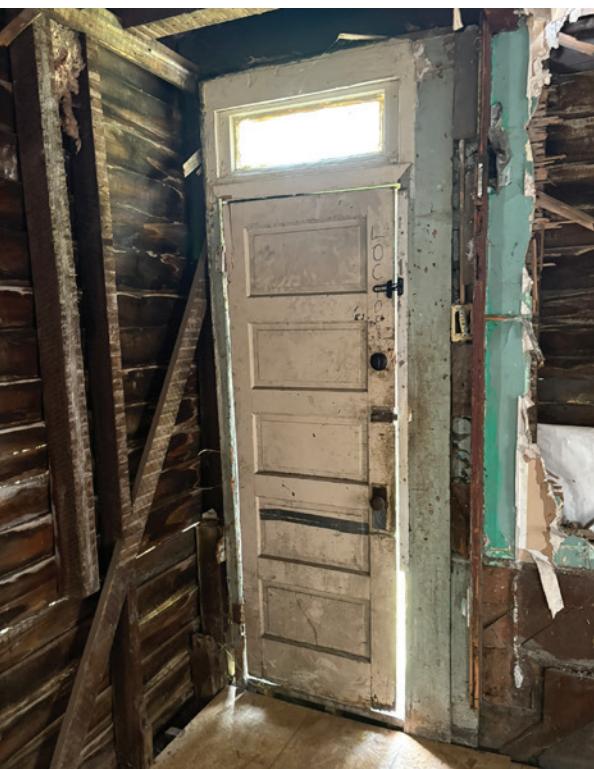
View of door and transom - the door appears to be a replacement. Project proposes removal of both for structural reseason.

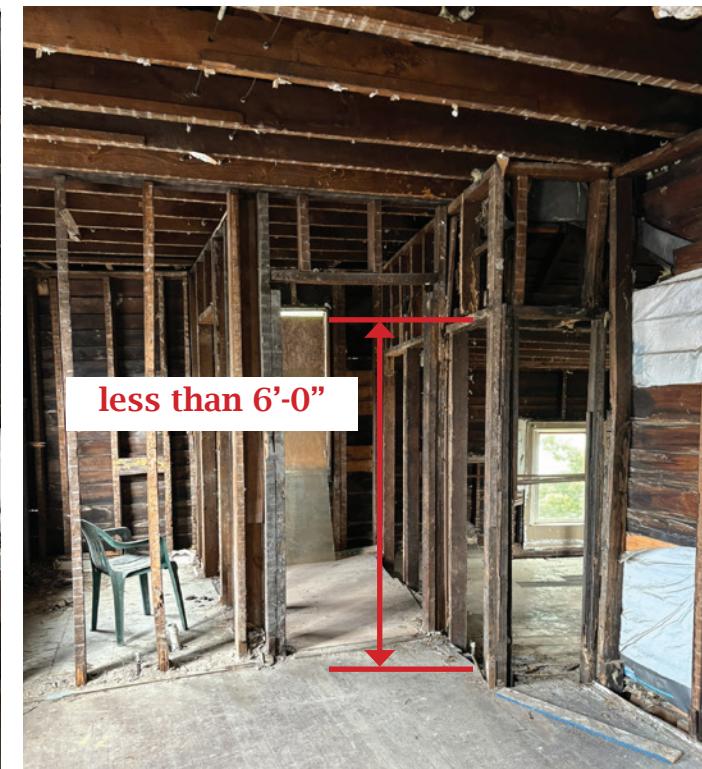
View of second floor and low headroom at intersection of volume 1 and volume 3

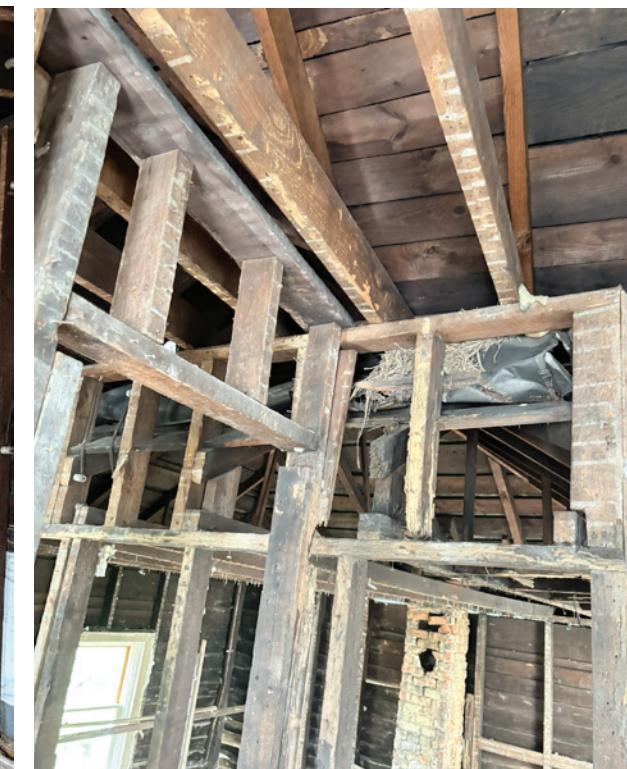
View of roofing material and low headroom

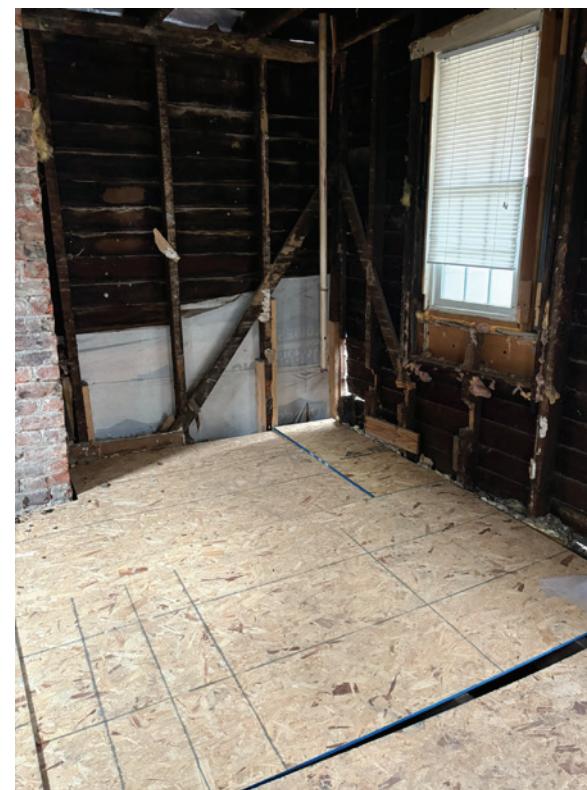
Volume 1, believed to be the original portion of the home, is a two-story structure that is shorter than the adjacent volumes. The first-floor framing in this section has failed, and the second floor is significantly undersized, bowed and in need of replacement. The existing floor-to-floor height does not allow for two usable stories once the structural framing is replaced with appropriately sized members for the span needed. The project proposes raising the roof of Volume 1 slightly—keeping it below the height of the adjacent roofs—in order to achieve habitable ceiling heights while maintaining a clear visual distinction between volumes.

View of area of floor failure

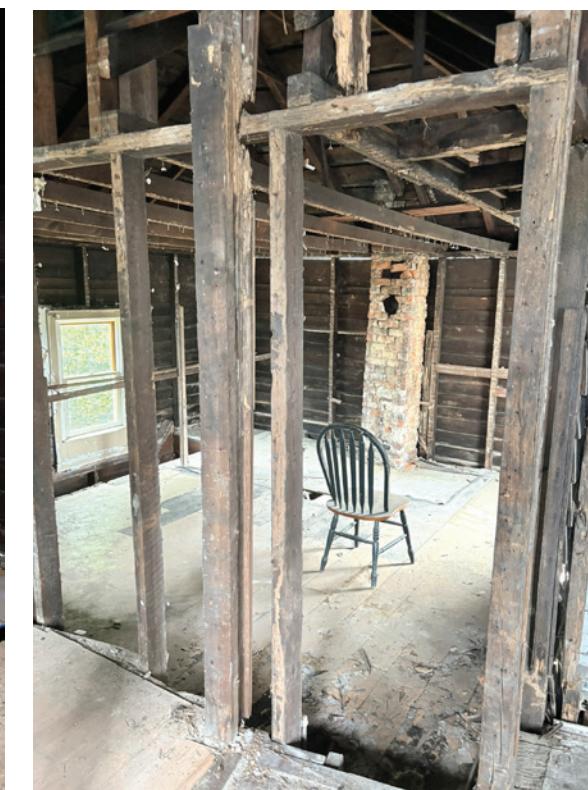
View of low headroom
