# CAR SUBMISSION FOR 2114 M STREET RENOVATION & ADDITION

*Prepared by LoCh Design  
June 26, 2025*

2114 M Street - PROJECT OVERVIEW

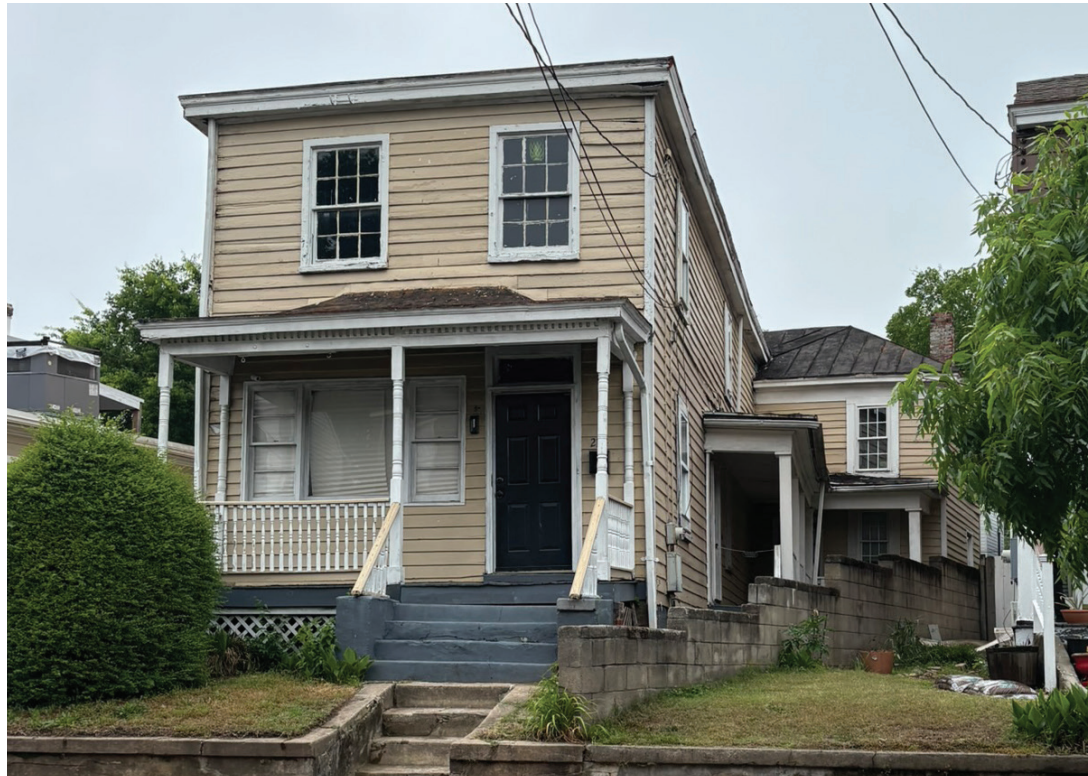
*View of front and east elevations*

*Note: The roof structure, frieze beam, fascia, dental molding, crown, brick masonry piers, appear to be original and will be retained and restored. The remainder of the porch will be replaced as shown in the attached documents..*

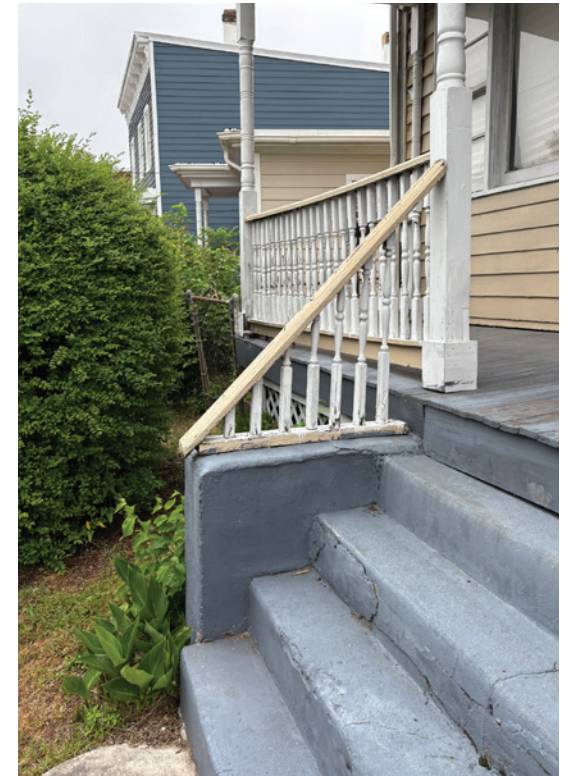
*View of front porch steps and rail*

*Note: The stair and side wall are in disrepair. and demolition is proposed.*

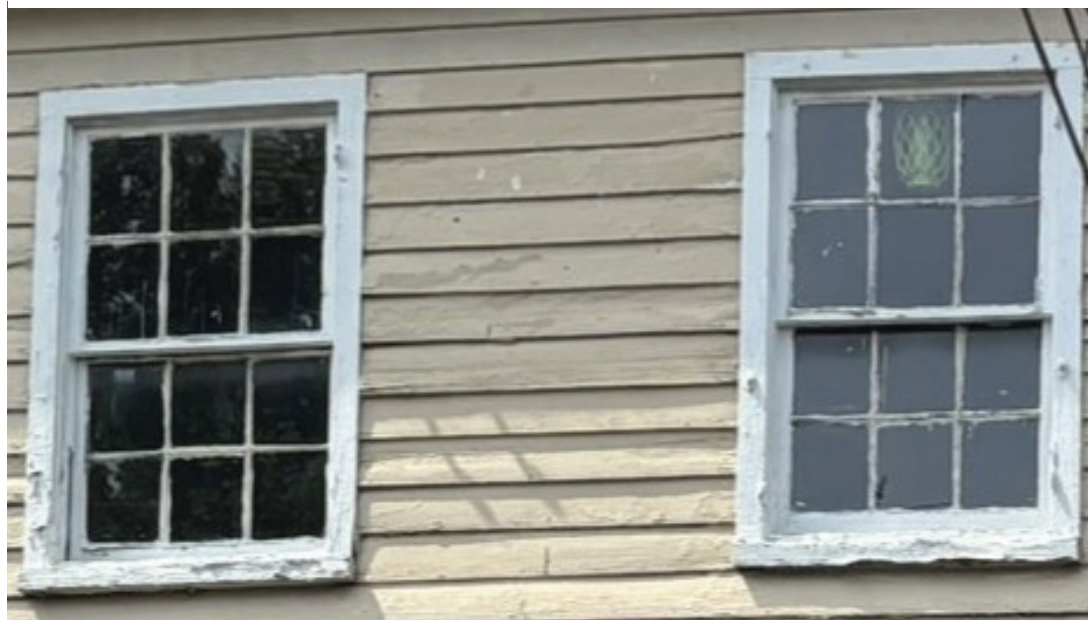
*View of possible original windows on the front elevation.*

*Note : The sashes would need to be entirely reconstructed due to the exterior portions of the muntins are no longer in place and there is not significant material remaining for the glazing compound. The project seeks to replace with new wood double-hung windows.*

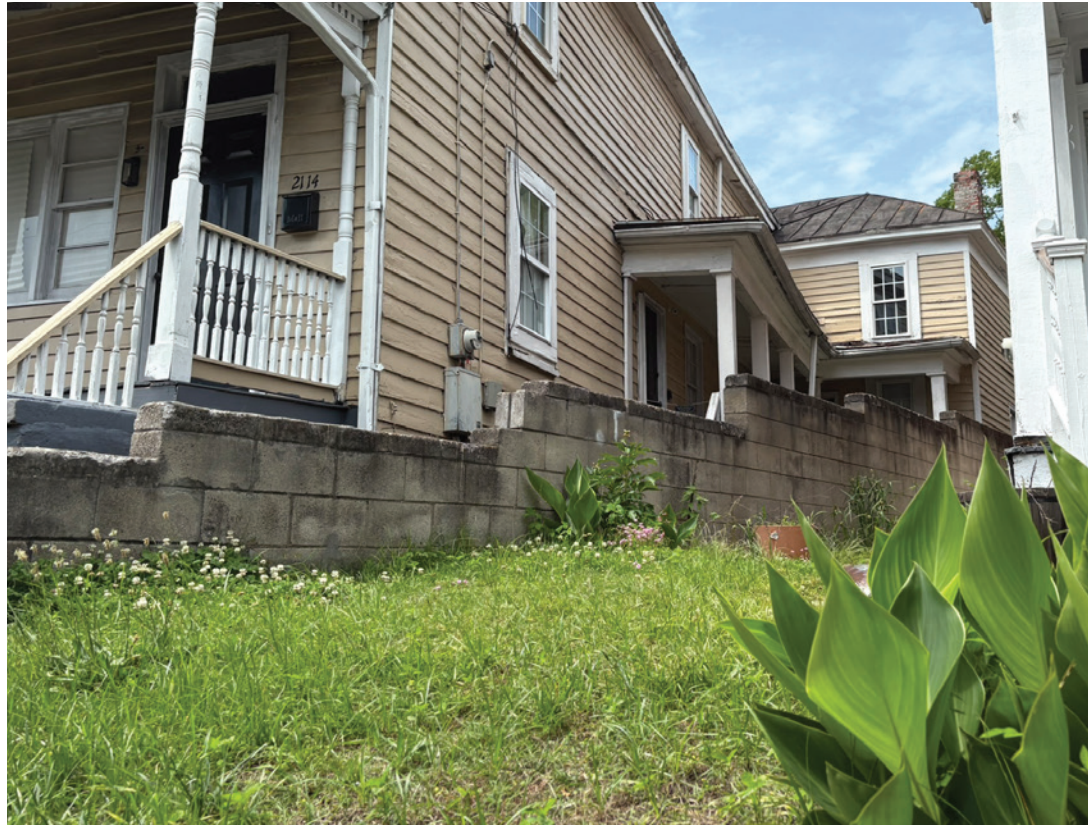
*View east side*

*Note: The intent is to relocate the meter to the west side of the home and work with the adjacent neighbor to remove the cmu fence/wall. All windows shown are replacement windows and are smaller than original openings.*

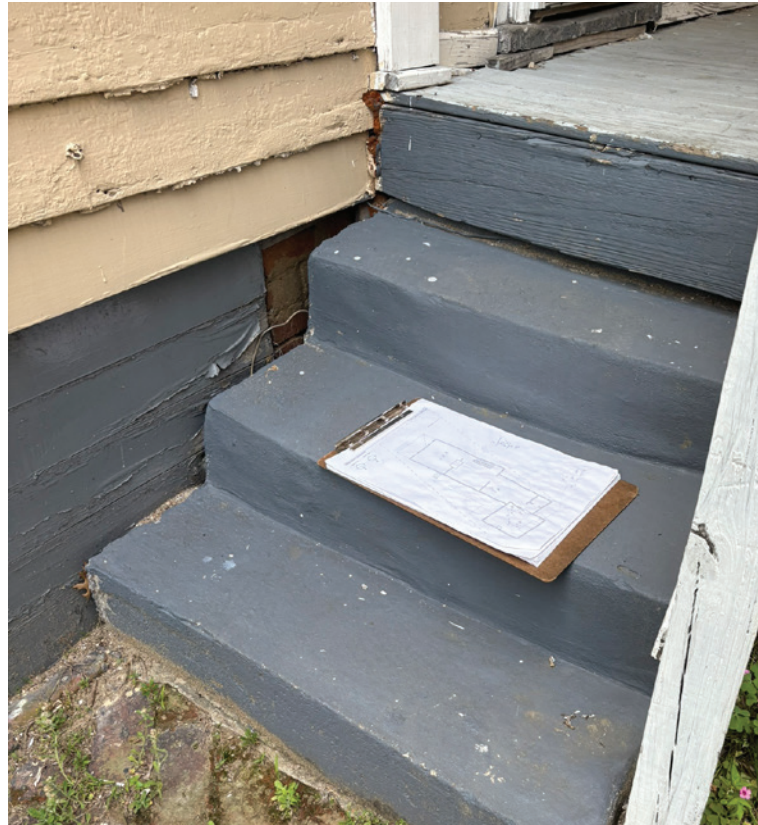
*View of porch steps to be demolished*

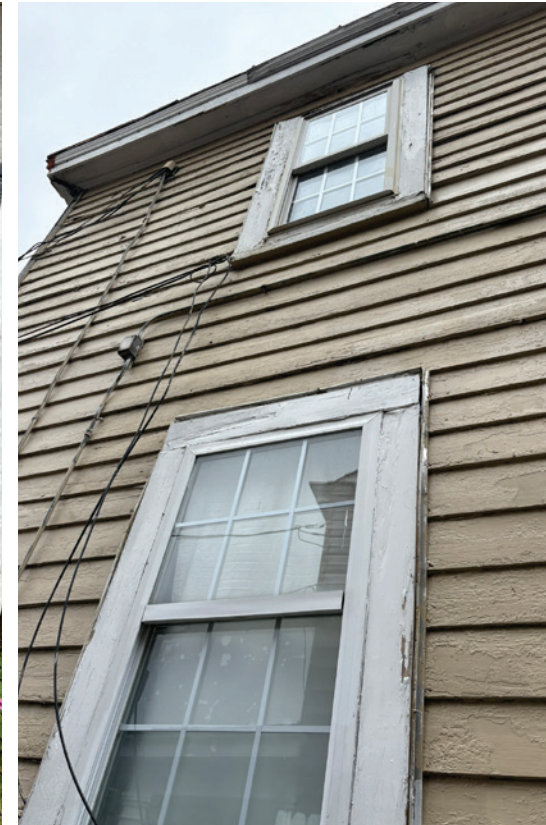
*View of windows on east side*

*Note: These windows have been replaced and are smaller than the original.*

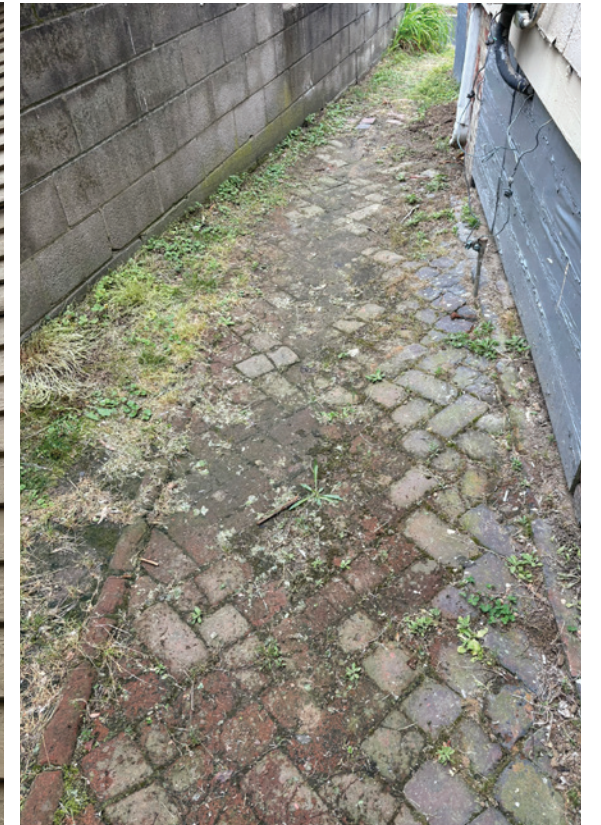
*View of brick paving to be restored and expanded*

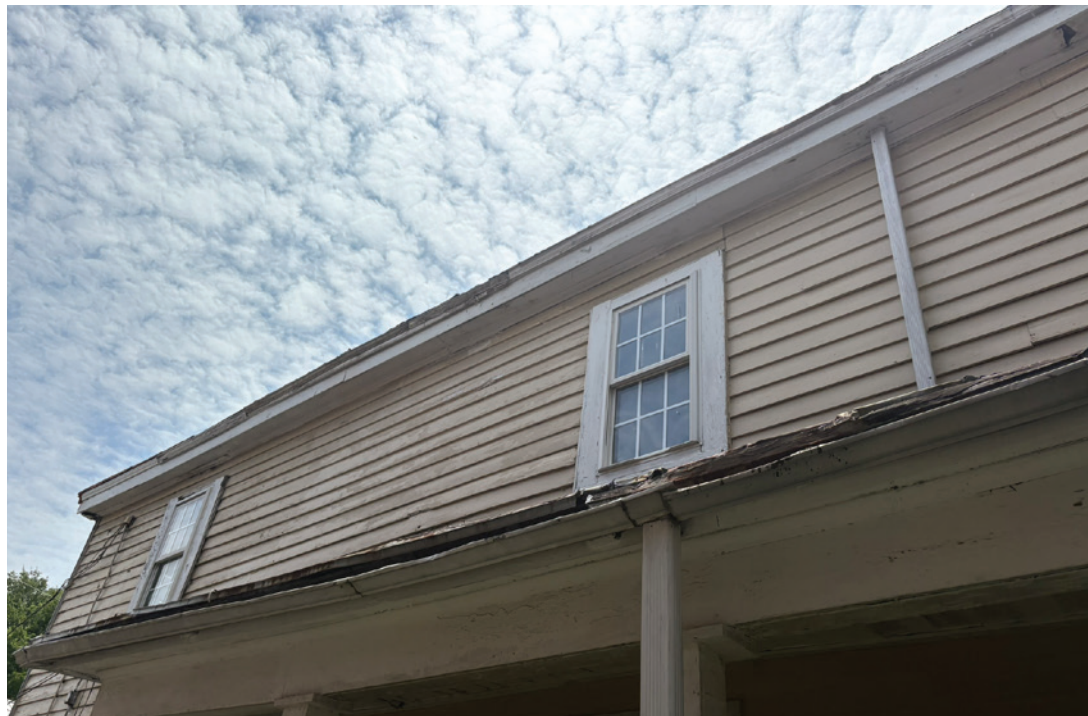
*View of non-original windows on east side*

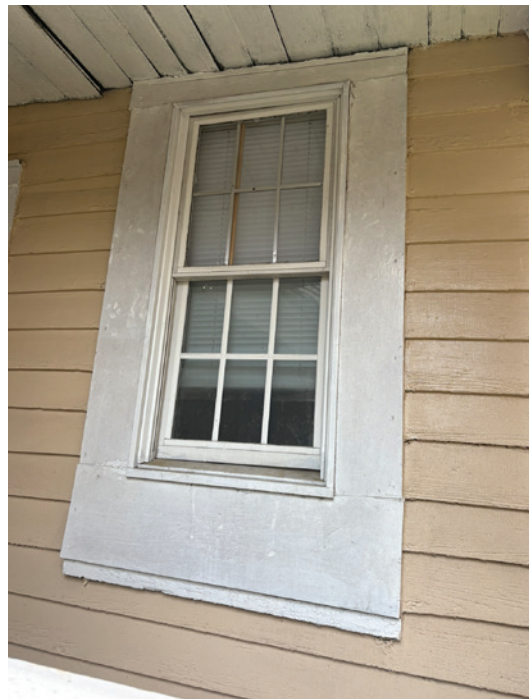
*View of replacement window on volume 1*

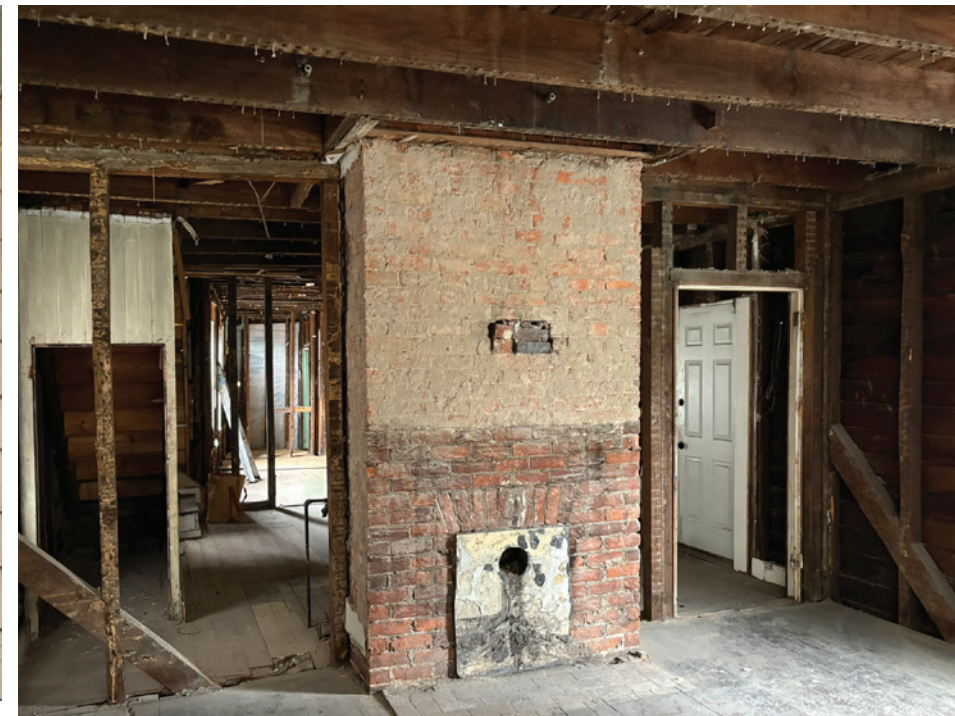
*View of non-original existing door to side porch*

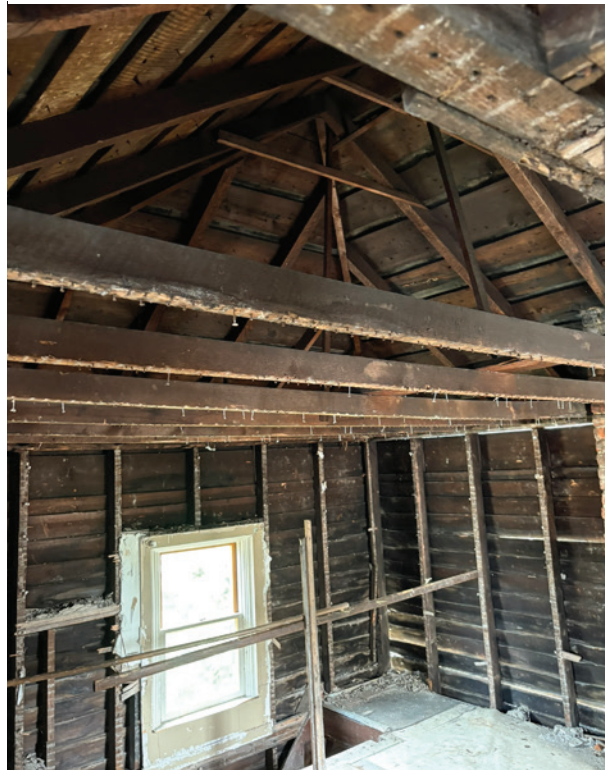
*View of non-original window and original roof structure that will be maintained and relocated upwards*

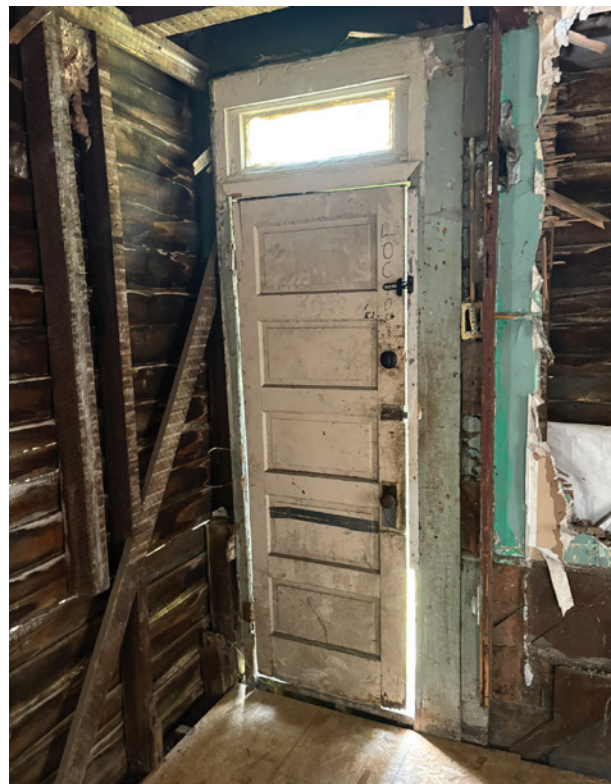
*View of door and transom - the door appears to be a replacement. Project proposes removal of both for structural reasons.*

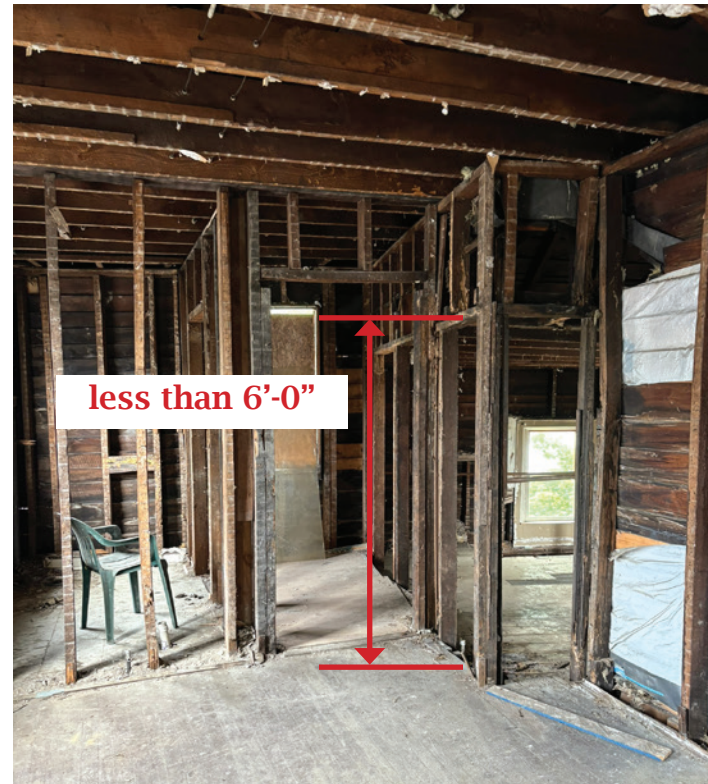
*View of second floor and low headroom at intersection of volume 1 and volume 3*

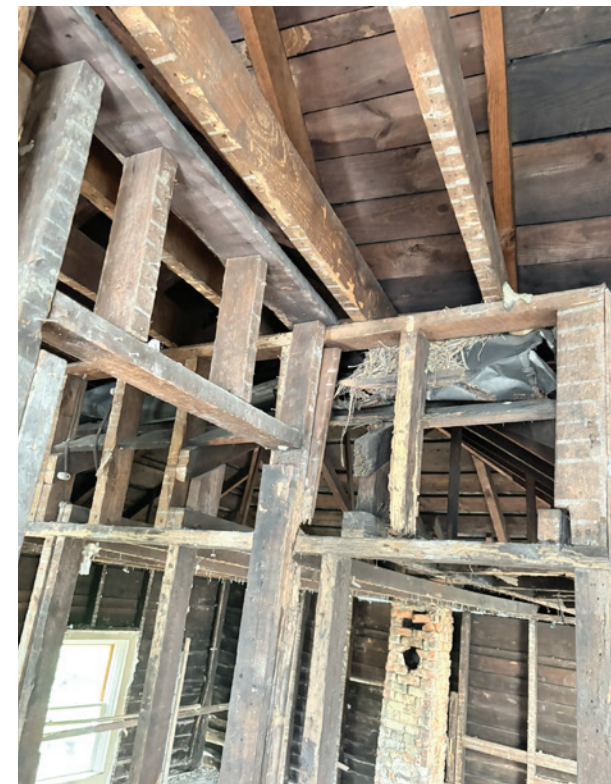
*View of roofing material and low headroom*

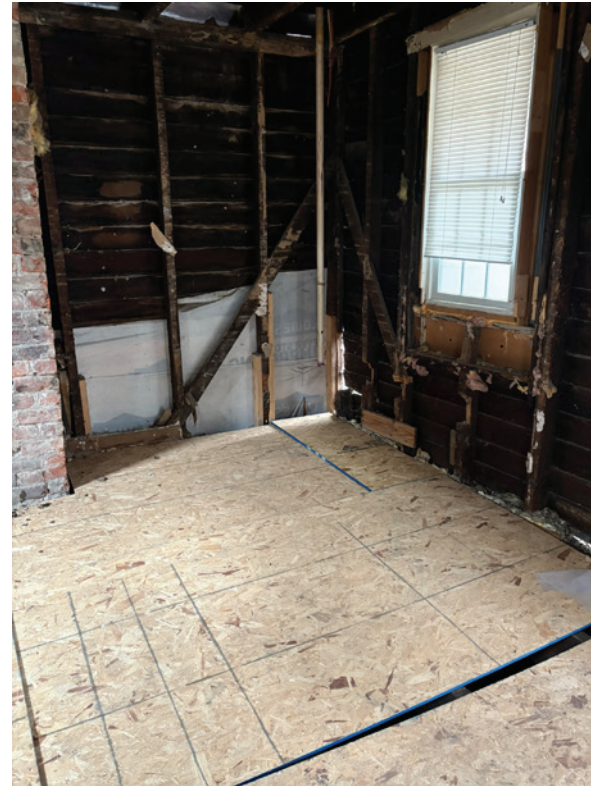
*View of area of floor failure*

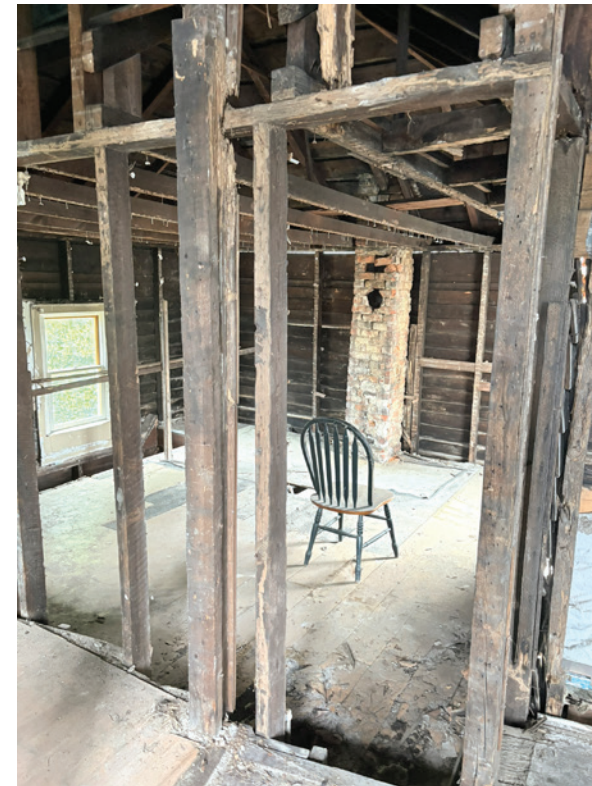
*View of low headroom*

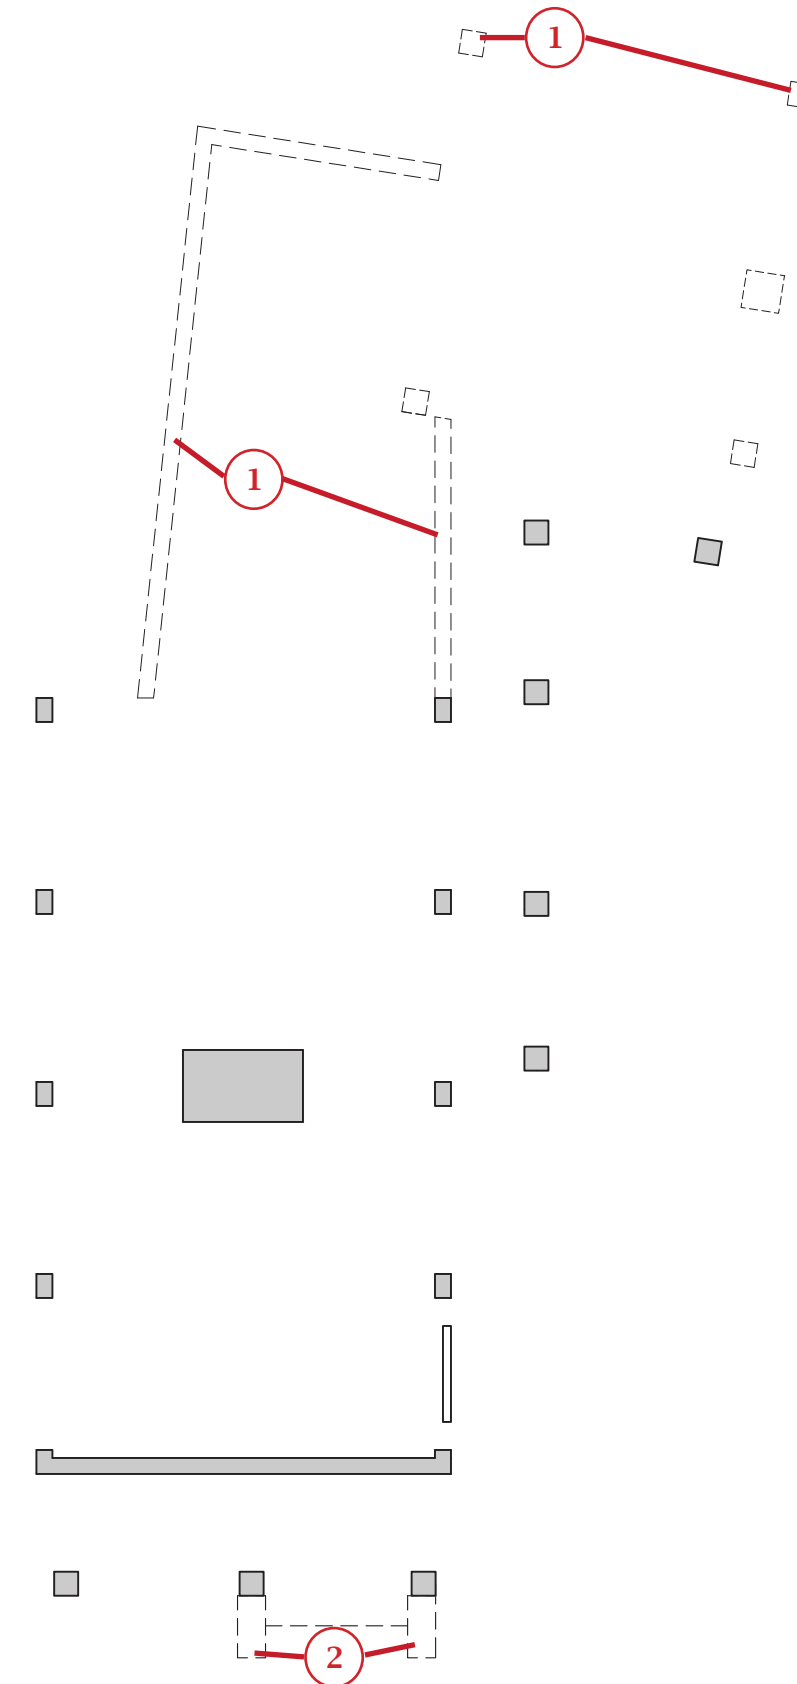
FOUNDATION DEMOLITION PLAN

1. Typical, remove existing failing foundation wall or pier indicated.
2. Typical, remove existing low wall.
