Staff Report
City of Richmond, Virginia

Commission of Architectural Review

| COA-103051-2021 | Final Review | Meeting Date: 12/21/2021 |
| Address: 2311 Venable Street | | |

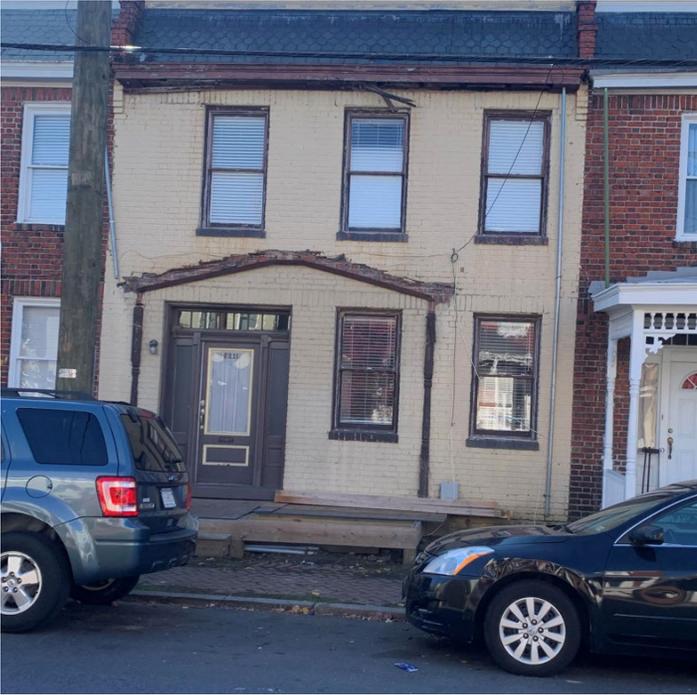
| Guideline Reference | Reference Text | Analysis |
|---|--|--|
| <p>Building Elements, porches, entrances, and doors #4 pg. 71</p> | <p><i>Do not remove or radically change entrances and porches important in defining the building's overall historic character. Front and side porches are architecturally more ornate than utilitarian back porches.</i></p> | <p>Based on photographic documentation of 2311 Venable Street, the original front porch featured decorative spindle work, sawn brackets, and turned posts. This design is also present on other unaltered front porches on the adjacent attached residences. Staff notes that the entirety of the front porch has been removed with the exception of the turned posts that are attached to the front façade.</p> |
| <p>Building Elements, porches, entrances, and doors #8 pg. 71</p> | <p><i>Do not strip entrances and porches of historic material and details that should be retained in any repair or partial replacement.</i></p> | <p>The applicant has removed the entirety of the original front porch, with the exception of the turned posts that are attached to the front façade. <u>Staff recommends that the applied turned posts on the front façade be retained.</u></p> |

Figure 1. Current photo of front façade

| Guideline Reference | Reference Text | Analysis |
|---|--|--|
| <p>Building Elements, porches, entrances, and doors #5 pg. 71</p> | <p><i>The entire porch should only be replaced if it is too deteriorated to repair or is completely missing; replacements should match the original as much as possible.</i></p> | <p>Based on photographic evidence and past code cases for this property, staff notes that the porch suffered from a lack of maintenance, rendering it deteriorated beyond repair and was subsequently removed. The newly proposed front porch does not match the original design. <u>Staff recommends that the reconstructed front porch match the original design as closely as possible.</u></p> |

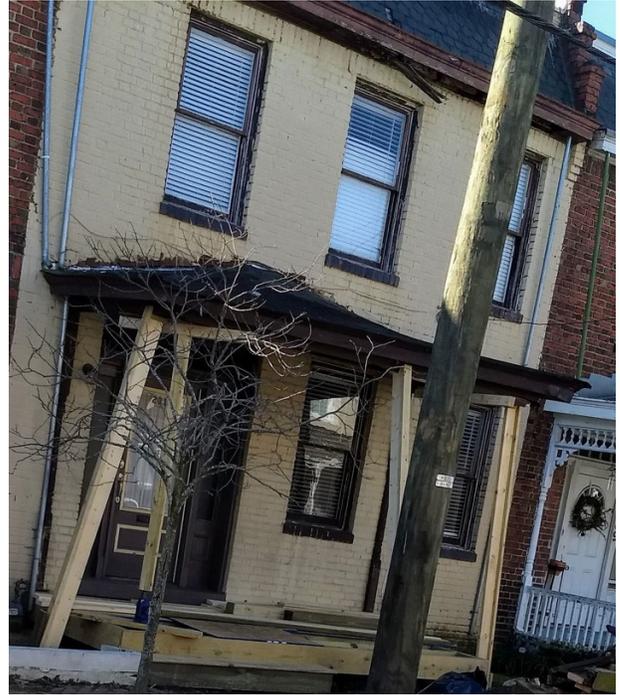
| COA-103051-2021 | Final Review | Meeting Date: 12/21/2021 |
|---|---|---|
| Previous Reviews | <p>While the Commission has not previously reviewed a COA application for this property, staff has been in touch with the applicant regarding a property maintenance violation that was issued in February of 2020. In order to abate the violation, the following work was to be completed: the decorative features (i.e. facial boards, trim, soffits, rake boards, etc.) that were removed from the property were to be repaired/replaced; all peeling, flaking, and chipping paint was to be eliminated prior to any painting; all rotten or damaged wood was to be replaced prior to any painting; and all exterior wood surfaces (including but not limited to doors, windows, front porch handrails, pickets, and decking) were to be power washed and have a protective treatment applied.</p> <p>It appears that when the violation was issued, the original front porch was still intact. The front porch was removed around March 2021 without CAR approval.</p> | |

Figure 2. Photo from March 2021 showing the unstable front porch that has since been removed

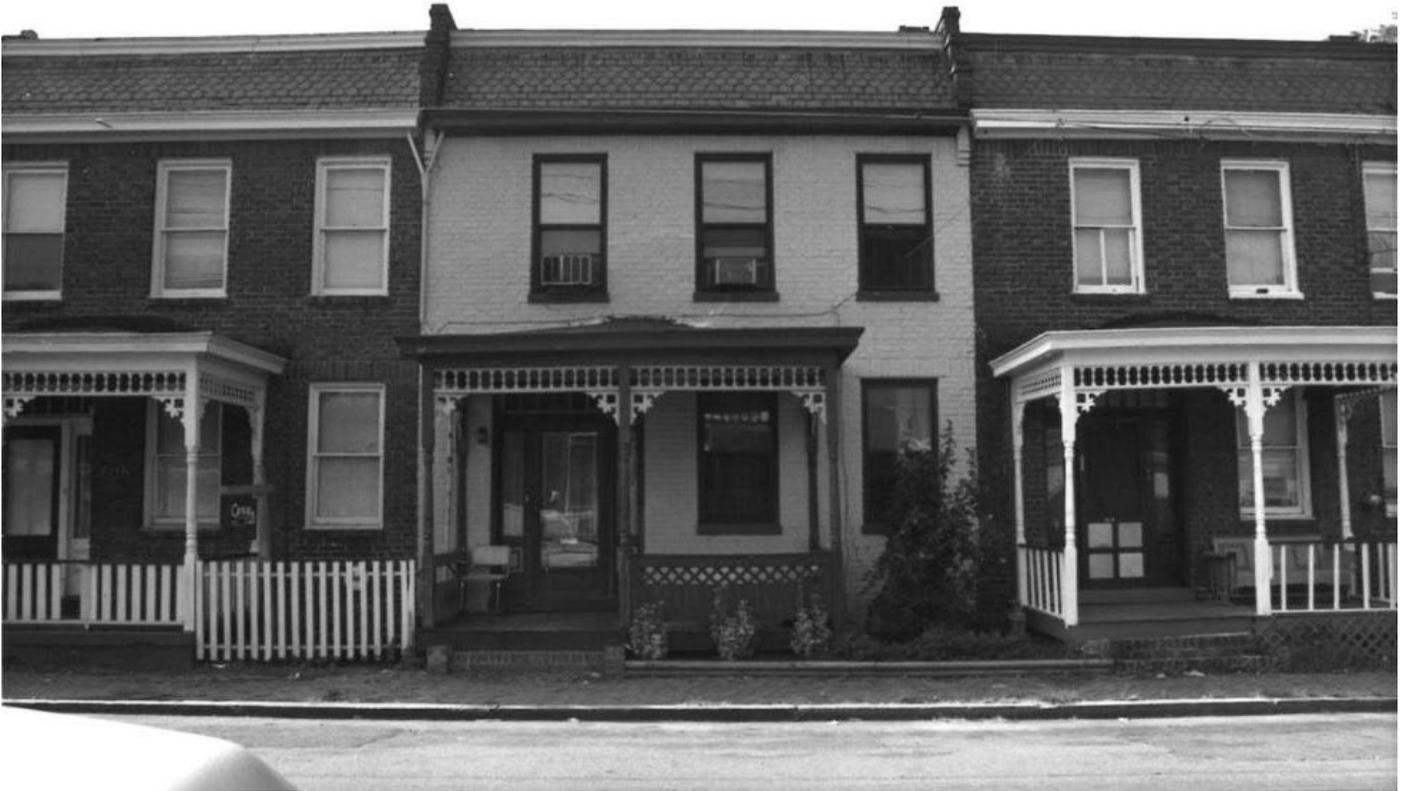
| <p>Porches and Porch Details, pg. 49 #2</p> | <p><i>When designing a new railing for a new infill building, or for an existing building which has lost its railing and for which no documentary or physical evidence survives, the balusters in the traditional Richmond rail are generally rectangular in section (with the narrow dimension facing the street) or square. The baluster is fitted into the recess in the top rail and a sloped bottom rail. Typical deck railings, consisting of nailed-up stock elements, are not approved as they are not based on a compatible historical model found in Richmond's Old and Historic Districts.</i></p> | <p>The applicant proposes installing new Richmond railing. <u>Staff was unable to locate photographic documentation of the original railing design on the porch and recommends approval of the new railing.</u></p> <p>A photo of the dwelling dating to 1993 indicates a latticework balustrade, but there is insufficient evidence to suggest that this detailing was original. An earlier, low-quality image of the dwelling, which was acquired from the City of Richmond Assessor's Office, indicates a balustrade with detailing similar to the proposed Richmond railing (exact date unknown).</p> |

Figure 3. Historic photo from VCU archives showing front porch with latticework balustrade (1993).
