Staff Report
City of Richmond, Virginia

Commission of Architectural Review

COA-103364-2021	Final Review	Meeting Date: 12/21/2021
Applicant/Petitioner	Chris Maka	
Project Description	Rehabilitate an existing residence; reconstruct a front porch and construct a new rear addition.	
Project Location		
Address: 2318 Venable St.		
Historic District: Union Hill		
High-Level Details: <ul style="list-style-type: none"> The applicant proposes to rehabilitate a two-story, ca. 1910 brick Italianate residence, including the construction of a rear, double deck, the construction of a small rear addition, and the demolition of the rear wall of the property. The applicant proposes to reconstruct the front porch. Staff notes that a rear projection has been completely demolished without review and approval by the Commission 		
Staff Recommendation	Approval, with Conditions	
Staff Contact	Alex Dandridge, alex.dandridge@RVA.gov , 804-646-6569	
Previous Reviews	<p>Under previous ownership, a similar application was approved by CAR in August 2019. The scope of work in that application included the demolition of a 1958, CMU, second story rear addition, the demolition of a deteriorated masonry wall on th

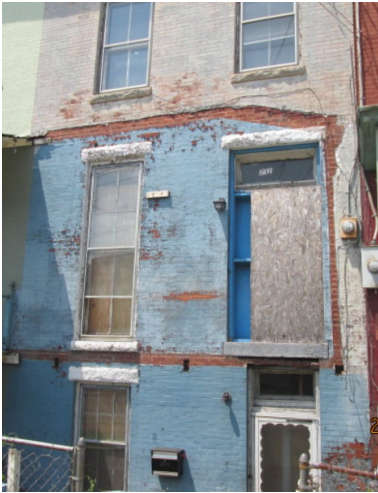
Figure 1. Current façade photo

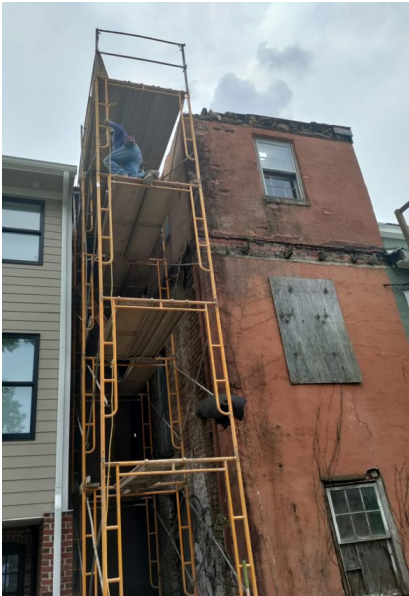
Figure 3. Photo from before August 2021 showing the poor condition of the rear wall before demolition

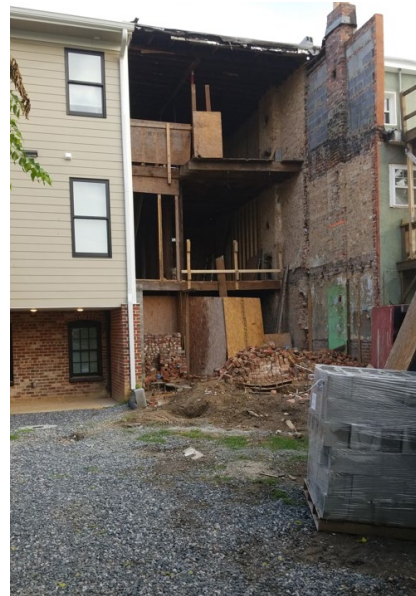
Figure 4. Photo from August 2021 showing the post-demolition rear wall
