**Staff Report**  
**City of Richmond, Virginia**

**Commission of Architectural Review**

6. COA-112853-2022	<b>Final Review</b>	<b>Meeting Date: 6/28/2022</b>
<b>Applicant/Petitioner</b>	Meghan Zapiec	
<b>Project Description</b>	Replace existing wooden windows with new aluminum clad wood windows.	
<b>Project Location</b>		
<b>Address:</b> 2905 E. Broad St.		
<b>Historic District:</b> St. John's Church		
<b>High-Level Details:</b> <ul style="list-style-type: none"> <li>The applicant requests permission to replace 9 existing 2/2 wooden windows of a 1881 Italianate, semi-attached, masonry dwelling with aluminum clad wood windows.</li> <li>Staff was unable to determine if the existing wood windows are original to the building, but believes that they are either original or installed predistrict designation IN 1957</li> </ul>		
<b>Staff Recommendation</b>	<b>Denial</b>	
<b>Staff Contact</b>	Alex Dandridge, <a href="mailto:alex.dandridge@rva.gov">alex.dandridge@rva.gov</a> , (804)-646-6569

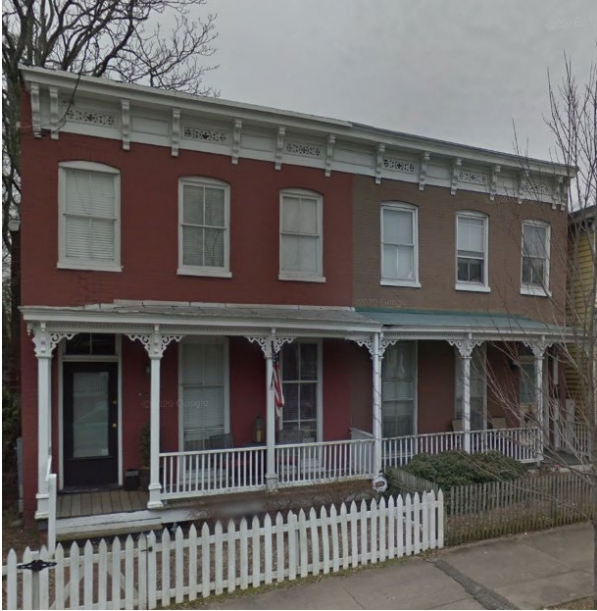
Figure 1. Façade photo, google street view

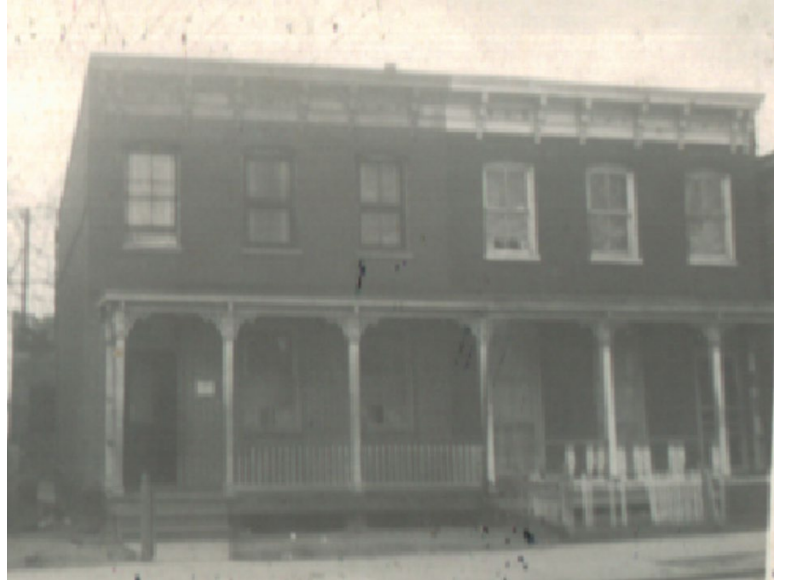
Figure 2. City Assessor's Card, 1950's. Windows appear to be the existing front façade windows.

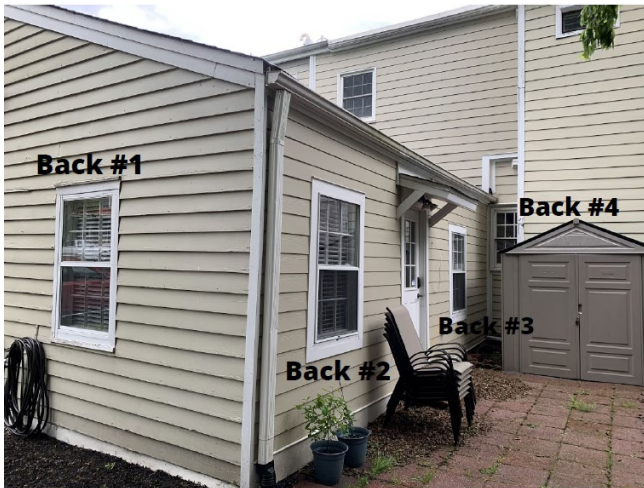
Windows, #12, pg. 69	<i>12. Thermal efficiency can be enhanced through the use of weather stripping, storm windows, caulking, interior shades, shutters, blinds and awnings, if appropriate.</i>	<p>The applicant has indicated to staff that they would like to replace the rear windows because they are not thermal-efficient. Staff suggests that storm windows can increase the thermal efficiency of single-pane wood windows. <u>Staff recommends the applicant consider installing interior or exterior storm windows, which can be administratively approved.</u></p>

Figure 3. Rear of dwelling

<b>Previous Reviews</b>	None.	
<b>Staff Recommendations</b>	<ul style="list-style-type: none"> <li>Applicant identify the source of the water that is causing the damage, and that the sill be repaired or replaced in-kind.</li> <li>Applicant consider installing interior or exterior storm windows, which can be administratively approved.</li> </ul>
