Staff Report
City of Richmond, Virginia

Commission of Architectural Review

| 3. COA-113062-2022 | Final Review | Meeting Date: 7/26/2022 |
| Project Description | Replace existing wood siding with a substitute material. | |

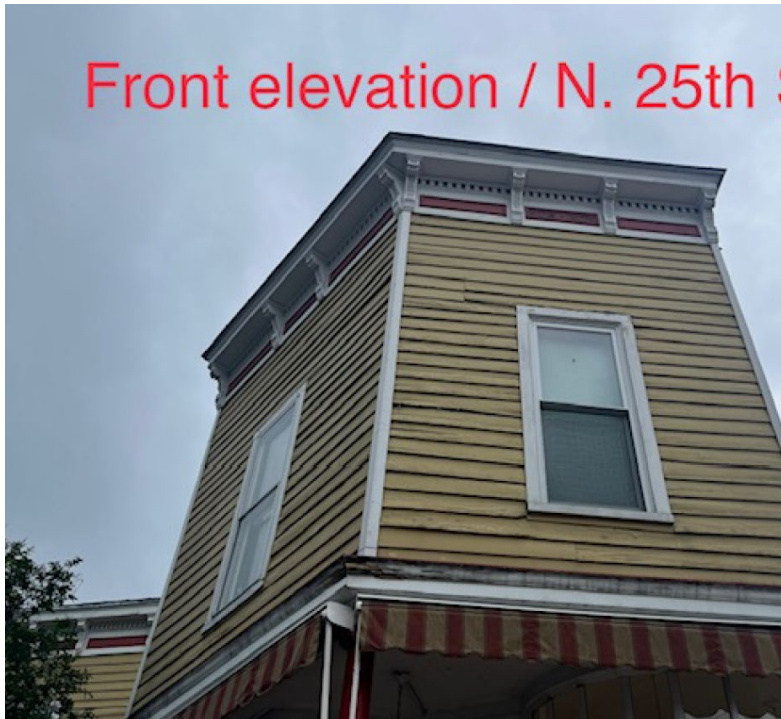
Figure 1. Existing conditions of front elevation.

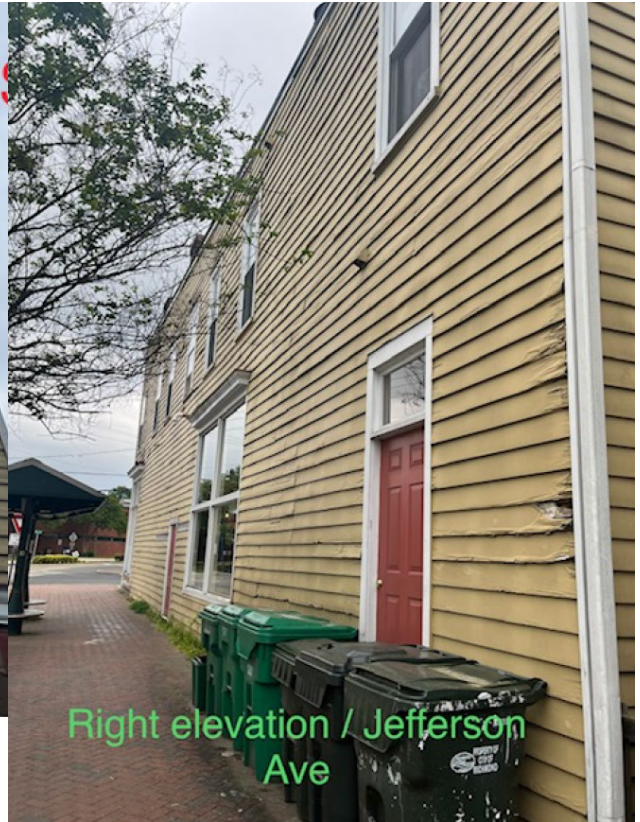
Figure 2. Existing conditions of Jefferson Ave. elevation

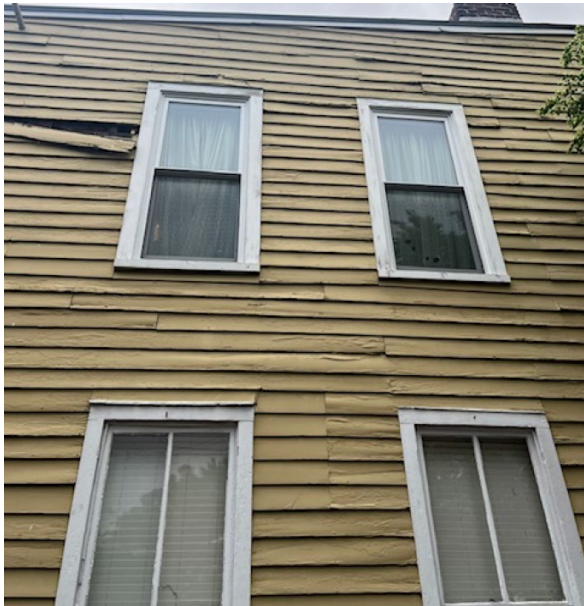
Figure 3. Existing conditions of N. 25th St. elevation.

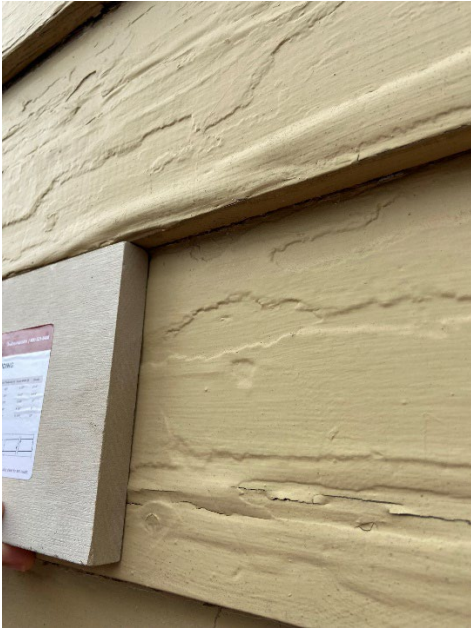
Boral comparison to existing wood siding

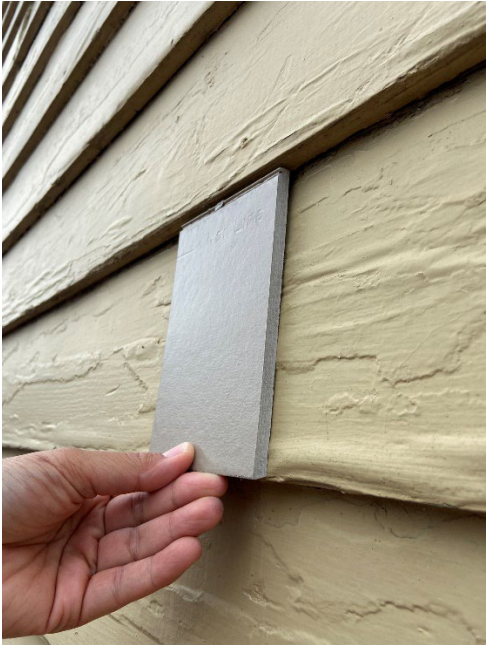
Fiber cement, HardiPlank, comparison to existing wood siding.

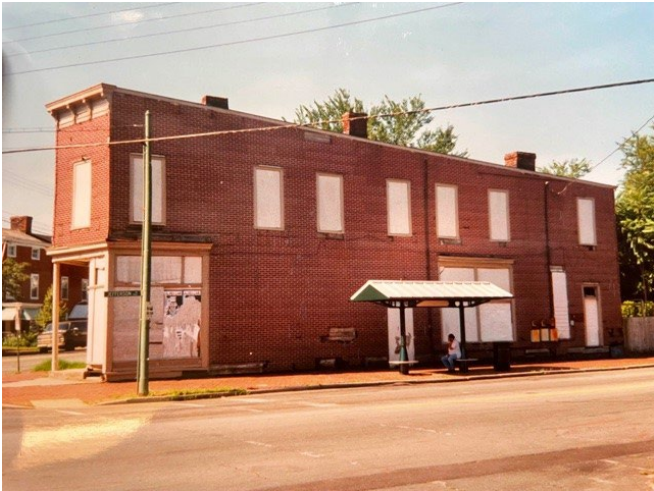
| | | <p>existing siding are buckling, and even falling off, exposing the framing underneath to the elements.</p> <p>Staff believes that the original siding could be failing, due to an extended period of time in the latter half of the 20th century when it was covered by novelty, faux brick siding which could have trapped moisture which accelerated decay.</p> <p>While 620 N. 20th Street was originally clad in old growth horizontal wood siding, staff finds a substitute material would be appropriate and more economical for the owner given the extent of siding that must be replaced. While wood is available, old growth timber is not common and significantly more expensive than new growth wood which makes up most of modern day replacement wood siding.</p> <p>New growth timber doesn't match the density and durability of old growth timber, having growth rings that are more widely spaced, making it more susceptible to pests, decay, and water intrusion.</p> <p>Replacing the existing siding with new growth wood at such an extent would cost upwards of \$130,000. Based on the city assessor's records, that is nearly 1/3 of the assessed improvement value of the property.</p> <p>Staff finds that the new growth timber that is used for wood siding today is costly and overall less durable than the old growth timber originally used, and that durable old growth timber that matches the characteristics of the original wood siding is not readily available, and may not be economically viable as a replacement.</p> |

Novelty siding, faux brick, present on 620 N. 25th approx 2000
