Staff Report
City of Richmond, Virginia

Commission of Architectural Review

3. COA-120546-2022	Final Review Meeting Date: 11/22/2022
Applicant/Petitioner	Louise Lockett-Gordon
Project Description	Construct a pergola.
Project Location

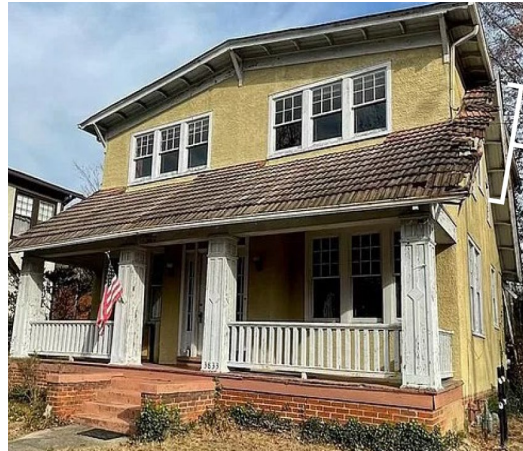
Figure 2. Deteriorated Concrete Tile Roof, 3833 Hermitage Road. Before

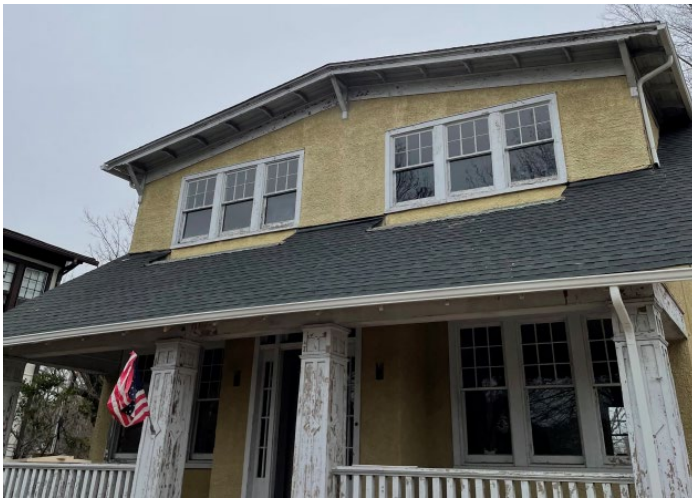
Figure 3. New asphalt shingles, 3833 Hermitage Road (After)

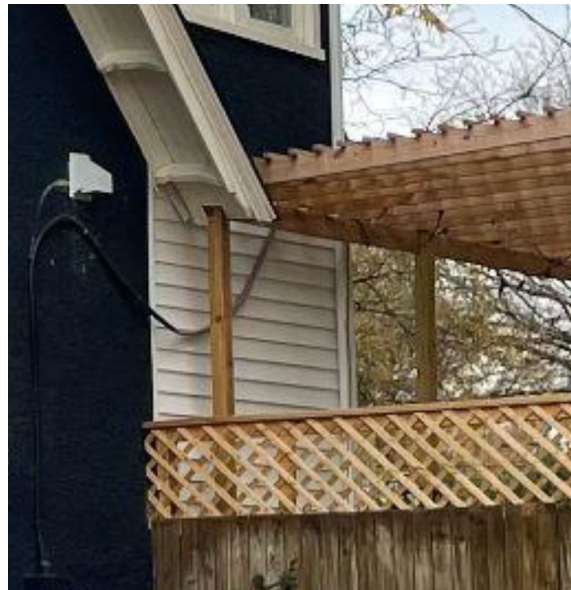
Figure 4. Notch cut into existing eave to accommodate pergola.

Staff Recommendations	<ul style="list-style-type: none"> Staff recommends <i>denial</i> of the current configuration of the pergola, and that the damaged eave be repaired to its original condition.
