**Staff Report**  
**City of Richmond, Virginia**

**Commission of Architectural Review**

6. COA-123343-2023	Final Review	Meeting Date: 1/24/2023
<b>Applicant/Petitioner</b>	Dr. Amanda George	
<b>Project Description</b>	Replace deteriorated wooden architectural elements with substitute materials.	
<b>Project Location</b>		
<b>Address:</b> 509 N 29 <sup>th</sup> Street		
<b>Historic District:</b> Church Hill North		
<b>High-Level Details:</b> <p>The applicant proposes to replace deteriorated architectural elements with substitute materials. The subject dwelling is a vernacular, frame, Italianate building with a full-width covered front porch circa 1880.</p> <p>It appears that the front porch posts and brick piers are not original to the building. The building also has a large rear addition.</p> <p>On the rear, the applicant proposes to remove a drip cap, fascia, window trim, soffit, and a door; replacing with PVC elements.</p> <p>On the front facade, the applicant proposes to remove the upper crown molding, fascia, and soffit; the front porch crown molding, fascia, and soffit, and replace with PVC elements.</p>

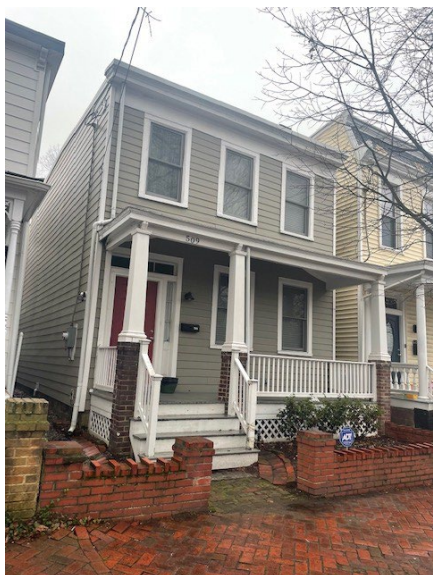
Figure 1. 509 N 29<sup>th</sup> Street front façade 2023

<p>In addition, staff advises that issues with water drainage from the front downspout be resolved to prevent future deterioration.</p> <p><u>Staff recommends that the new front door design be simple and submitted to staff for review and approval.</u></p>
<p><b>Building Elements, Porches and Porch Details, #5, pg.49</b></p>	<p>Porch roofs are encouraged to utilize standing- or flat-lock metal seam roofs that are hand-seamed, or closely approximate handseaming. Seams that, in section, are large, rectangular seams, reminiscent of pre-formed seams utilized on prefabricated industrial or commercial structures, are not acceptable. Membrane roofs are acceptable substitutes for flat-lock seamed metal roofs.</p>	<p>The applicant proposes to replace the existing front porch roof with black EPDM roofing. Black EPDM is an appropriate substitute material for front porch roofs.</p>

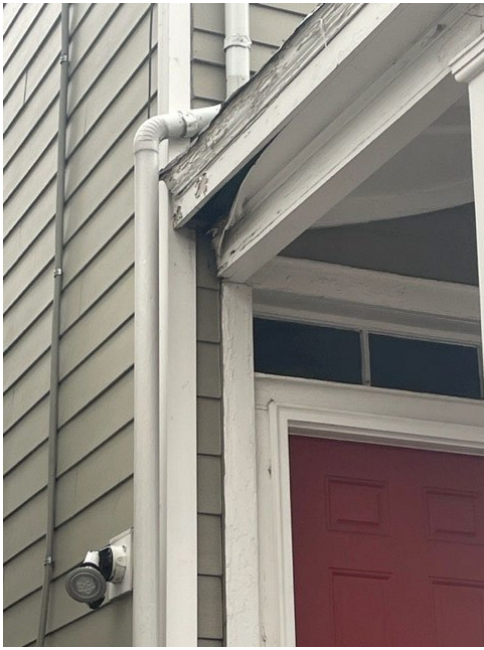
*Figure 3. 509 N. 29 front porch deteriorated wooden elements.*

<p>On the front façade, the applicant is proposing to replace the existing upper crown molding, fascia, and soffit and the front porch's crown molding, fascia, and soffit. These elements will be replaced with PVC</p> <p>The applicant also proposes to replace the front door. Staff does not believe that the existing front door is original to the property.</p> <p>The front stairs, hand rails, and post are proposed to be removed and replaced with wooden posts, composite wood treads and PVC risers with concealed fasteners. Railings will be TimberTech's Impression Rail Express Aluminum Railing System in white. City records indicate that the existing stairs and railings are not original to the structure and were constructed in 2007-2008. Staff supports the replacement of the front porch stairs with the listed materials.</p>
<p><b>Substitute Materials, pg. 60</b></p>	<p><i>When and where to use substitute materials is a decision to be reached only after careful consideration for the consequences to an historic structure and not before more appropriate preservation options have been explored.</i></p> <p><i>The use of synthetic materials that will alter the appearance, proportion and/ or details of an historic structure is strongly discouraged.</i></p> <p><i>The Guidelines give the Commission guidance, and ultimately the authority, to approve substitute materials, stating that, "substitute materials may be appropriate and economical replacements" in the following circumstances:</i></p> <ol style="list-style-type: none"> <li><b><i>1. Unavailability of Historic Materials</i></b></li> <li><b><i>2. Unavailability of Skilled Craftsman</i></b></li> <li><b><i>3. Replacement of poor quality materials.</i></b></li> </ol>	<p>Staff was unable to locate any documentation that demonstrated the front façade materials listed for replacement (other than the front stairs and railing) are not original to the dwelling.</p> <p>On a site visit, staff observed some deterioration on the front porch entablature likely caused by a leaking downspout, but only in the areas that were connected to the face of the building. Paint was peeling on the crown molding due to what looked like excess moisture.</p> <p>The molding details on the front porch and upper cornice are not elaborate and would be easily replicated; however, Staff doesn't believe the entirety of the front porch and upper cornice molding, fascia, and soffit are deteriorated beyond repair and recommends that other preservation measure be explored prior to allowing for their removal and replacement with a substitute material.</p> <p><u>Staff recommends that the front porch and second-story cornice molding, fascia, and soffit be repaired rather than replaced.</u></p>

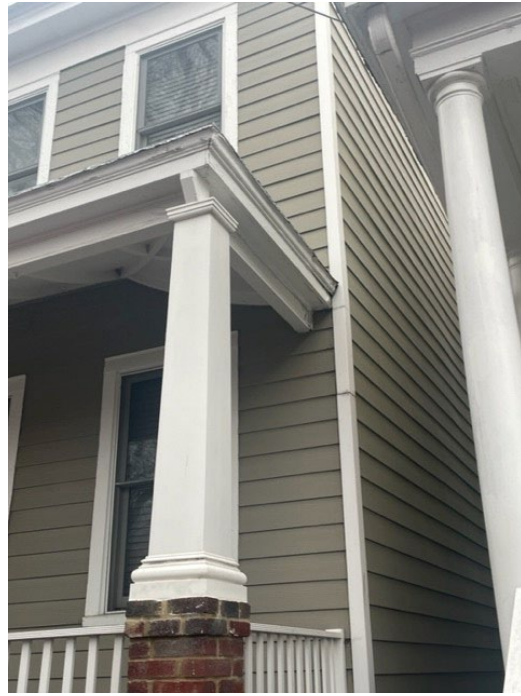
*Figure 4. 509 N. 29 front porch wooden elements.*
