## Commission of Architectural Review

9. COA-128330-2023	Regular Review	Meeting Date: 4/25/2023
Applicant/Petitioner	Colin Elliott	
Project Description	Renovation of the existing garage, located at the rear of the property.	
Project Location

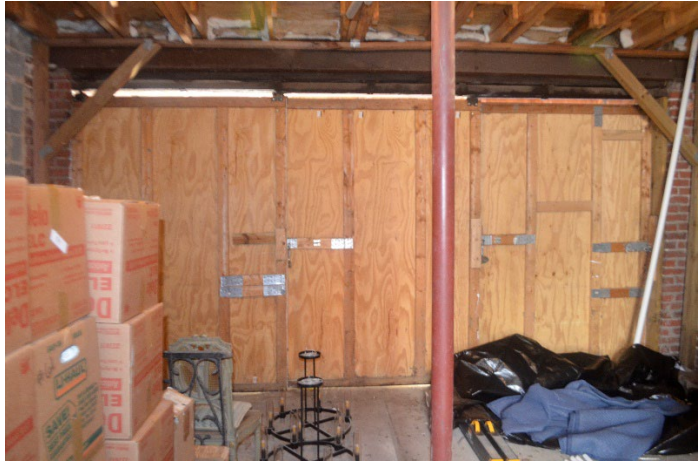
Figure 2. Interior of the garage door which will be replaced with a new, automatic door.

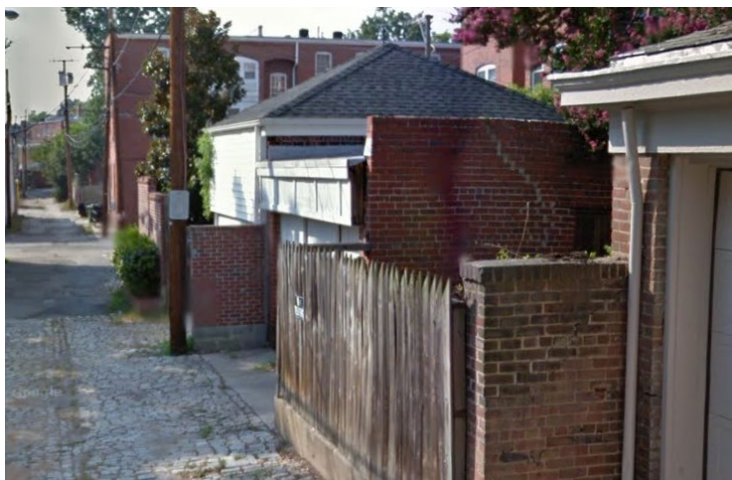
Sometime after 2011, the east wall of the garage was redone with CMU blocks and a brick veneer. A Google Maps photograph from 2011, shows the historic east wall of the garage with a window in the middle. The renovation of the garage's east wall was not done with CAR approval and was not built soundly. The garage roof is not in good condition structurally and needs to be replaced. The applicant proposes to reconstruct the

Figure 4. View of the historic east wall of the garage from Google Street View in July 2011. This wall was replaced without CAR approval, sometime after 2011.

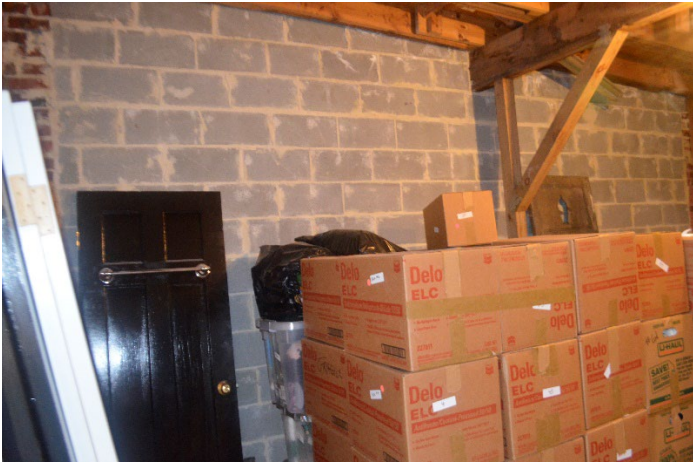
Figure 5. Interior view of the garage's replaced east wall, which was built sometime after 2011.

New Construction: Residential Outbuildings, page 51	<i>4. Prefabricated yard structures are discouraged. Screening will be considered as a mitigating factor for the installation of these structures.</i>	The garage will all be built of brick. The east wall was reconstructed with CMU blocks, which will be taken out. The garage width will be lengthened with the reconstruction an all-brick wall.
New Construction: Fences & Walls, page 51	<i>1. Fence, Wall and Gate designs should reflect the scale of the historic structures they surround as well as the character of nearby fences, walls and gates.</i>	<p>The proposed brick wall will be constructed in the same massing and scale as neighboring brick walls.</p> <p><u>Staff recommends that the new brick wall be constructed with similar dimensions, color and mortar joint profiles to the historic brick.</u></p>
New Construction: Fences & Walls, page 51	<i>2. Fence, wall or gate materials should relate to building materials commonly found in the neighborhood.</i>	The proposed wall will be built of brick similar to other walls found along the alley.

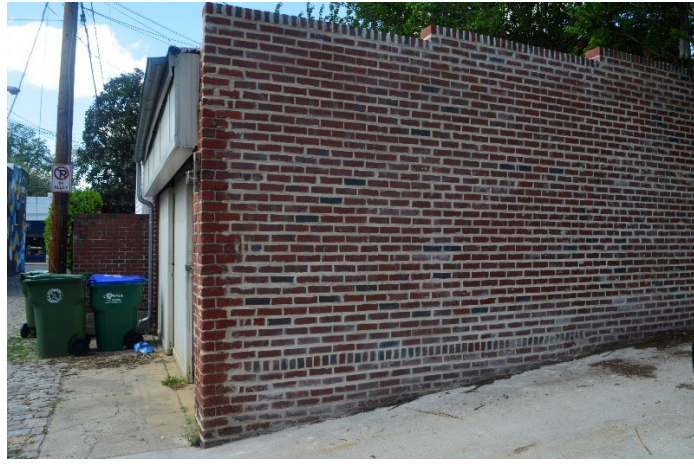
Figure 6. Existing brick veneer wall on the east side which was built sometime after 2011.

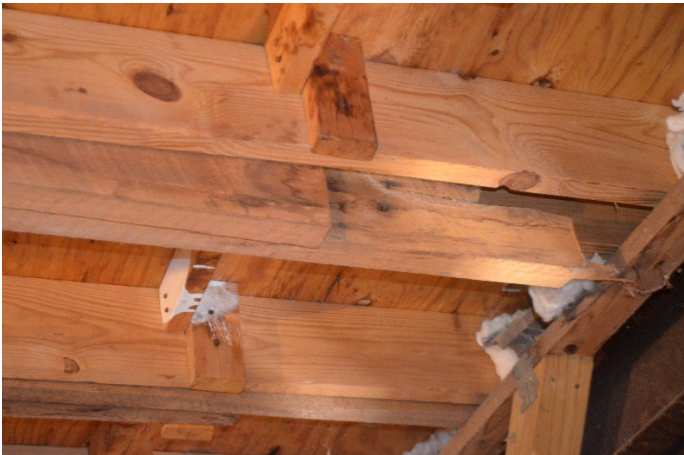
Figure 7. Interior view of the structurally unsound roof in the garage.

roof, similarly to the current roof. The east wall will be redone similarly to the rest of the garage but extended four feet farther east.

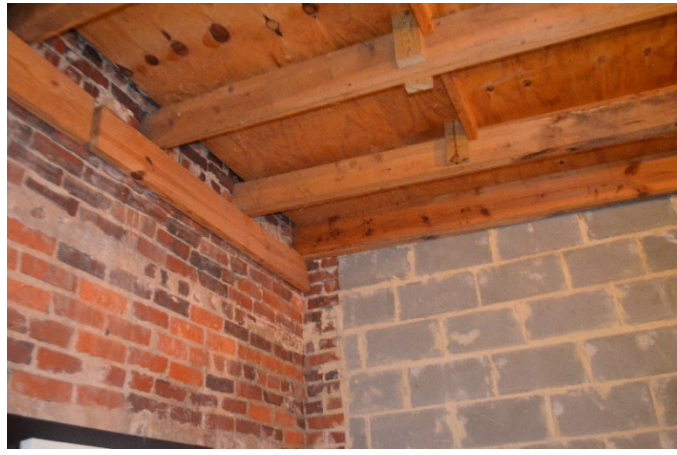
Figure 8. Interior of the garage showing the northeast corner, and the replacement east wall.

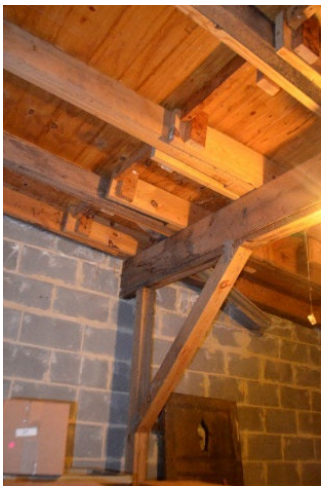
Figure 9. Interior view of the garage's east wall. The photograph shows additional wall braces added to support the unsound roof.

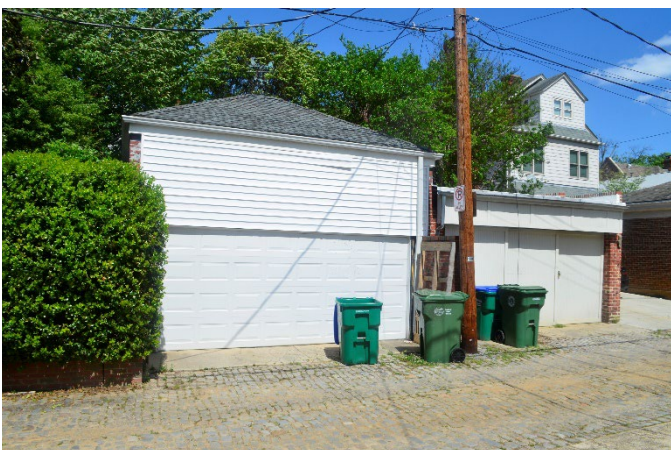
Figure 15. 2917 Monument Avenue garage. The façade of this garage appears to have been modified at some point. The 2915 Monument Avenue garage can be seen on the right side of the photograph.
