# Commission of Architectural Review SUBMISSION APPLICATION

LOCATION OF WORK: 307 N 29th Street DATE: 11/18/2015

**Detailed Description of Proposed Work**

For: 307 N 29th Street, Richmond  
Owners: Karen Sherry & Alan Braddock

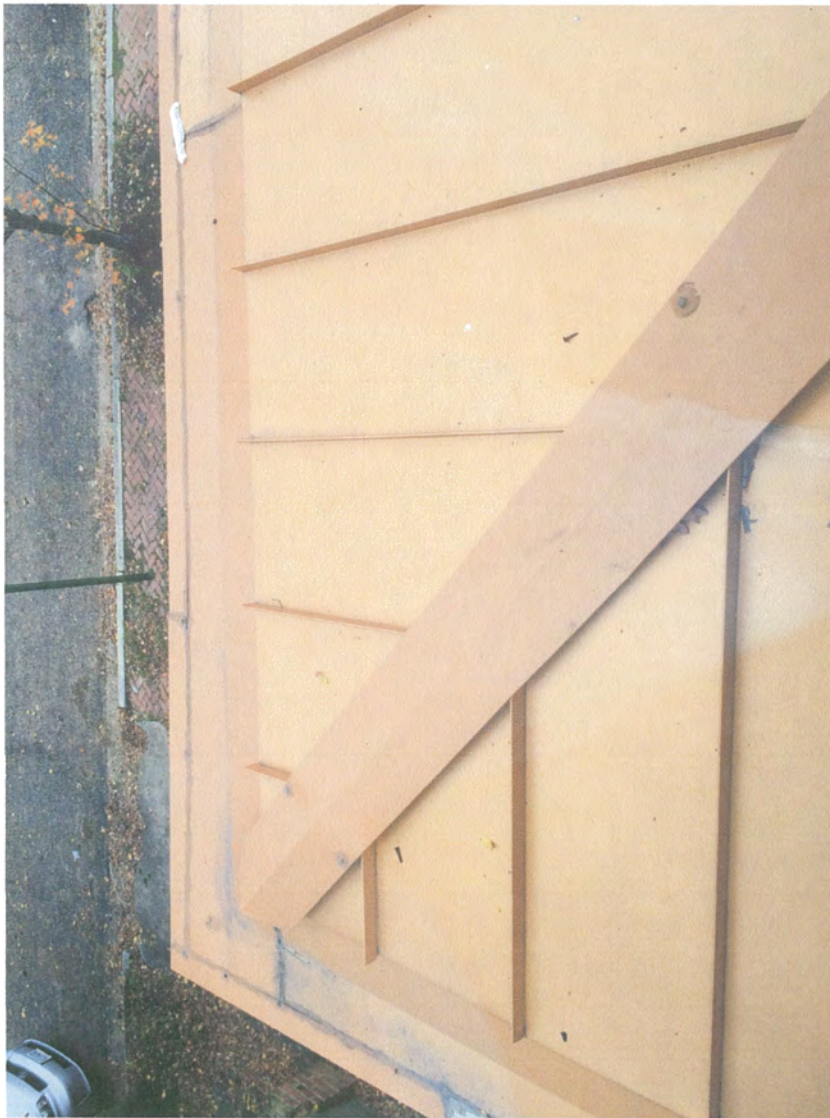
We purchased this house in September 2015 and learned during the inspection process that the roof of our front porch needs repair work. We had Graham Aston of Saunders Roofing inspect the roof and propose treatment. The porch roof is currently made of a snap-lock metal roofing system. (We believe that the current roof was installed in 2006 during a rehabilitation of the entire house; we do not have any documentation about this.) Saunders Roofing determined that the metal roofing panels were not installed properly and do not provide water tight conditions -- the seams at the eave, hips, and joint are not properly sealed and flashed, creating the potential for water damage to the structure of our house. Furthermore, the porch roof has a low pitch (1 in 12 inches) and Saunders Roofing feels that the snap-lock metal system is not suitable for low-pitch areas.

Fig. 3: Photograph of porch roof from upstairs window (showing snap-lock metal roofing)

Saunders Roofing has proposed repair work that involves replacing the snap-lock metal roof system with a modified bitumen roof membrane with a granulated surface. (This is the same material that covers about 70% of the main roof of the house.) This bitumen roof membrane is better-suited for low-pitch areas.
