## COMMISSION OF ARCHITECTURAL REVIEW APPLICATION/CERTIFICATE OF APPROPRIATENESS

July 20, 2017

Re: Standard Porch replacement

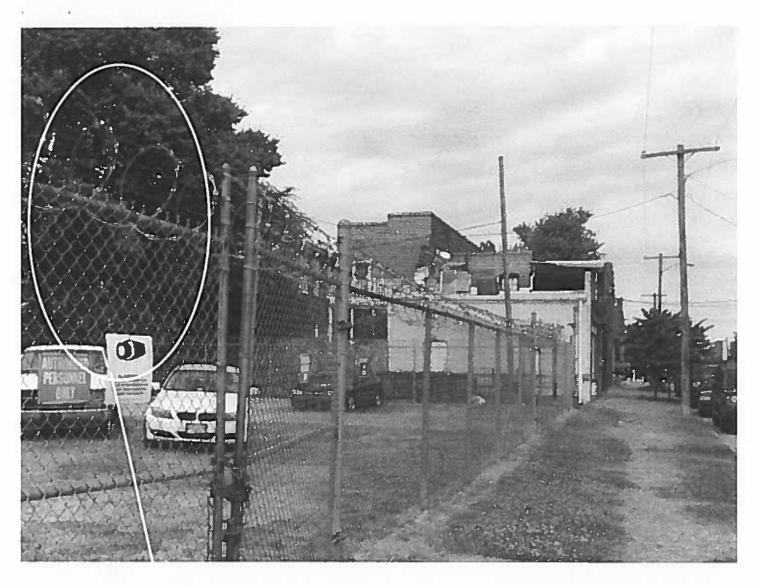
OUR BACK OF HOUSE IS BACK HERE THE VIEW OF OUR PORCH FROM THE STREET (OR LACK THEREOF) - Over the chain link, coiled wire, and left of all the 2015 installed, unapproved coooking vents on the restaurant.

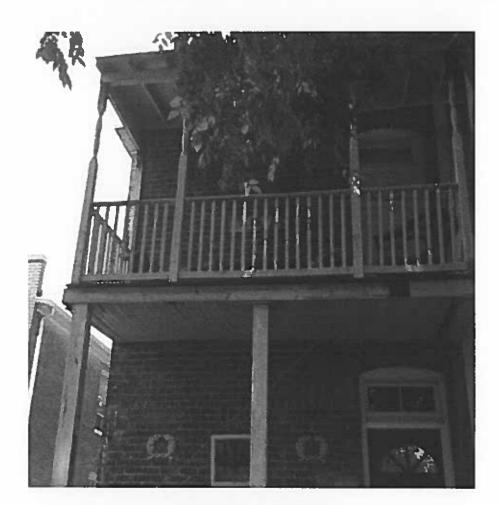
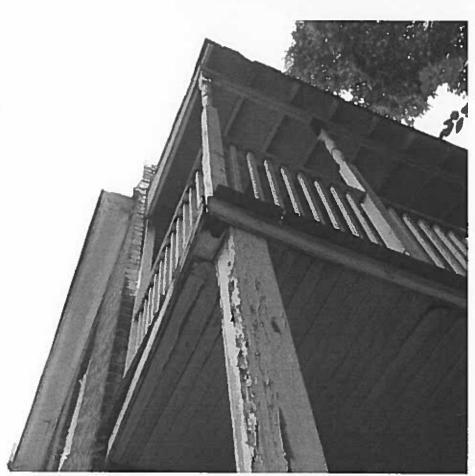
**FULL EXTERIOR SHOTS**

This is a request for a review of attached plans. The existing porch is no longer safe and need to be removed and replaced. There are attached pictures showing deterioration and rot in all elements. The upper porch is no longer safe to use as the floor is sagging and rotted. I have also attached the form from the City of Richmond Permits and Inspection office to detail my specifications and dimensions of materials for the replacement.

The included photos will show both the current state of the existing porch and it can be seen that at some point there was an outside staircase whether it was original or not it would be hard to know. The current porch is clearly not original and is composed of more modern and inferior materials than would have been used in any original construction of this period.

The replacement will be constructed of treated lumber of the dimensions indicated on the porch section form. My interpretation of the regulations set forth in your material, Part III, Sec. 2, is that this project meets the criteria for an "in-kind replacement " of an existing porch.

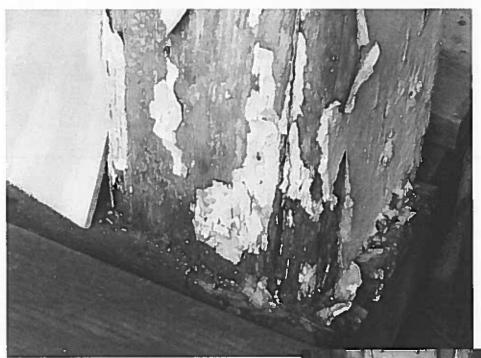
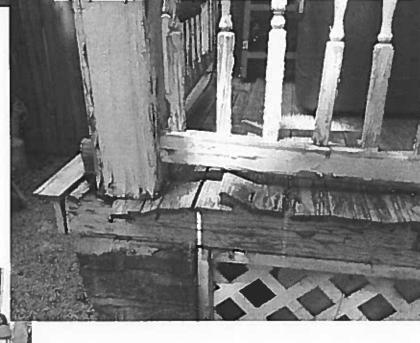
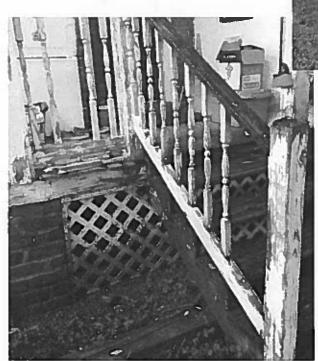
WOOD ROT AND CRUMBLING FLOOR, RAILINGS AND POSTS
