COMMISSION OF ARCHITECTURAL REVIEW APPLICATION / CERTIFICATE OF APPROPRIATENESS

The tiled lower landing front access first step off of the public sidewalk in front of 2235 Monument Avenue known as Rixey Court Condominium.

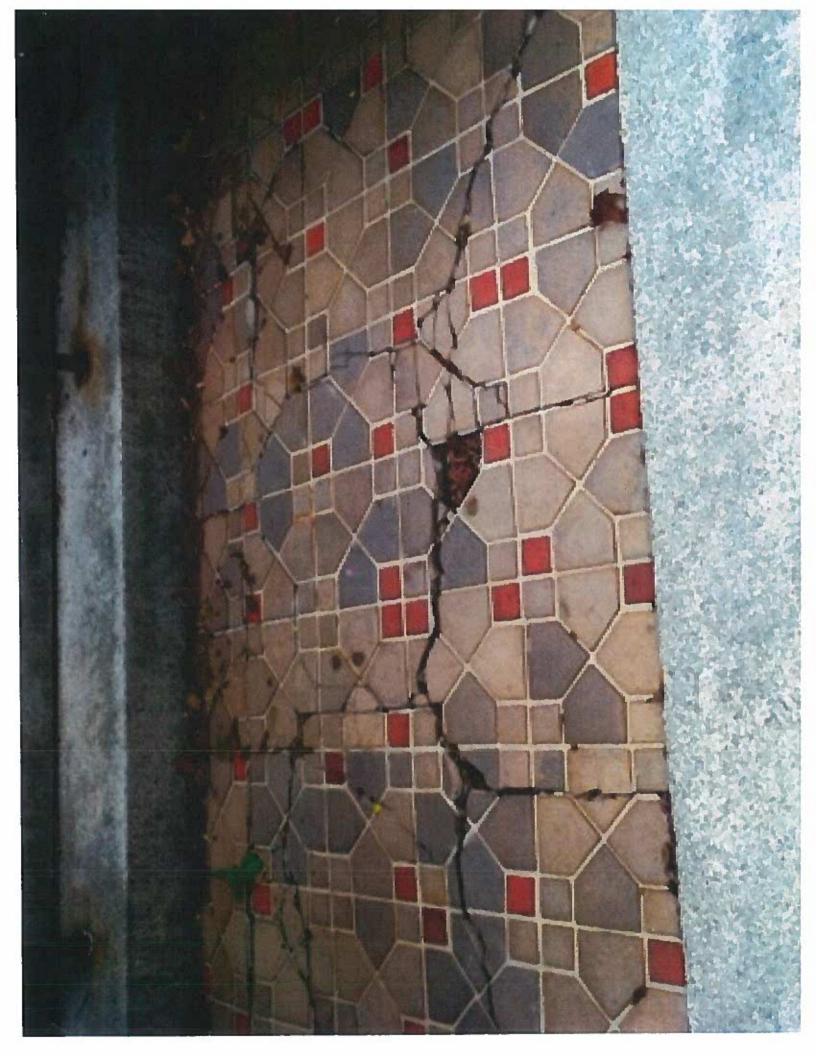
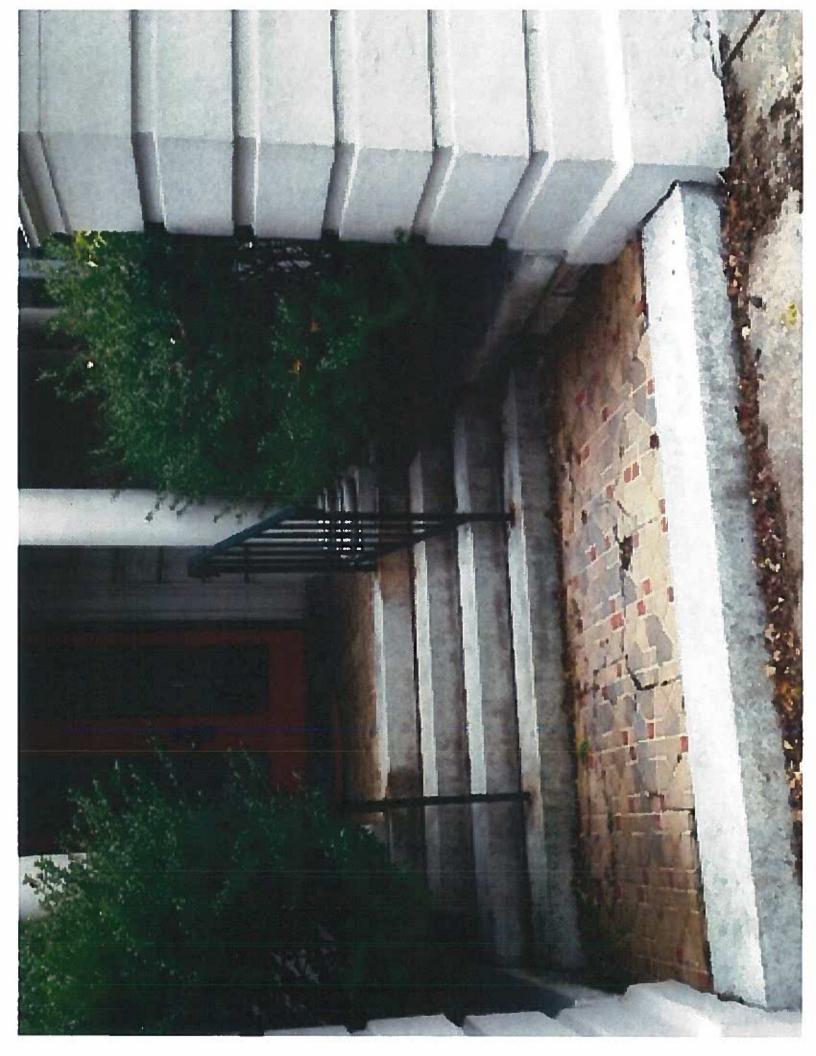
Current Condition

Due to age and wear, the tile inset is cracked, broken and raised because of an unstable base. There is no discernible concrete slab substructure. In it's present condition, the step creates a hazard of possible tripping or falling upon entry. The granite surround is in need of some repair.

Due to the instability of the area, all current tile and the substructure must be removed of all debris until solid ground is reached. Reconstruction will include the use of crushed stone for a solid base covered by a 4" slab for rebar.

Further investigation of the neighborhood, revealed a number of properties fronting on Monument Ave. with a solid stone and similar granite surround entry. We propose to replace our entry step with a solid 6" limestone cut in three pieces to preserve the existing symmetry in the steps above. See attached drawing. In addition to mirroring the entries of numerous Historical Properties fronting on Monument Avenue, it would also be structurally sound and appealing visually as the combination of the limestone with the granite surround is compatible to the existing facade.
