4. COA-049224-2019

2113 M Street

Commission of Architectural Review

STAFF REPORT

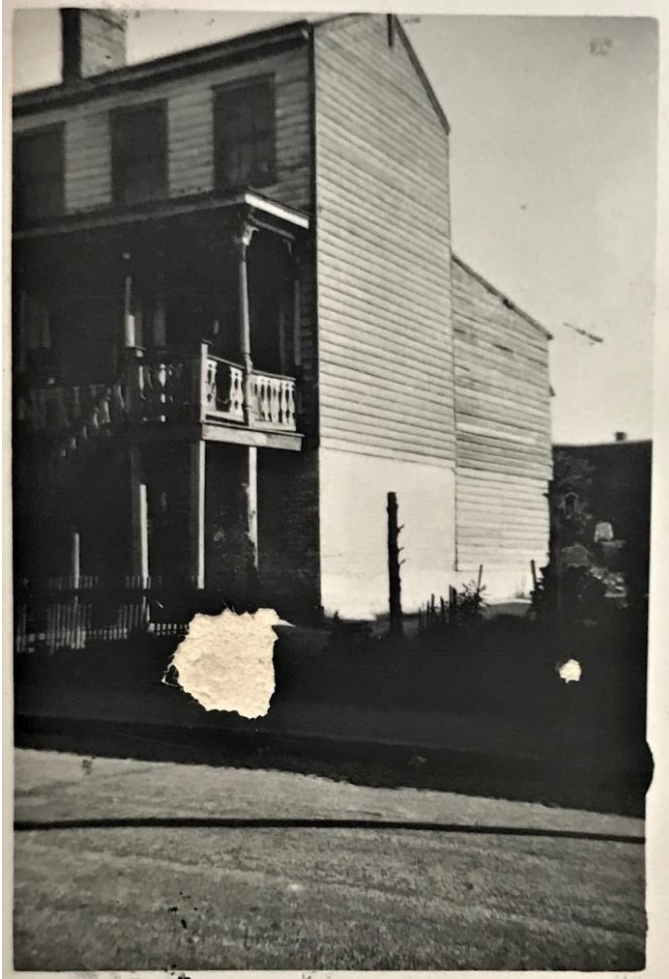
Figure 1. Assessor's record, date unknown.

The proposed design does not match photographic evidence of the historic porch. Historic images of the porch show turned posts, sawn brackets, cutout railings, high wooden piers, a landing, and stairs that run east parallel to the façade (see Figures 1&2). Though the porch shown in the photographs is not of a traditional Greek Revival style, the stylistic elements such as turned posts and cutout railings are common in this area of Union Hill. The photographs date from the 1940s and 1950s and staff believes this design, whether it is original or not, is important to the history of the building and is the only surviving evidence of a historic design.

- The porch be reconstructed per the photographic evidence to include turned posts, cutout railings, sawn brackets, high wooden piers, a landing, and stairs that run west into the side yard, as they did prior to the porch's collapse.
- The brick be removed from the concrete pad and the retaining wall and front steps be returned to their original appearance, a low concrete wall and concrete steps.
- The new window opening be removed and the west elevation be returned to its historic appearance.

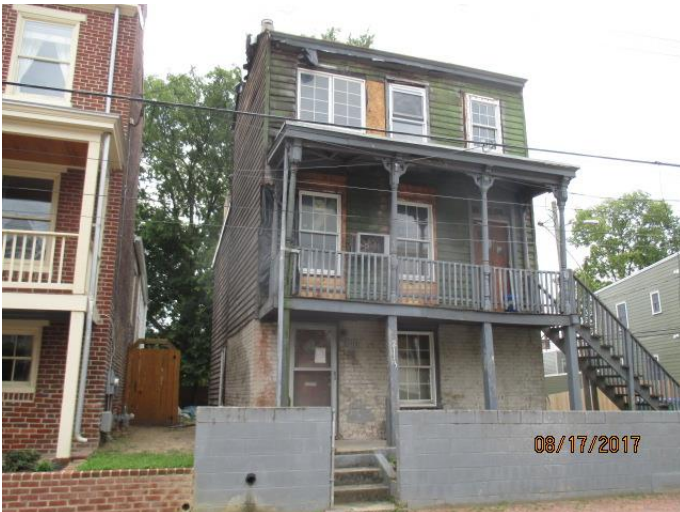
Figure 3. Assessor's record, 2017.

Most recently the front porch featured a stairway that ran west, parallel to the façade, into the large side yard. Based on tax assessment records, the front porch was rebuilt in the 1970s and this may have been when the design of the stairs was altered. The porch collapsed due to storm damage within the past two years. Very clear pictorial evidence exists which shows the historic and more recent design of the front porch, both of which included front steps to the ground. As no evidence exists which supports the design submitted by the applicant, staff recommends the porch be reconstructed per the photographic evidence to include turned posts, cutout railings, sawn brackets, high wooden piers, a landing, and stairs that run west into the side yard, as they did prior to the porch's collapse.

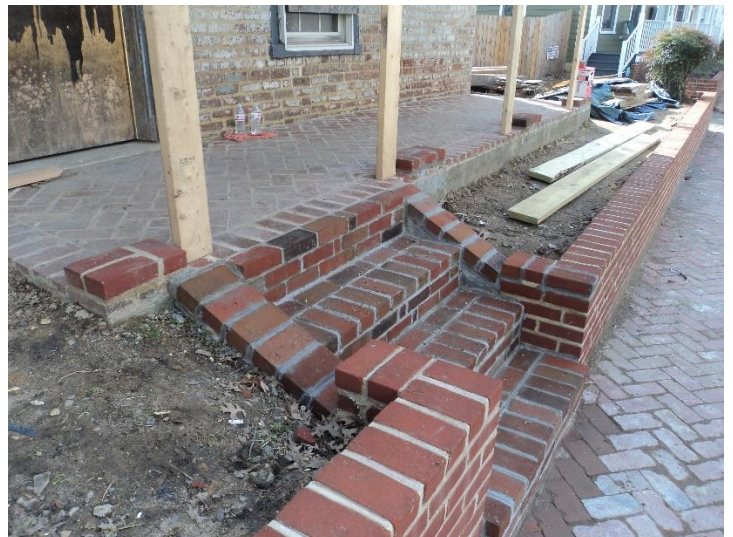
Figure 4. Front of 2113 M Street, 2019.

During a site visit on February 19, 2019 staff discovered work has been completed that did not receive an approval. An existing wall and front steps have been removed and rebuilt and a window has been added to the west elevation.

On a site visit staff discovered that the front retaining wall and front steps to the property have been rebuilt in brick and a brick veneer has been added to the concrete pad under the front porch without prior approval. This block of M Street contains many examples of low concrete retaining walls and concrete steps. Recent photographs of the property also indicate that a concrete block wall was constructed on top of an existing concrete retaining wall, which is seen in the 1940s photograph. As the Guidelines recommend against altering an entrance to give a false appearance, such as changing concrete to brick, staff recommends the brick be removed

from the concrete pad and the retaining wall and front steps be returned to their original appearance, a low concrete wall and concrete steps.

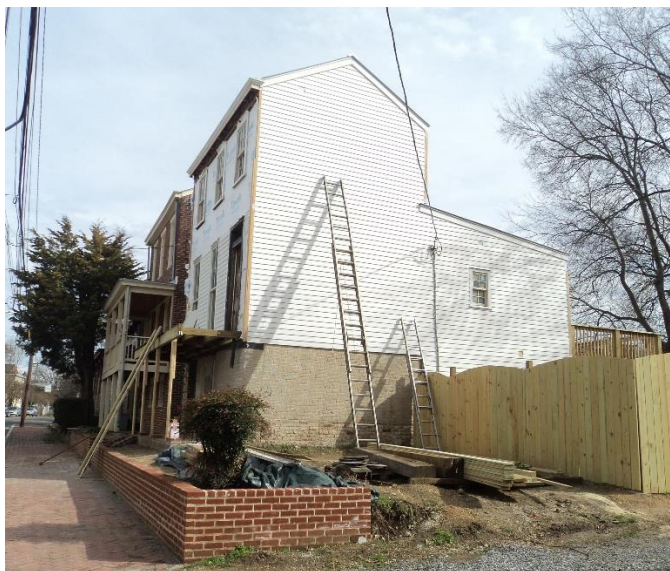
Figure 5. West elevation.

On a recent site visit staff discovered that a new window opening has been cut into the west elevation of the home. This window was not shown on the previously approved plans and was installed without approval. Historic photographs of the building indicate that this elevation historically did not contain any openings.

Though the window is on a side elevation, the property has a large side yard adjacent to an alley which makes the elevation highly visible from the street. Furthermore, staff finds that the 4/4 window is not compatible with the architectural character of the building or the district and is an inappropriate alteration that creates an inaccurate sequence of construction.

Staff recommends that the new window opening be removed and the west elevation be returned to its historic appearance.
