11. COA-091347-2021

4002 Hermitage Road

Commission of Architectural Review

STAFF REPORT

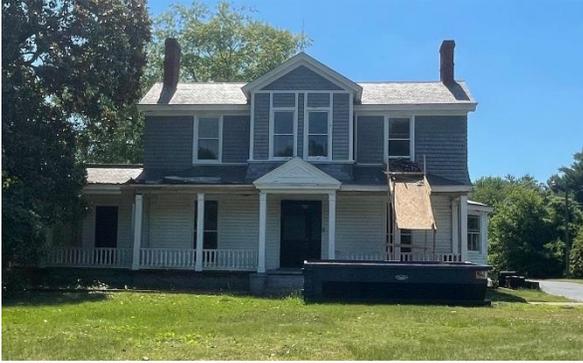
Figure 1. 4002 Hermitage, front facade, May 2021

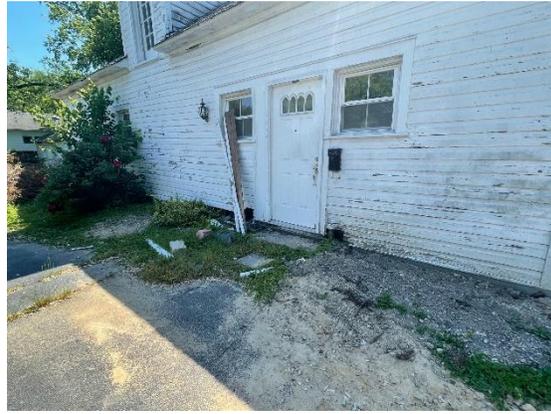
- Exterior repairs to the existing carriage house will include the construction of new concrete footing with a brick veneer, and the reframing of the lower two feet of the outer walls. Both alterations will match the original materials in-kind, including brick and siding.

Figure 2. 4002 Hermitage, existing conditions, carriage house deterioration

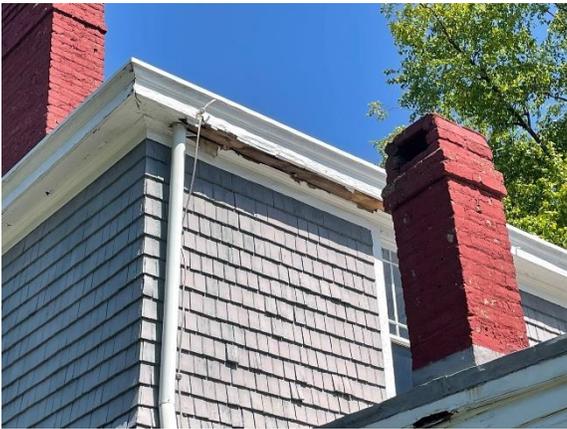
- A deteriorated built-in gutter will be replaced with EPDM roofing material.
- The slate roof will be replaced with a synthetic slate roof.
- Existing metal roofing areas will be replaced in-kind.

Figure 3. 4002 Hermitage, existing conditions, built-in gutter deterioration

- Staff recommends that the built in gutter be repaired and replaced in kind.

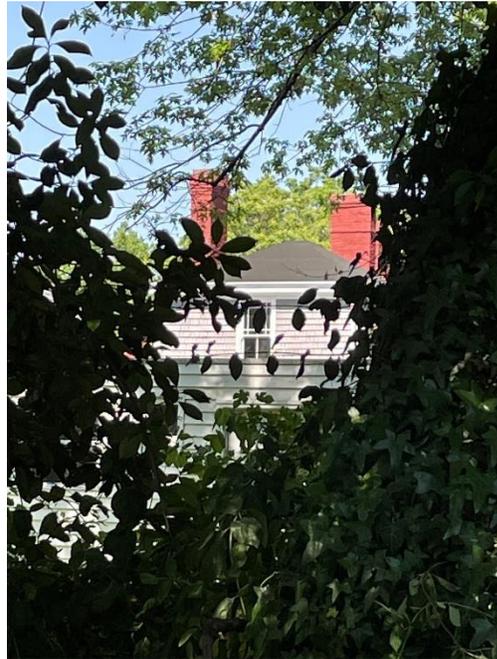
- On a site visit, staff noticed that the slate roof is unaltered on the front façade facing Hermitage Road, but all roofing material has been removed from the rear of the residence.

Figure 4. 4002 Hermitage, view from rear alley, roofing material removed from rear.
