Staff Report
City of Richmond, Virginia

Commission of Architectural Review

COA-100316-2021	Final Review	Meeting Date: 10/26/2021
Applicant/Petitioner	Martin Johnson	
Project Description	Remove deteriorated wooden siding and install fiber cement siding.	
Project Location

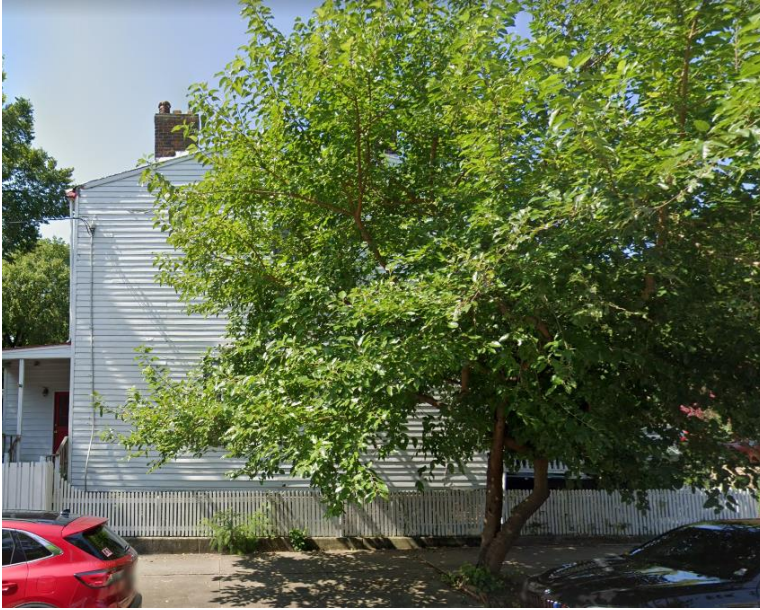
<p>Substitute Materials – Fiber Cement Siding, pg. 60</p>	<p><i>Fiber cement siding is a siding option that has limited application for use on historic properties. Advertised as an alternative to vinyl or wood products, the application of these products in City Old and Historic Districts should be restricted to new freestanding buildings, secondary elevations with limited visibility from the public right-of-way, new additions with limited visibility from the public right-of-way, and new outbuildings. The use of fiber cement siding products as a substitute for original wood trim and siding on historic structures is discouraged. Fiber cement siding is often thinner than wood siding, providing a narrower profile that makes the wall appear flat. Fiber cement siding should reveal a smooth surface, rather than a faux “wood grain.”</i></p>	<p>The applicant proposes to replace historic wood siding with fiber cement, hardie plank siding on a secondary elevation. However, even though it is a secondary elevation, it faces E. Broad Street, the busiest artery in the St. John’s Church District and is visible.</p>

Figure 3. Elevation facing E. Broad St.

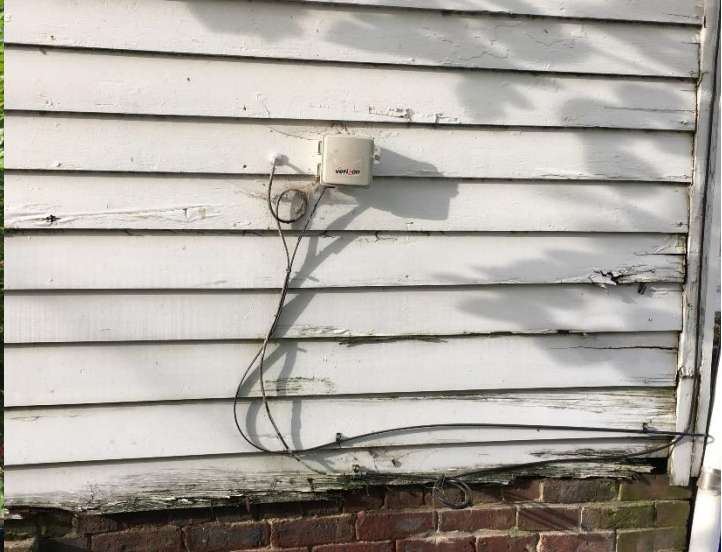
Address: 219 N. 28th St.		
Historic District: St. John's Church		
High-Level Details: <ul style="list-style-type: none"> The applicant proposes to replace rotted wood siding on the north elevation of a ca. 1851 Italianate home with unbeaded, smooth hardie plank. The new hardie plank will match the color and profile of the siding on the rest of the house. 		
Staff Recommendation	Denial	
Staff Contact	Emily Routman, Emily.routman@richmondgov.com	
Previous Reviews	The applicant received an Administrative Approval for the replacement of rotted wood siding with smooth hardie plank on the south elevation of the house in September 2021.	
Staff Recommendations	<ul style="list-style-type: none"> Denial of the hardie plank siding. The applicant should replace the rotted wood siding with in-kind materials and color.

Figure 4. Rotted wooden siding
