**COMMISSION OF ARCHITECTURAL REVIEW
STAFF REPORT
April 24, 2018, Meeting**

8. **COA-033493-2018** (J. Jordan & D. Cooley) **2105 East Marshall Street
St. John's Church Old and Historic District**

Project Description: **Install a chain between existing concrete posts**

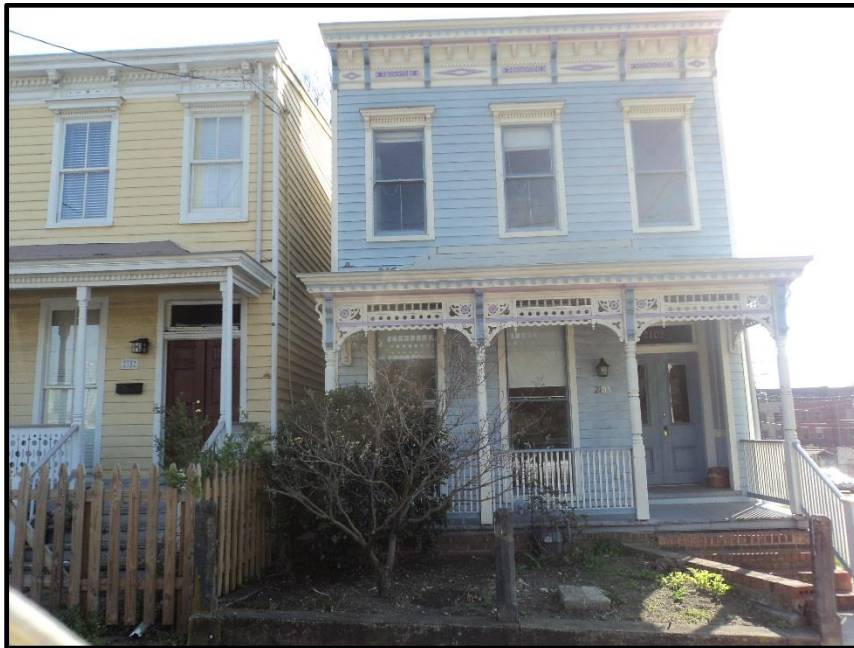
818 North 25th Street (March 2018)

Description of Existing Structure: The existing structure is a frame Italianate structure near the intersection of East Marshall Street, Jefferson Avenue, and North 21st Street and is near the base of Jefferson Park. Currently at the front of the property, there are concrete posts.

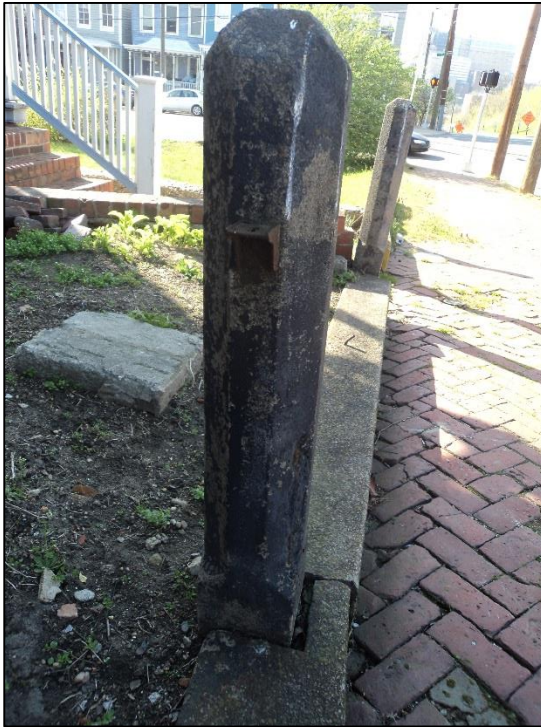
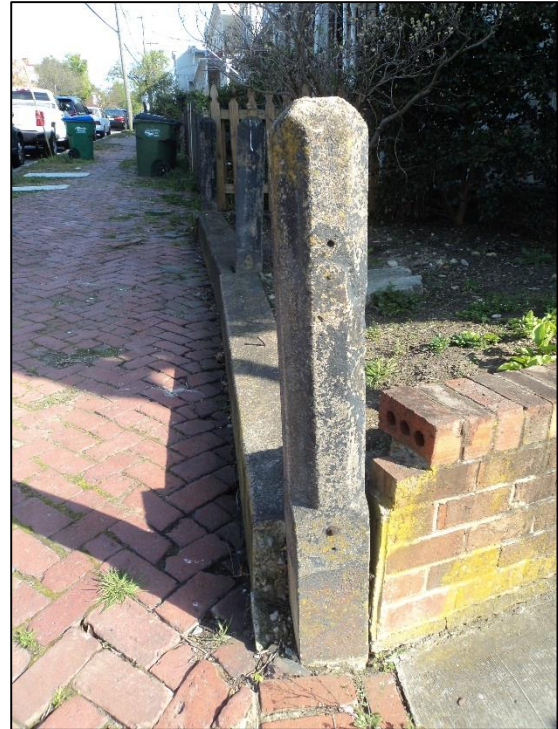
Metal Brackets and Screws on Concrete Posts at 2105 E. Marshall (April 2018)

Staff recommends denial of the project. The *Richmond Old and Historic District Handbook and Design Review Guidelines* state that new street-front fences and gates should be compatible with the historic structure in design, materials, and location and should be based on physical or documentary evidence from the site (pg. 78, #3). The physical evidence indicates a metal picket fence was located between the concrete posts as metal brackets and screws remain.
