2. COA-060555-2019

Commission of Architectural Review

STAFF REPORT

Demolish two attached sheds and make exterior repairs.

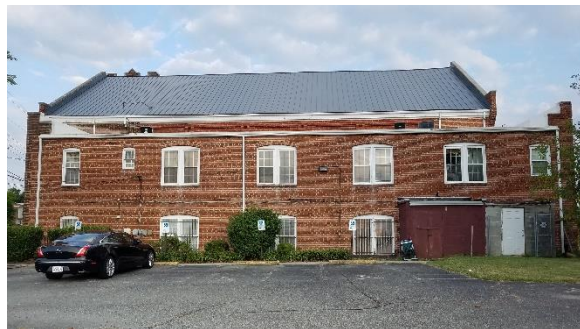
Figure 2. Sixth Mount Zion Baptist Church, east elevation.

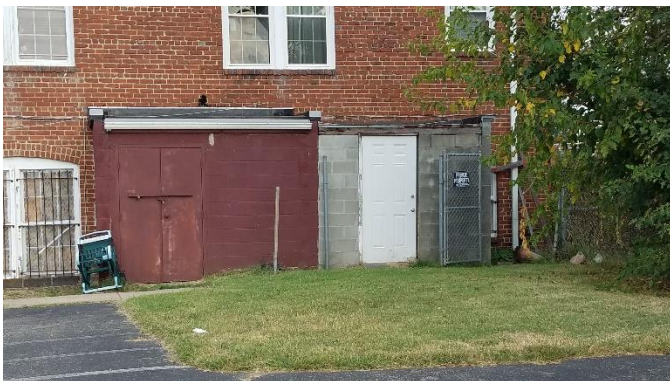
Figure 3. Existing sheds to be removed.

The applicant proposes to demolish two attached sheds. DHR has approved the removal of the sheds. Staff believes that the sheds do not contribute to the historic character of the building and recommends approval of their demolition.

Once the sheds are removed, the applicant proposes to restore the windows based on the pattern and design of the existing windows. Staff finds this is consistent with the Secretary of the Interior Standards for Rehabilitation.
