Staff Report
City of Richmond, Virginia

Commission of Architectural Review

COA-094659-2021	Final Review	Meeting Date: 7/27/2021
Applicant/Petitioner	Kimberly & Nicholas Macauley	
Project Description	Install 3 new window openings; paint a new mural to replace the existing.	
Project Location		
Address: 14 S. 15th St.		
Historic District: Shockoe Slip		
High-Level Details: <ul style="list-style-type: none"> The applicant proposes creating 2 new window openings on the 2nd floor of the north side of the building and 1 new window opening on the 1st floor of the south side of the building, contingent on getting a no-build easement from adjacent property owners. The proposed mural on the north side of the building is to be donated to Mending Walls RVA. On a site visit, staff noticed the existing mural had already been painted over. 		
Staff Recommendation	Partial Approval	
Staff Contact	Emily Routman, Emily.routman@richmondgov.com	
Previous Reviews	The current mural on the north-facing wall was approved by CAR in 2013. A proposed mural on the south-facing wall was denied by CAR.

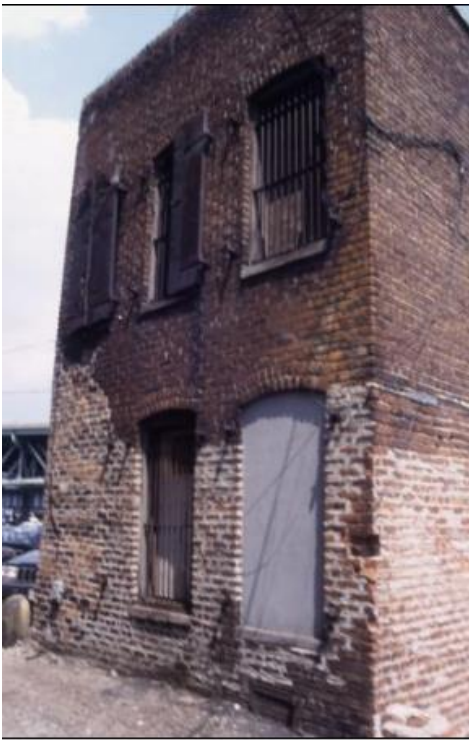
Figure 3. 1998 photo of rear of building, altered later.

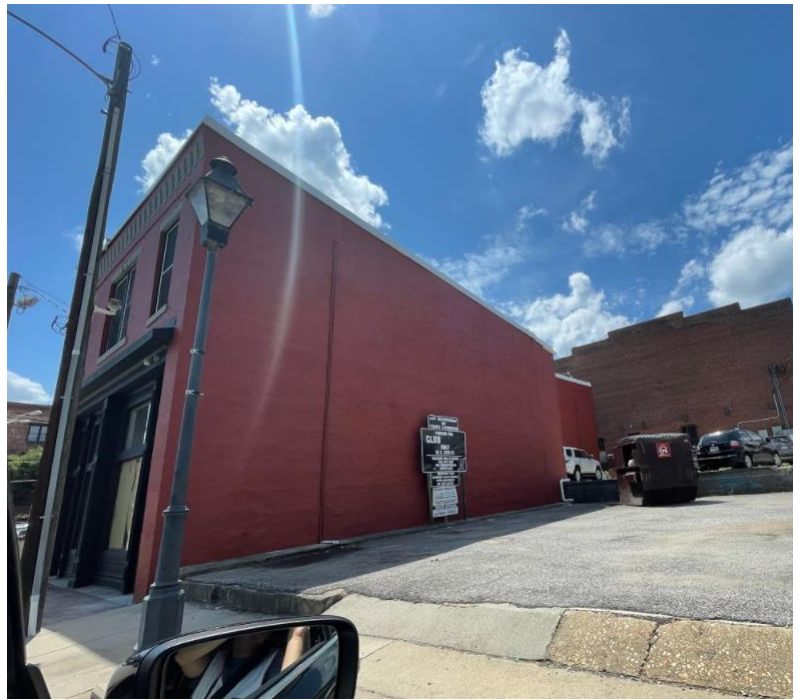
Figure 4. Current photo of north elevation of building, site of proposed mural

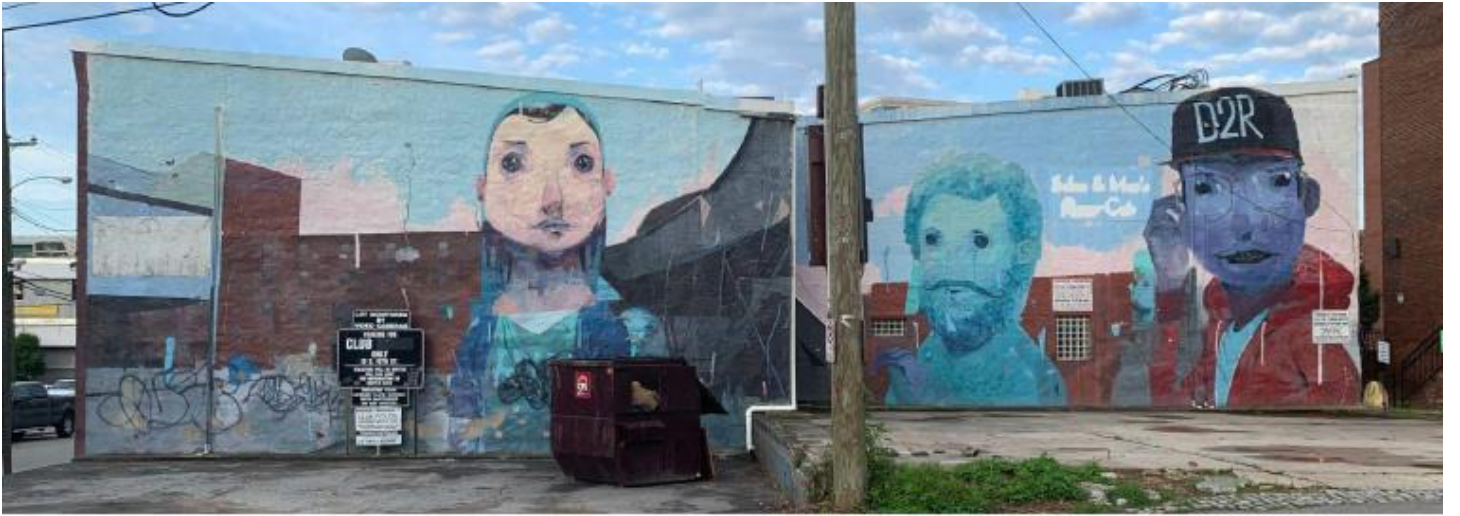
Figure 5. Mural on north side of the building, painted over in 2021.
