Commission of Architectural Review

2. COA-138395-2023	Final Review Meeting Date: 11/28/2023
Applicant/Petitioner	John W. Collier III
Project Description	Rehabilitate an existing dwelling and construct a rear addition.
Project Location	
Address: 514 West Marshall Street	
Historic District: Jackson Ward	
<p>High-Level Details:</p> <ul style="list-style-type: none"> • The project includes a complete rehabilitation of the exterior and interior. • A new addition will be added to the northwest side of the rear/north side. The addition will be 16 by 10 feet. • The porch was removed due to its poor condition. • The dwelling was divided into two apartments around 1950. 	
Staff Recommendation	Approval
Staff Contact	Annie Delaroderie, anne.delaroderie@rva.gov , 804-646-6335
Previous Reviews	The City of Richmond property maintenance required that the front porch to be removed sometime in 2019, due to its unsafe condition; however, Staff was unable to locate any documentation of this decision.

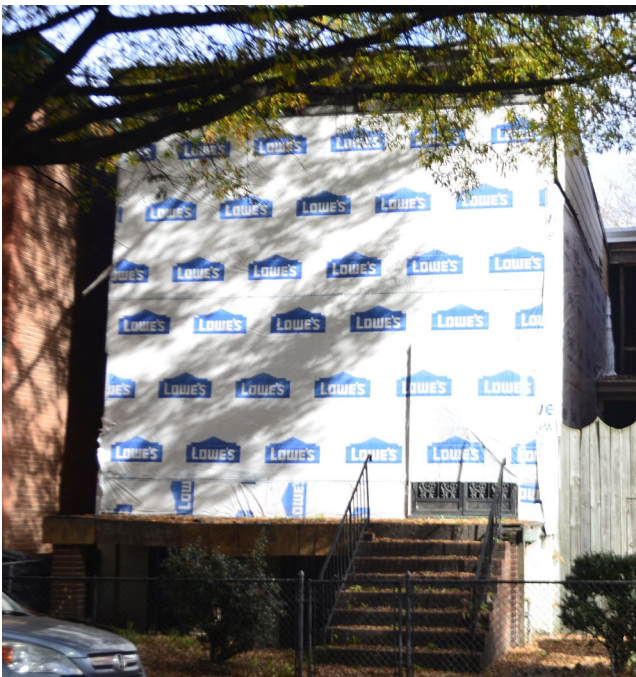
Figure 1. Current view of 514 West Marshall Street. The photograph was taken on November 17, 2023.

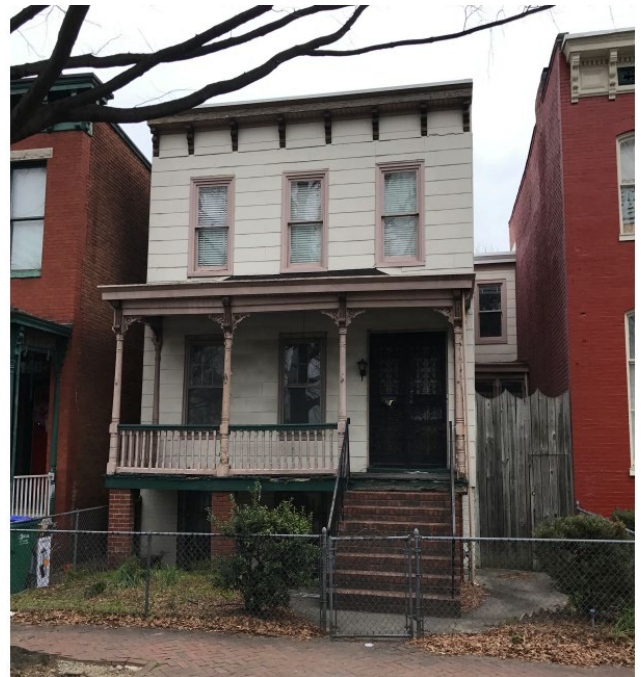
Figure 2. View of 514 West Marshall Street, from March 1, 2019.

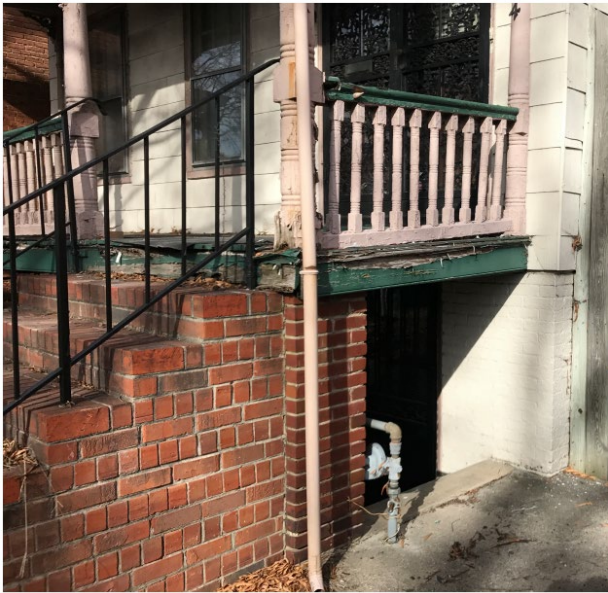
Figure 5. Detail of the front porch before it was removed. Photograph from March 1, 2019.

Residential Buildings: Typical Problems, page 87.	<p>Inappropriate Porch Remodeling and Porch Removal: <i>A significant character-defining architectural feature is lost when original porches on historic homes are removed.</i></p>	<p>The city asked the owner of 514 West Marshall Street to remove the porch at this residence due to its poor condition. The porch roof and all of its components are inside the house. The owner intends to repair the porch materials and put the porch back in place to match its original appearance, including roof form and material. <u>Staff recommends that paint colors for the porch be submitted to staff for Administrative Review and Approval.</u></p>
Wood: Typical Problems, page 91.	<p>Cracked or warped boards <i>may result from long-term exposure to the extremes of weather or from pressure stresses. Removal and replacement with sound boards is often the only solution.</i></p> <p>Cracked, peeling or blistering paint <i>signals excessive moisture, improperly prepared paint surfaces or chemical incompatibility of paint layers. Rot is a fungus that consumes wood and thrives in dark, moist areas such as unventilated or light-deprived areas.</i></p>	<p>A front porch floor remains in place, but does have areas that are deteriorated beyond repair. The supporting corner and side porch boards are in poor condition, showing severe rot, decay, and cracked paint. <u>Staff recommends that decking boards that are deteriorated beyond repair be replaced in-kind to match the width and profile (tongue and groove), width, and be installed perpendicular to the face of the building.</u></p>

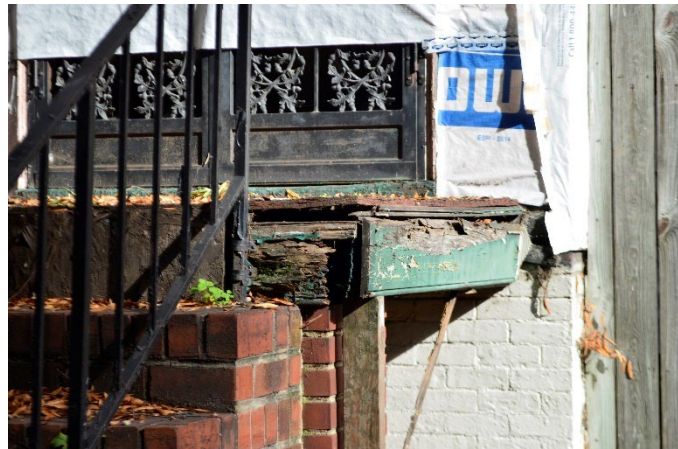
Figure 6. Detail of current porch floor deterioration.

Conditions for Approval	<p>Staff recommends:</p> <ul style="list-style-type: none"> • that paint colors for the front porch be submitted to staff for Administrative Review and Approval. • that decking boards that are deteriorated beyond repair be replaced in-kind to match the width and profile (tongue and groove), and be installed perpendicular to the face of the building. • that the lap siding be either fiber cement siding or wood. Final material submitted to staff for review and approval. • that the new deck have a finished appearance with no exposed hardware. • that the railings on the new decks not be “nailed-up” pickets, but be a finished design such as “Richmond Rail”. Final railing design be submitted to staff for review and approval. • that the applicant submit photographs of the existing windows

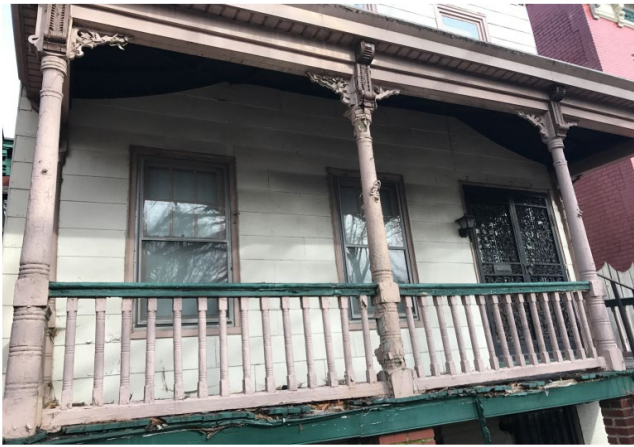
Figure 7. Front porch details from March 1, 2019.

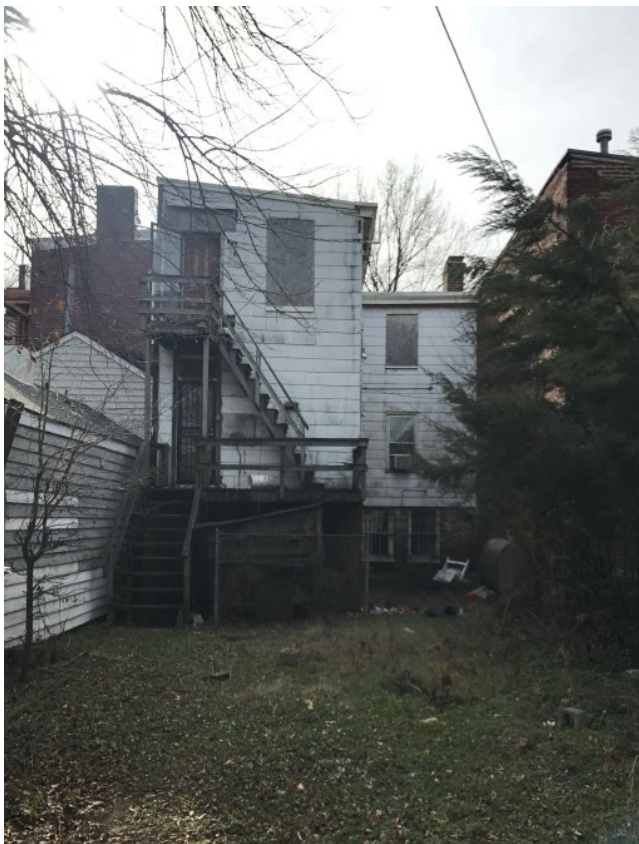
Figure 9. Rear view of 514 West Marshall Street, March 1, 2019.

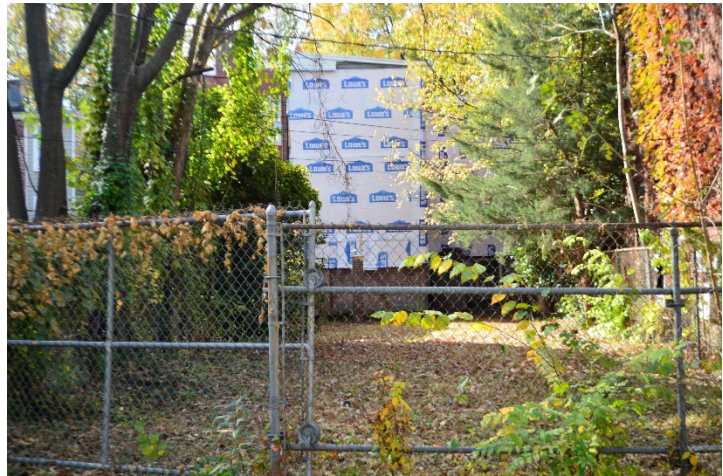
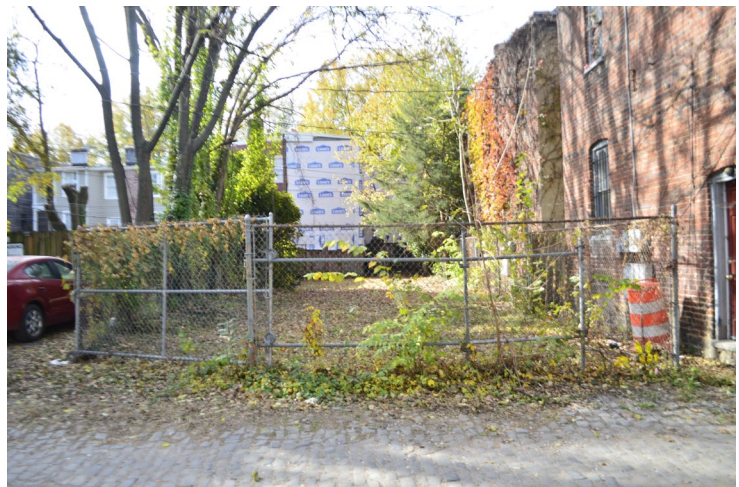
Figures 10 and 11. Current rear view of 514 West Marshall Street. Figure 11 shows the distance of the new addition from the alley.

Standards For New Construction: Siting, page 46.	<p><i>1. Additions should be subordinate in size to their main buildings and as inconspicuous as possible. Locating additions at the rear or on the least visible side of a building is preferred.</i></p>	<p>The proposed addition is planned to be situated in the area adjacent to the existing rear addition. The new addition will be located at the rear and will be no taller than the existing addition and the primary dwelling.</p>
Standards For New Construction: Form, page 46.	<p><i>1. New construction should use a building form compatible with that found elsewhere in the historic district. Building form refers to the specific combination of massing, size, symmetry, proportions, projections, and roof shapes that lend identity to a building.</i></p>	<p>The addition will be compatible with the historic building and other buildings in the historic district. Several of the historic buildings on this block have rear brick or wooden additions.</p>
