Commission of Architectural Review

3. COA-144134-2024	Final Review	Meeting Date: 3/26/2024
Applicant/Petitioner	Jennie & Walter Dotts	
Project Description	Install a new balustrade.	
Project Location		
Address: 2720 East Broad Street		
Historic District: St. John's Church		
<p>High-Level Details:</p> <p>The applicant proposes to install a new, cast stone balustrade at the primary entrance of a stuccoed, Italianate building circa 1875.</p> <p>The balustrade will have the following dimensions: Balusters will be 2' 4 1/2" tall. Bases will be square 5 3/4". Upper Banister will be 5 3/4" wide and 4 1/8" thick. Newel post will have an octagonal 8" base.</p> <p>The existing design of the primary entrance is not original to the building and has undergone alterations over the years.</p>		
Staff Recommendation	Approval	
Staff Contact	Alex Dandridge, alex.dandridge@rva.gov , (804) 646-6569	
Previous Reviews	None.	
Conditions for Approval	None.

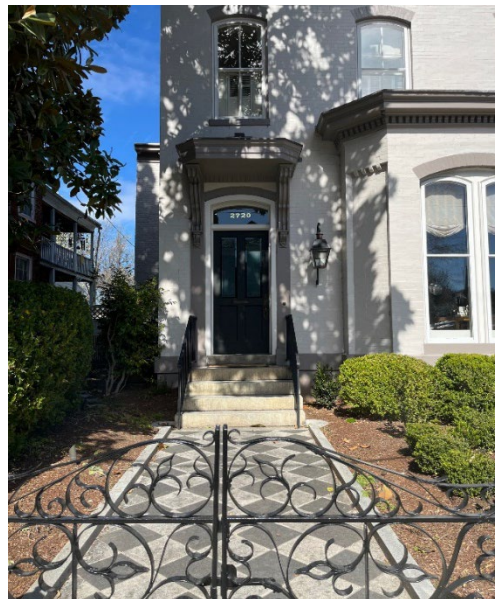
Figure 2. 2720 East Broad Street. Primary Entrance. Location of new balustrade.

<p><i>the appearance of that railing. If no documentary evidence survives, look for physical evidence (this may benefit from the help of a design professional).</i></p>	<p>base of the porch's stairs that suggest that a larger newel post or baluster could have been present in this location at some point in the past.</p> <p>The primary entrance of this building, including the bracketed hood, entry door, and transom are not original to the building. Additionally, staff was able to locate photographic documentation that demonstrates that the primary entrance has undergone several alterations overtime. Staff believes that the proposed balustrade is compatible with the existing architectural elements on the building.</p>
<p>Porch and Porch Details, pg. 49</p>	<p><i>1. Porch railings and balustrades are important character-defining features of historic buildings. The proportions of these railings are a significant contributing feature to the appearance of both the individual structure and the character of the entire neighborhood.</i></p> <p><i>3. New porch railing designs, compatible with the overall design of the building, will also be considered.</i></p>	<p>The building has a heavy, wide cornice supported by decorative brackets that wrap its corners and sides. In addition, there is a hood above the front door that features robust brackets. Staff finds that the proportion of the new balustrade is compatible with the building.</p> <p>Staff finds that the new porch design, while more robust than the existing, is compatible with the overall style of the building and considers it appropriate.</p>
