Staff Report City of Richmond, Virginia

Commission of Architectural Review

| 7. COA-135960-2023. | Final Review Meeting Date: 9/26/2023 |
| Project Description | Result of a Notice of Violation: Alter a front yard, concrete curb, veneering it in thin brick. |

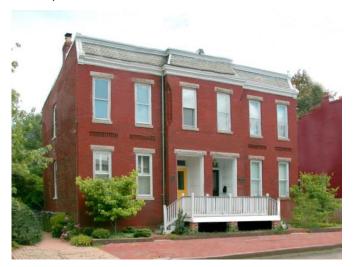
| Guideline Reference | Reference Text | Analysis |
|---|--|---|
| | | The semi-attached dwellings at 209-211 N. 27 th Street are identical, and the concrete curbs out front were identical as well, continuing the motif of visual uniformity between the two units. |

Figure 1. Semi-attached dwellings at 209-211 N 27th Street, Valentine Museum Archives

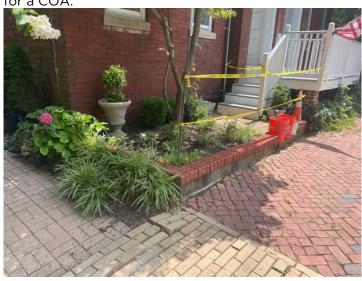
| Guideline Reference | Reference Text | Analysis |
|---|--|---|
| | 2. Existing brick or stone walls, boxwood | It appears that the concrete retaining wall was cracked and in need of repair. |

Figure 2. Staff observed work being completed without a COA on July 26, 2023. Staff sent an application page and a courtesy email to the property contact on file, suggesting they stop work and apply for a COA.

| Guideline Reference | Reference Text | Analysis |
|---|--|---|
| | removed or replaced with contemporary | Per the <i>Guidelines</i> , the concrete curb should have been repaired or reconstructed to match the original rather than covering the damaged curb with brick. Staff recommends denial of the application, and recommends that the original concrete curb be repaired and retained, or reconstructed to match the original in height and dimension. |
