**Commission of Architectural Review
Certificate of Appropriateness Application**

Property Address: 3104 E Broad St , Richmond, VA, 23223 (BLDR-147901-2024) Current Zoning: R-6
Historic District: St John's Church

SCOPE OF WORK:
DESCRIPTION: EXTERIOR FACADE PROVIDING RESTORATION, AND IN-KIND PLACE REPLACEMENTS BASED ON THE DISTRICT'S HISTORIC STANDARDS AND GUIDELINES

EXTERIOR RESTORATION
DOCUMENTS
3104 E. BROAD ST
RICHMOND, VA
23223

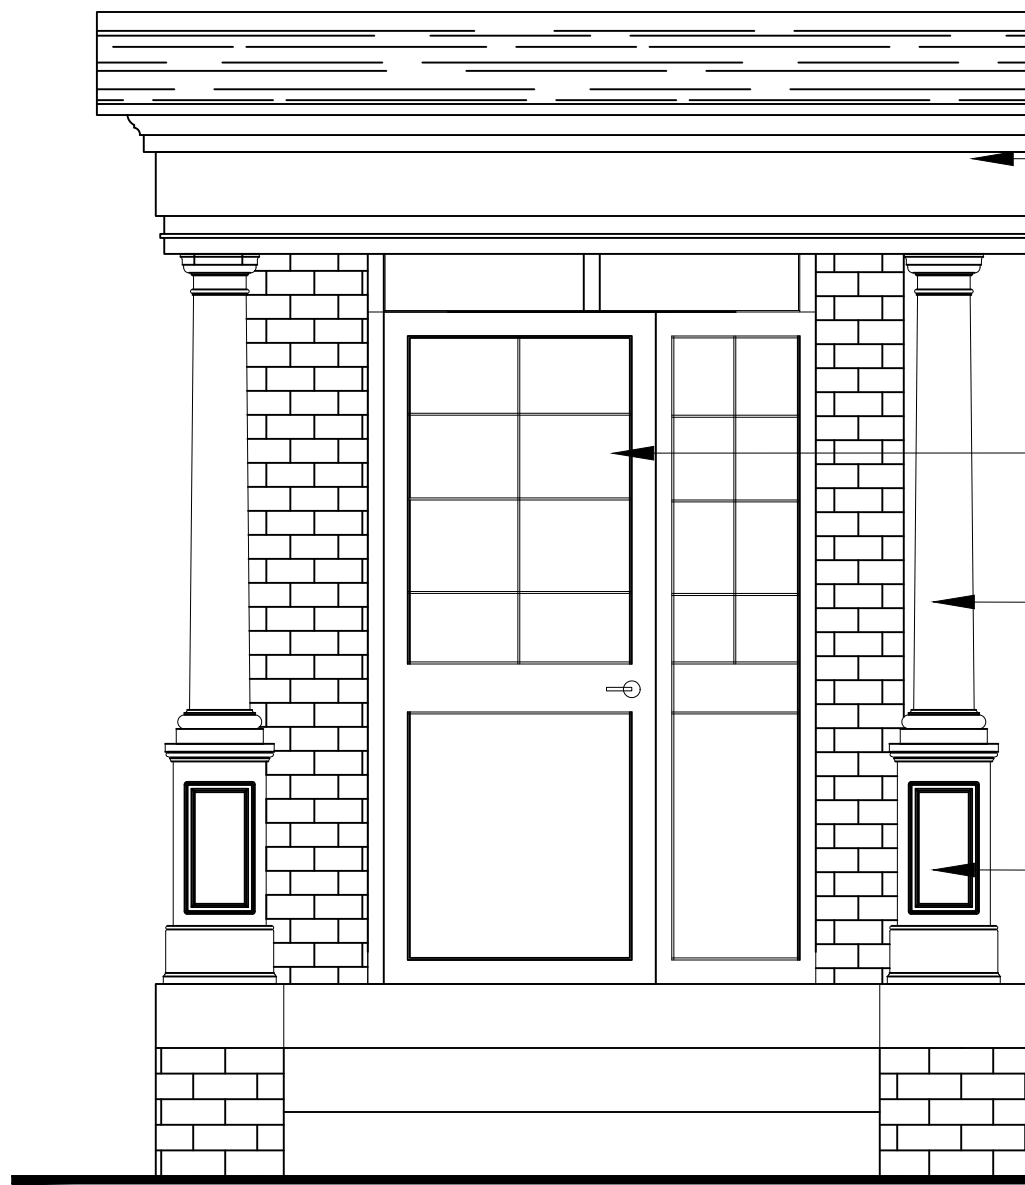
4
A-3

EXISTING PORCH WOOD ENTABLATURE TO BE
REPAIRED. SEE WOOD RECOMMENDATIONS ON
WOOD REPAIR OR REPLACEMENT ON THIS SHEET AND
SHEET A-6

NEW WOOD DOOR WITH SIDELIGHT AND TRANSOM ABOVE.

EXISTING WOOD COLUMNS TO BE REPAIRED AS NEEDED.
SEE RECOMMENDATIONS FOR WOOD REPAIR ON THIS
SHEET AND SHEET A-6

EXISTING WOOD COLUMNS DADOS TO BE REPAIRED AS
NEEDED.SEE RECOMMENDATIONS FOR WOOD REPAIR ON ON
THIS SHEET AND SHEET A-6

WOOD RECOMMENDATION NOTES:
REPAIR WOOD MEMBERS BY PATCHING, PIERCING-IN CONSOLIDATING
AND USING IN-KIND REPLACEMENT OF DAMAGE PIECES AS NEEDED.

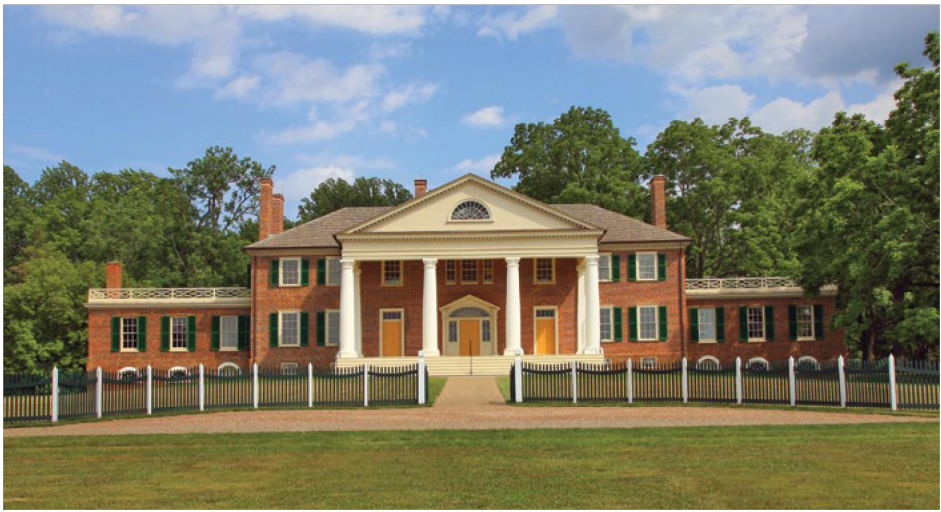
[1] (a) When it was acquired by the National Trust for Historic Preservation in the 1980s, Montpelier in Montpelier Station, VA, the home of James and Dolley Madison, had been much altered and enlarged since it was first constructed. Based on historical documentation and research, Montpelier was accurately restored to its 1820s appearance when the president and his wife lived there (b). Photos: Courtesy of The Montpelier Foundation.

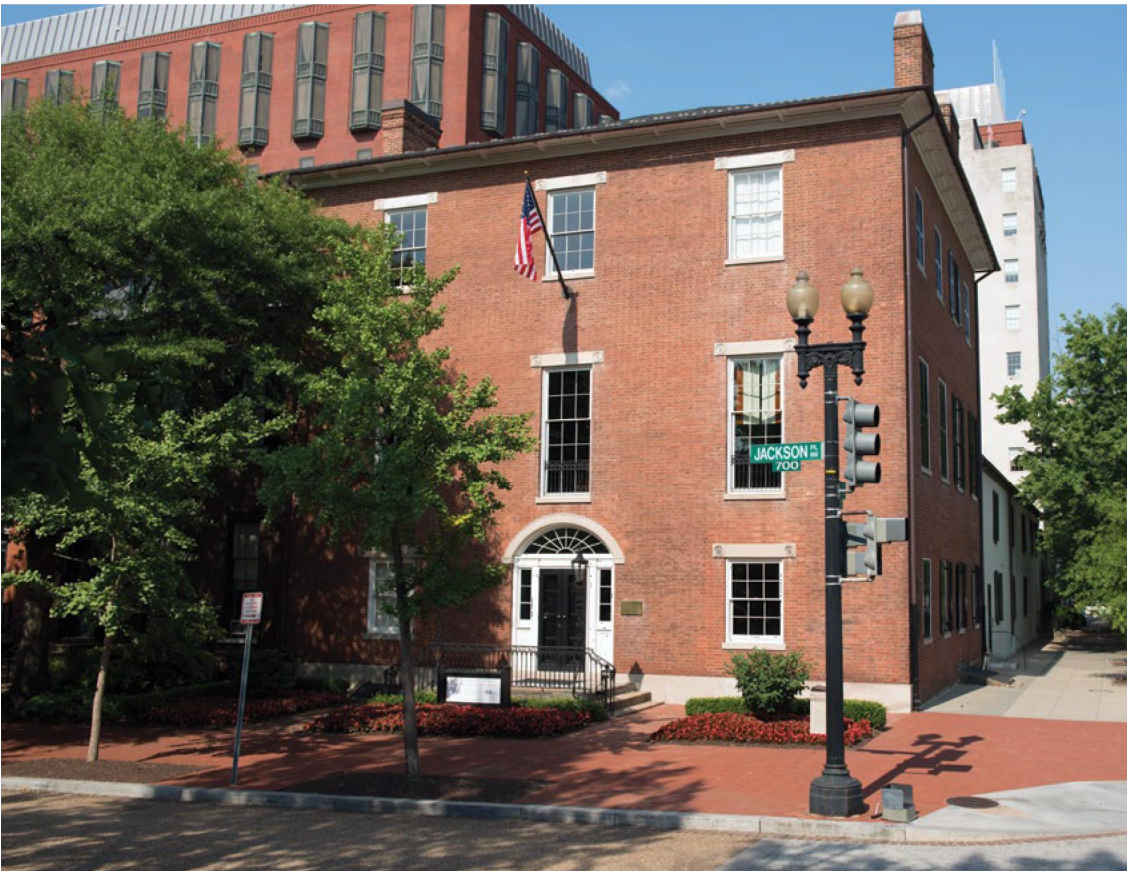
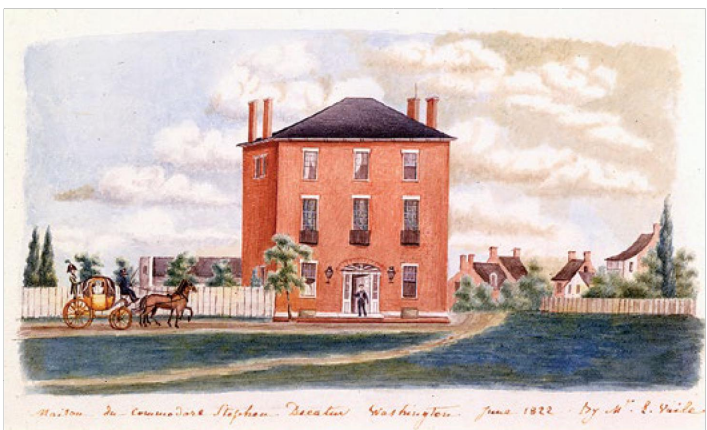
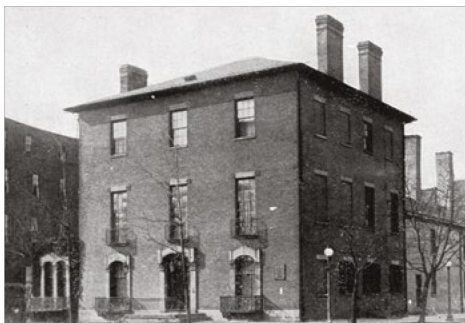
[2] (a) Decatur House in Washington, DC, was designed by William Henry Latrobe and constructed in 1816. (b) In the late-19th century, the façade was “modernized” by removing the limestone inlets on the first floor and replacing them with decorative sandstone inlets in the style of the period. (c) In the mid-20th century, the house was brought back to its original appearance based on historic documentation. Photos: The White House Historical Association and Decatur House, a National Trust Site.

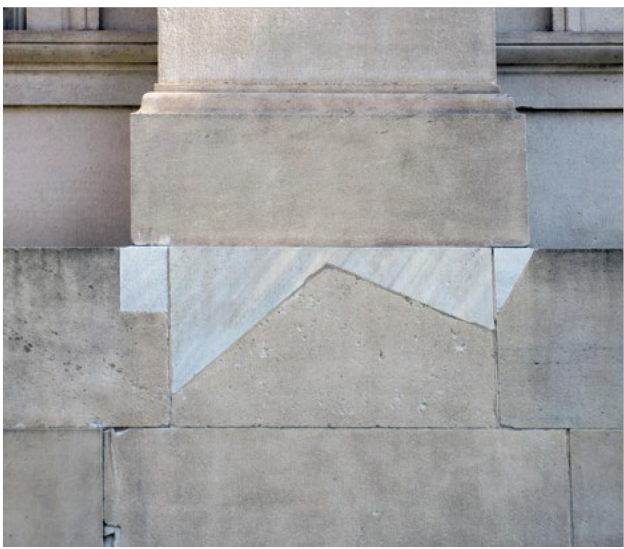
[3] Not Recommended: Although the Dutchman stone repair has been well executed, the replacement stone is not a good color match.
