Staff Report
City of Richmond, Virginia

Commission of Architectural Review

3. COA-107852-2022	Final Review	Meeting Date: 3/22/2022
Applicant/Petitioner	Samuel Daniel	
Project Description	Reconstruct a front yard retaining wall, front steps, and landing.	
Project Location		
Address: 3203 Monument Ave.		
Historic District: Monument Avenue		
High-Level Details: <p>The applicant proposes to replace a front yard retaining wall, steps, and front porch floor of a circa 1910, Georgian Revival residence</p> <p>The existing, brick retaining wall will be replaced with a lower brick wall of 1'6" with 3' brick piers all capped with 4" granite units.</p> <p>The existing concrete steps will be replaced granite treads.</p>		
Staff Recommendation	Partial Approval	
Staff Contact	Alex Dandridge, alex.dandridge@rva.gov	
Previous Reviews	None.	
Staff Recommendations	<ul style="list-style-type: none"> • The new brick retaining wall and piers not feature granite caps, but a brick with a rowlock bond or another simple brick bond. • The new granite font porch floor be installed to resemble the seams of the existing concrete porch floor, installed in four units. • Staff recommends denial of the accent gra

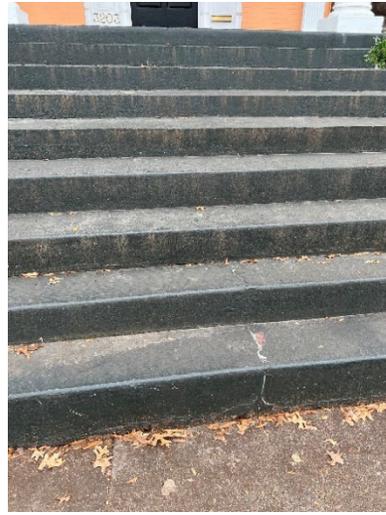
Figure 2. Condition of front stairs

Standards for Site Improvements, Fences and Walls, pg. 78	6. A new fence or wall should be constructed using materials and designs appropriate to the District. Height restrictions are governed by the Zoning Ordinance.	<p>Brick is a common material used for retaining walls throughout the district.</p> <p>Granite isn't a common material found on front yard retaining walls within the district.</p> <p>The new retaining wall will be similar in height to the adjacent brick retaining walls, and will be in compliance with height restricts set forth in to City's zoning ordinance.</p>
Standards for Rehabilitation, Residential Construction, 1, 6, 7, 9, pg. #59	<p>1. Retain original features and materials that define the building style, including but not limited to wood siding, shingles, stucco and masonry.</p> <p>6. Retain original entrances and porches including doors, frames, fanlights, sidelights, steps, balustrades, pilasters, entablatures, columns and decorative features.</p> <p><i>7. Repair damaged elements instead of replacing them. Use materials that match the original in type, or use physically and chemically compatible substitute materials that convey the same appearance as the surviving elements or sections. Use available documentation when reconstructing missing elements.</i></p>	<p>Staff finds that the existing brick retaining wall does not contribute to the architectural style of the dwelling.</p> <p>The existing porch roof, columns, door, sidelights and balustrade will be retained, and not impacted by the scope of this project.</p> <p>The applicant has demonstrative that the existing concrete steps and porch are damaged and unsafe. The concrete stairs show sign of deterioration and the concrete porch floor is cracking and sinking.</p> <p>On a site visit staff observed that the front stairs are not deteriorated beyond repair, however do appear to be uneven and cracked. The applicant requests to replace the concrete stairs with granite. Staff believes that granite will resemble concrete in appearance</p>

<p><i>Pictorial, historical or physical documentation can be helpful.</i></p> <p><i>9. Do not remove or radically alter fundamental architectural features such as windows, roofs or porches.</i></p>	<p>and the work will create a more consistent and safe stair tread. Staff recommends approval of the replacement of the front stairs with granite.</p> <p>The front porch floor is much higher than street level and will be minimally visible from the street and sidewalk. On a site visit Staff observed the sinking of the front porch floor and has analyzed the photos of cracks and chipping submitted by the applicant. Staff recommends replacement of the concrete front porch floor with granite, which will resemble concrete in appearance.</p> <p>Staff finds the diamond design for the front porch floor created with granite accent ribbons is ornate, and doesn't resemble the existing floor. There isn't evidence that a design such as this existing in the past. <u>Staff recommends denial of the accent granite ribbons on the front porch floor.</u></p> <p>To more accurately resemble the existing concrete front porch floor, <u>Staff recommends that the new granite front porch floor be installed to resemble the seams of the existing concrete porch floor, installed in four units.</u></p>

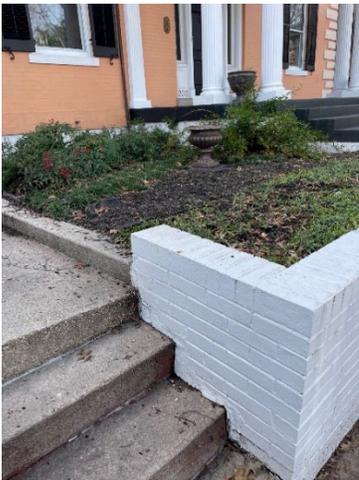
Figure 3. Cement retaining wall connection to the existing masonry wall.

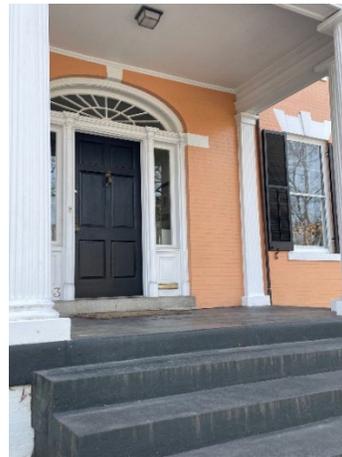
Figure 4. Sinking of front porch floor. View from sidewalk.

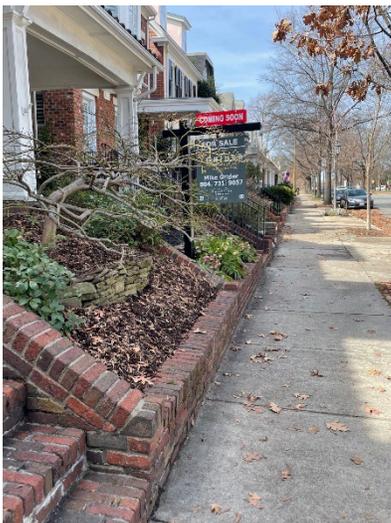
Figure 5. Retaining walls adjacent to the property.

Guideline Reference	Reference Text	Analysis
Fences & Walls 1 & 2, pg.#	<i>1. Fence, wall, and gate designs should reflect the scale of the historic structures</i>	Low, brick retaining walls are common features found on the 3200 block of Monument Avenue. The proposed brick retaining wall will be unpainted, unlike the

<p><i>they surround, as well as the character of nearby fences, walls, and gates.</i></p> <p><i>2. Fence, wall, or gate materials should relate to building materials commonly found in the neighborhood.</i></p>	<p>existing, and will have 3' brick piers at end points of the wall. There is an example of a brick retaining wall adjacent to the subject property that features brick piers.</p> <p>The proposed brick wall, steps, and piers will feature granite caps. Staff notes that granite caps on brick retaining walls is not a design or material commonly found in the district. Other examples of brick walls on this block do not feature granite caps, but rather a rowlock course brick pattern as a cap. <u>Staff recommends that the new brick retaining wall and piers not feature granite caps, but a cap brick laid in a rowlock bond or another simple brick bond.</u></p>
Standards for Site Improvements, Fences and Walls, 1-3, pg. 78	<p><i>1. Original fences and walls should be retained and maintained whenever possible.</i></p> <p><i>2. Existing brick or stone walls, boxwood hedges, wooden picket fences and cast or wrought iron fences should not be removed or replaced with contemporary features.</i></p> <p>3. If not original to a site, new street-front fences, walls, and gates should be compatible with the historic structure in design, materials, and location, and should be based on physical or documentary evidence from the site.</p>	<p>Staff was unable to find photographic documentation demonstrating the existing wall is not original to the property. However, on a site visit, Staff noticed that the brick used in the retaining wall features wider mortar joints with a different reveal than the brick used on the front façade of the dwelling. The brick type also appeared to have a different, rougher finish. There was also evidence that the masonry retaining wall could have been built on top, and in front of a lower concrete retaining wall which is visible along the side the front yard (see figure 3.)</p> <p>The proposed, new retaining wall will feature brick and granite. Granite is not a common material utilized in front yard retaining walls on this block of Monument Avenue. Staff finds that existing walls on this block are constructed of brick or concrete alone.</p>
