Staff Report City of Richmond, Virginia

Commission of Architectural Review

4. COA-156672-2024	Final Review Meeting Date: 11/26/2024	
Applicant/Petitioner	Patrick W. McClane, AIA	
Project Description	Demolish a non-original valet parking booth.	
Project Location		
Address: 13 West Franklin Street, Second Baptist Church		
Historic District: West Franklin Street		
High-Level Details:		
The applicant proposes to demolish a non-original valet parking booth at the rear of Second Baptist Church.		
The valet parking booth is a small masonry building with light colored brick and a hipped roof with faux slate. According to the CAR records, the building was constructed around 1993.	114 114 114 114 114 114 114 114	
Brick piers and metal fencing will be installed to the north (left side) of the demolished valet building to match the existing fencing.	16 5 6 8 12 14 5 10 16 13 13 13 14 5 10 10 13 13 13 14 5 10 10 13 13 13 14 5 10 10 10 13 10 10 10 11 10 10 10 10 11 10 13 10 10 11 13 10 10 10

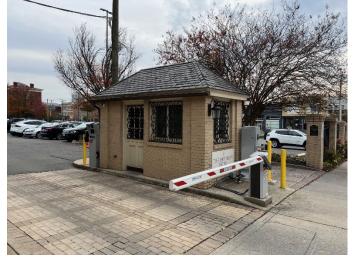
Figure 1. North Elevation of Valet Building.

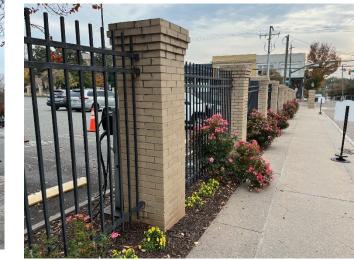
Figure 4. Existing fence. Brick piers and metal fencing. To be replication adjacent to demolished Valet Building.
