Staff Report  
City of Richmond, Virginia

# Commission of Architectural Review

3. COA-098251-2021	Final Review	Meeting Date: 10/24/2023
Applicant/Petitioner	Matt Jarreau & Casey White – C & M Properties	
Project Description	<b>Result of a Notice of Violation:</b> Revision to previously issued COA to demolish and reconstruct two, one-story commercial storefronts originally proposed for rehabilitation.	
Project Location		
Address: 3302-3308 E. Marshall Street		
Historic District: Chimborazo Park		
<p>High-Level Details:</p> <p>The applicant proposes to reconstruct two, one-story commercial buildings, 3304 East Marshall [ca. 1925] and 3306 East Marshall [ca. 1910] in response to an illegal demolition of the structures in September 2023 without a demolition permit or Certificate of Appropriateness. Both buildings were contributing buildings in the Oakwood-Chimborazo National Register Historic District</p> <p>The reconstruction will be in conjunction with the previously approved new construction at 3302 &amp; 3308 East Marshall Street, and at the rear of 3304 &amp; 3306 E. Marshall.</p> <p><i>This application focuses only on the demolition and reconstruction of the demolished storefro

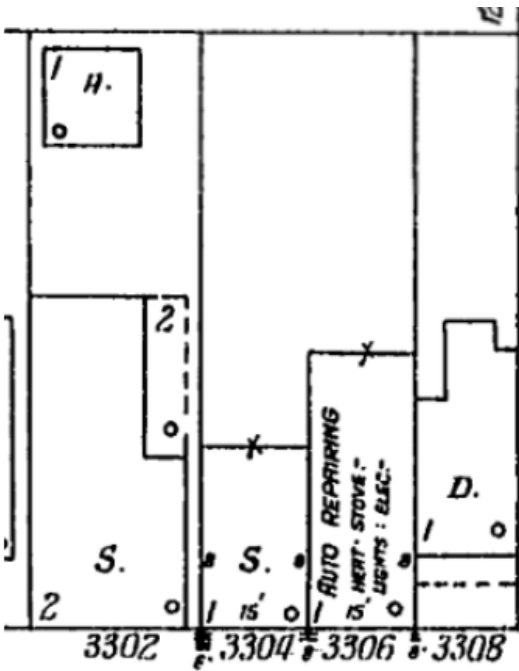
Figure 1. 1924-1925 Sanborn Map showing 3302, 3304, 3306 and 3308 East Marshall Street.

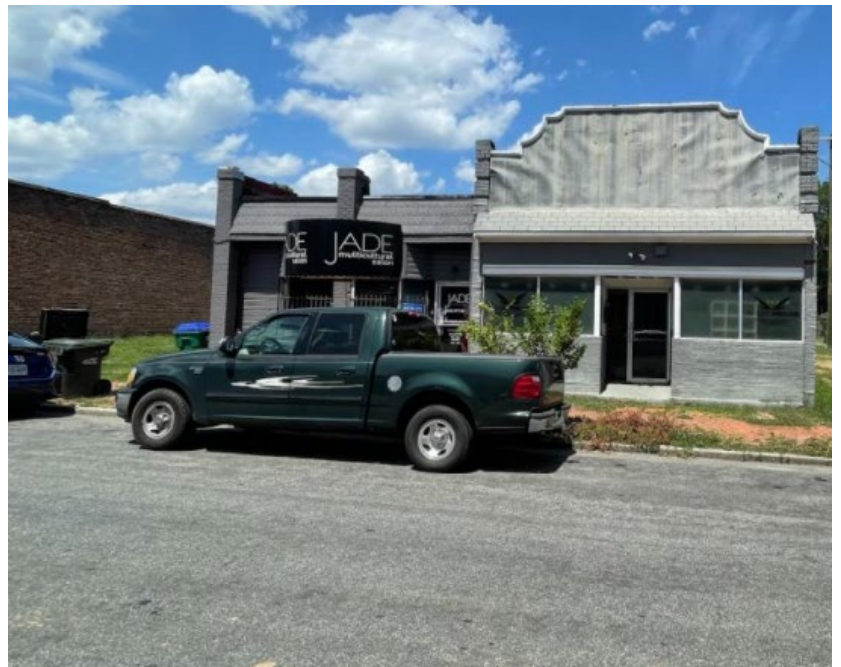
Figure 2. July 2021 elevation showing 3304-3306 East Marshall Street.

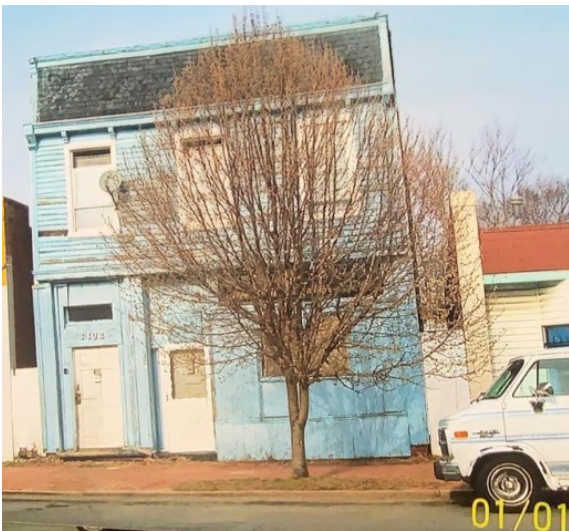
Figure 3. 2003 photo of 3302 East Marshall Street (demolished).

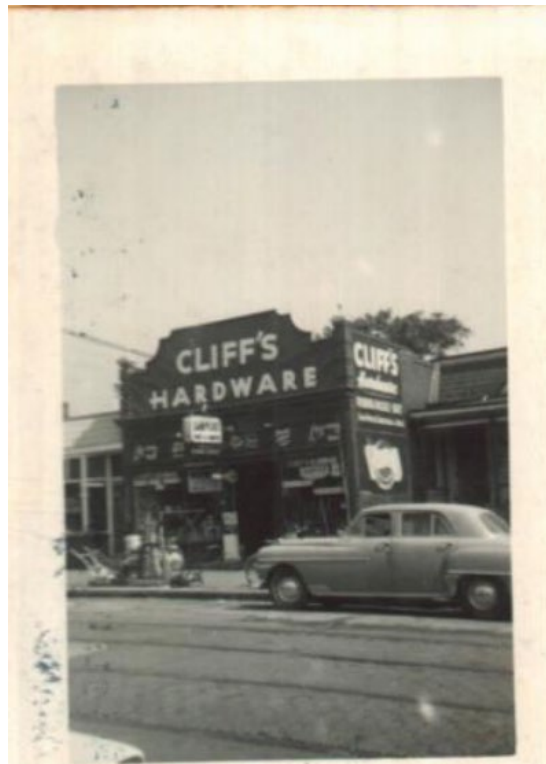
Figure 4. Historic photo of 3306 East Marshall.

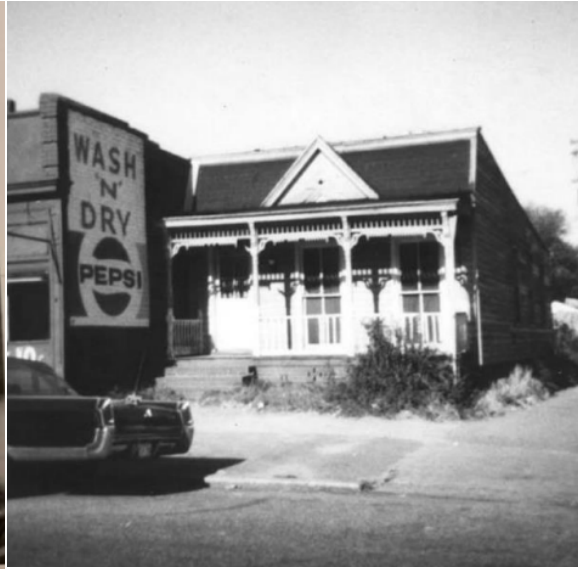
Figure 6. Historic photograph showing 3308 East Marshall Street (demolished).

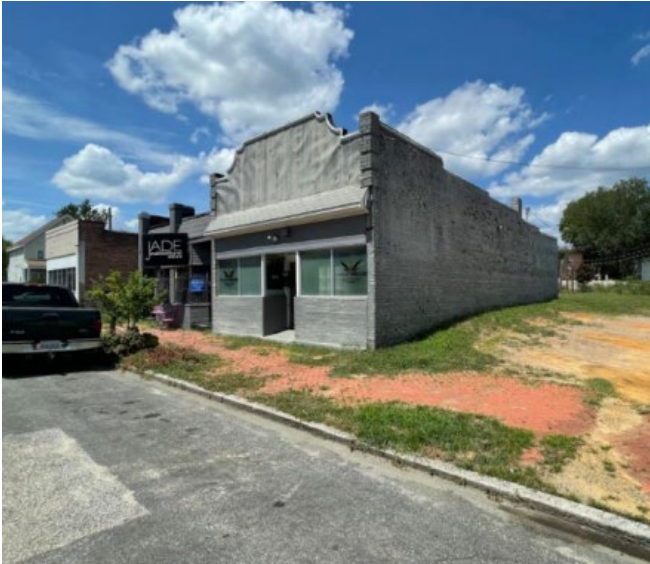
Figure 7. View of 3304-3306 East Marshall Street facades facing west.

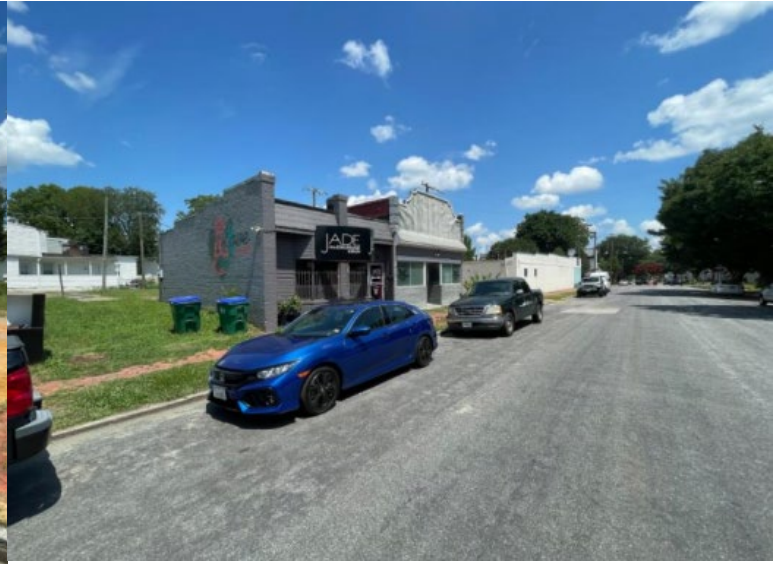
Figure 8. View of 3304-3306 East Marshall Street facades facing east.
