Commission of Architectural Review Certificate of Appropriateness Application

RE: COA Application: 2417, 2419, & 2421 Carrington Street (E0000-471/010, /011, /012)

Field Summary Report

Project:	2417 Carrington Street, Richmond, Virginia	Permit Number:	N/A
Client:	Mike Thomas	Inspected by:	Charles R. Field, P.E.
Date:	August 25, 2023	Time:	12:30 pm
Weather:	Clear	Temperature Range:	70's

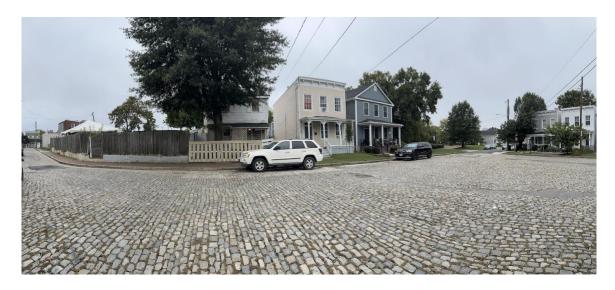
Figure 3: Picture of existing conditions at 2413-2421 Carrington Street

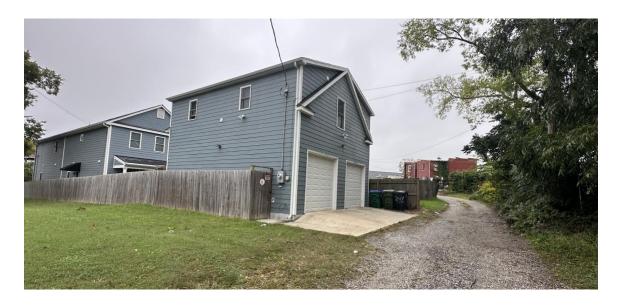
Figure 4: Picture of accessory building at 2413 Carrington fronting the rear alley

gable roof and uses a traditional three-bay design. The same approval, along with a Special Use Permit (Ord. 2018-329) authorized the construction of a detached two-story accessory building fronting the rear alley which contained a first floor garage and second floor accessory dwelling unit. This accessory building, at roughly 21' 4" in height is compatible with the proposed rear dwellings which are proposed at 22' 2". The historic dwelling at 2415 Carrington Street is of a three-bay design with Italianate features and is approximately 27 feet in height and 18 feet in width. The proposed dwellings fronting Carrington Street would be 23-24 feet in height and 20 feet in width for the traditional townhome style dwellings which is consistent with the adjacent historic home.

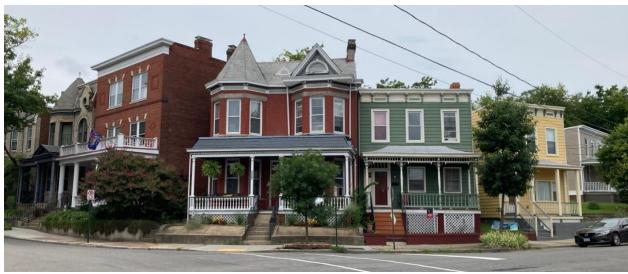
Figure 5:Range of forms fronting the intersection of Princess Anne Ave. and N 21st Street in Union Hill

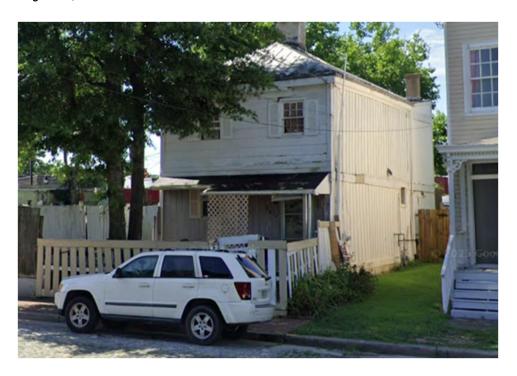
2417 Carrington Road, Richmond, Virginia

Exterior inspection of the home finds that the house is in poor condition.

Since the roofs, walls, floors and foundation have failed, the house is a threat to public safety. It should be razed.

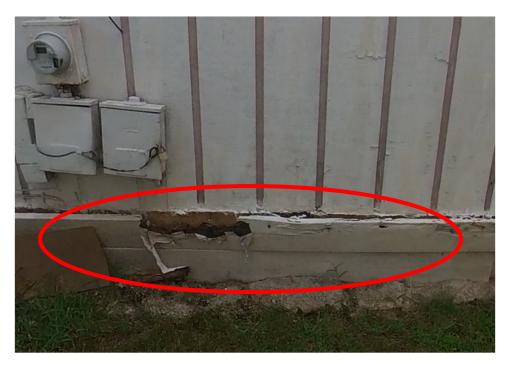
The original foundation of the home is missing and has been replaced with wood. The wood has deteriorated and rotted. The home's original siding has been removed and replaced with a combination of 1x material, plywood panels and T111 wooden siding, all of which has rotted.

The homes foundation has been replaced with wood, which has rotted.

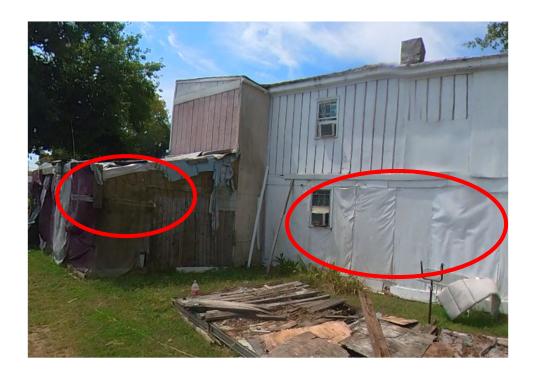
The homes siding was removed and replaced with a mix of materials, all of which has begun to rot.

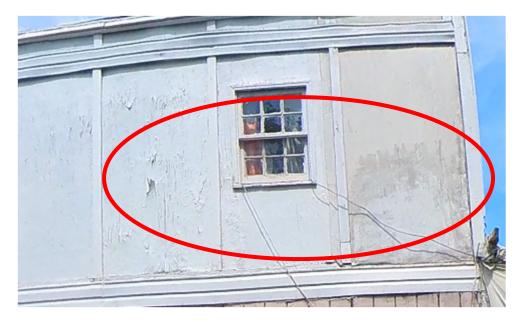
An addition was added to the left side of the home. The addition appears to be sheathed with a patchwork of materials, from OSB panels to fabric and plastic tarps. All wooden components of the addition are rotting. Another addition was added to the rear of the home, which pitches towards the original house. Plywood panels were used to sheath the addition. These panels are rotting.

Painted plywood panels were used to sheath the rear of the home. The panels are rotting.

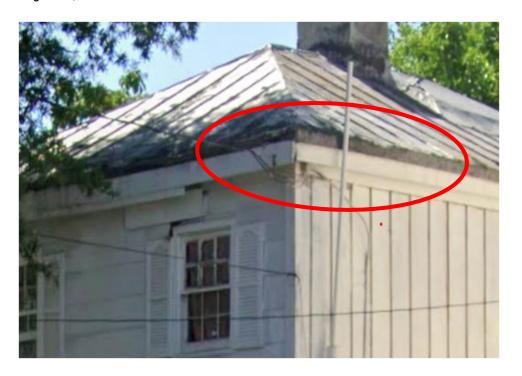
The original hip roof is present. Extensive rot is observed where the roof line meets exterior walls. Additionally, the roof has rotted where the hip roof intersects with the roof of the addition.

Extensive rot is present in the roof structure.

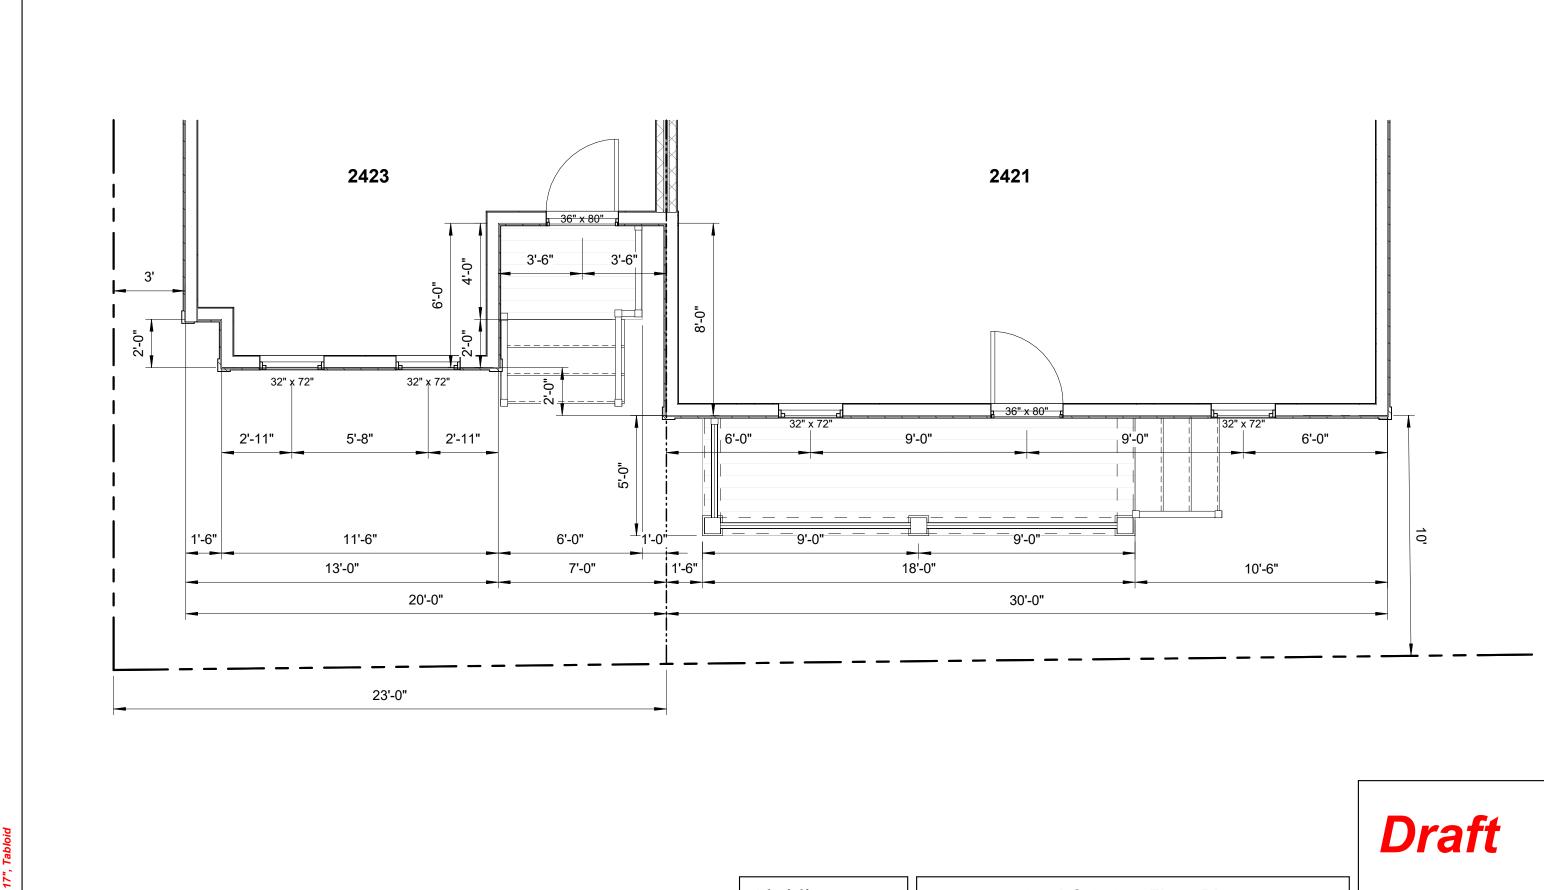
A1.3 📙

2421 & 2423 - Floor Plan 2417 Carrington Street - CAR Plans Richmond Hill Design Build LLC
