**Staff Report**  
**City of Richmond, Virginia**

**Commission of Architectural Review**

6. COA-126477-2023	<b>Final Review</b>	<b>Meeting Date: 3/28/2023</b>
<b>Applicant/Petitioner</b>	Pari Valad	
<b>Project Description</b>	Install a mural on a secondary elevation of a previously painted masonry building.	
<b>Project Location</b>		
<b>Address:</b> 301 W Broad Street		
<b>Historic District:</b> West Broad Street		
<b>High-Level Details:</b> The applicant proposes to install a mural on painted brick. The mural will take up the full scale of the building. The mural is not considered a sign by zoning.		
<b>Staff Recommendation</b>	<b>Approval, with Conditions</b>	
<b>Staff Contact</b>	Samantha Lewis, 804-646-5207, Samantha.lewis@rva.gov	
<b>Previous Reviews</b>	None.	
<b>Conditions for Approval</b>	<ul style="list-style-type: none"> <li>The lintels and sills not be painted, and that the design stay below the molding on the third floor as to not obscure the brick diamond pattern. Final mural design indicating that these architectural elements will not be painted as part of the mural to be submitted to staff for administrative review and approval.</li> </ul>

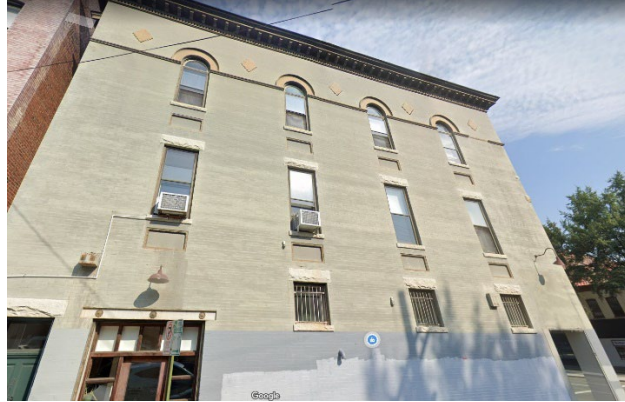
Figure 2. Proposed side elevation to be painted.

<b>Standards for Signage, p. 65, #4</b>	A mural should not obscure or distort the historic features of a building.	The nomination form calls out the granite lintels and sills, the brick arches, and brick diamonds above the third story windows as being character defining. The proposed design appears to partially paint or fully paint some of the window lintels and sills and not paint others. The nomination form specifically calls out the granite lintels and sills on this building. <u>Staff recommends the lintels and sills not be painted, and that the design stay below the molding on the third floor as to not obscure the brick diamond pattern. Final mural design indicating that these architectural elements will not be painted as part of the mural to be submitted to staff for administrative review and approval.</u>
<b>Standards for Signage, p. 75, #5.</b>	Murals should be in compliance with the general signage requirements for Old and Historic Districts, where applicable.	Staff notes that this mural is not considered a sign by the underlying zoning. Based on photographs, it appears the building had painted signs on the side bay closest to W. Broad Street and on the front elevation. (Figure 7).

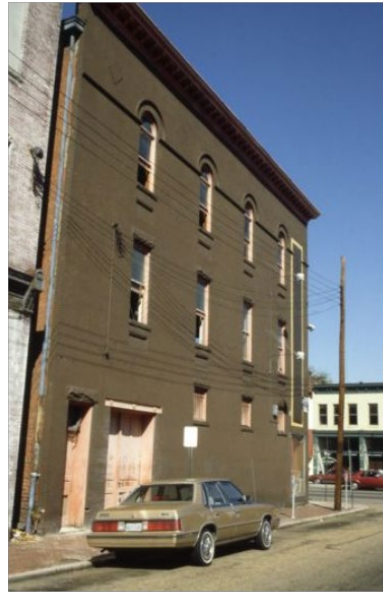
Figure 4. 1988 Madison St Side Elevation

Guideline Reference	Reference Text	Analysis
<b>Paint, p. 63, #1</b>	Do not paint historic brick or stone masonry that has not previously been painted.	The building at 301 W Broad Street is a masonry building, already painted a light blue-gray color. Staff notes that photographs show the building being painted as far back as 1988.

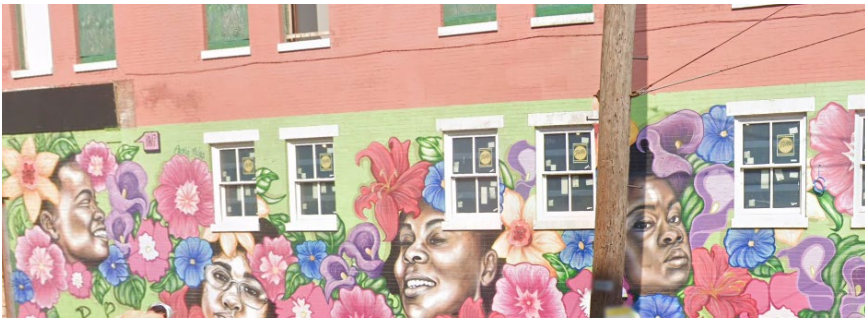
Figure 8. Example of CAR approved mural where stone lintels were not authorized to be painted.
