VIRGINIA UNION UNIVERSITY  
VANN TOWER

## WRITTEN DESCRIPTION

### PROPOSED WORK

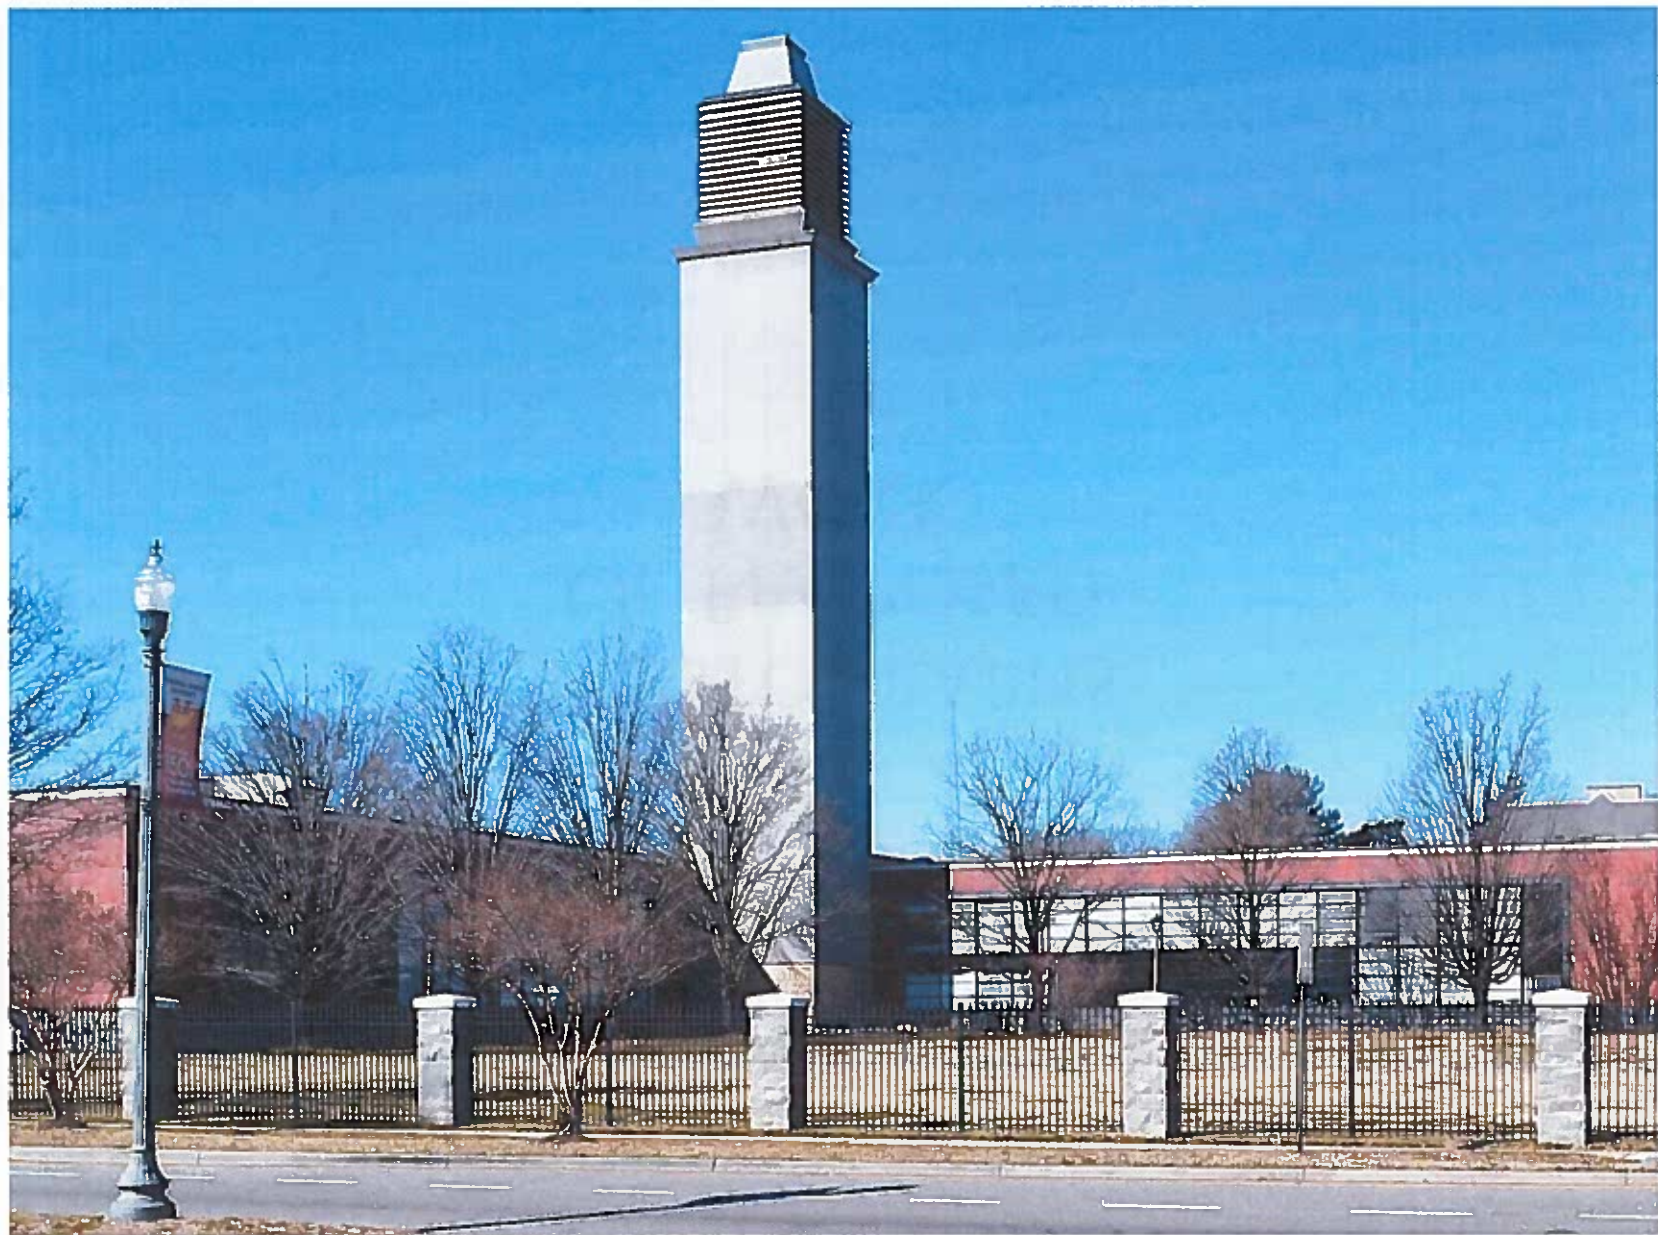
*View of Vann Tower before sign installation (DHR)*

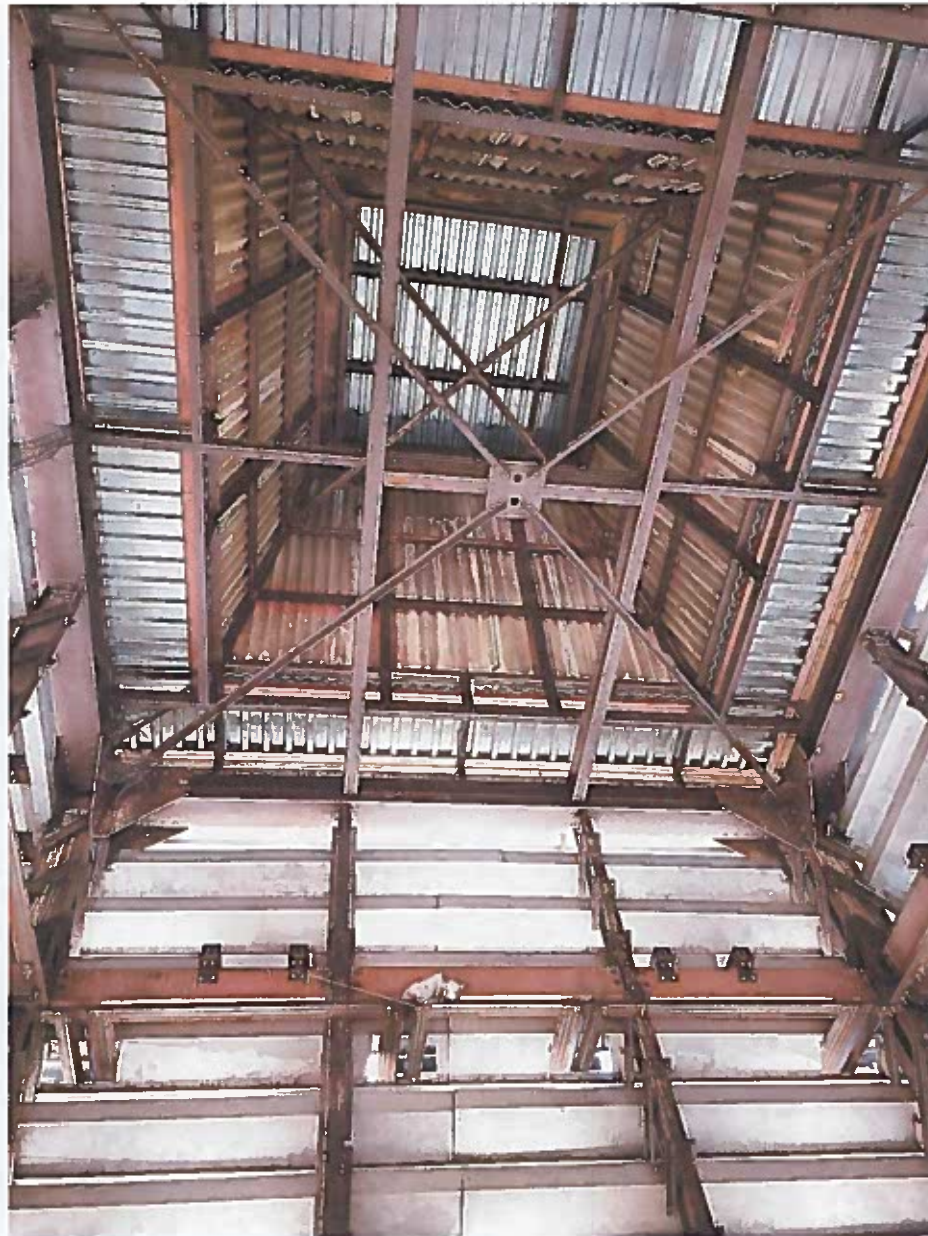
*View of Interior Peak*

The peak of the tower is capped with an steel structure cap with aluminum louvers. Before installation of the signage, a number of these had been damaged but are concealed by the signage.

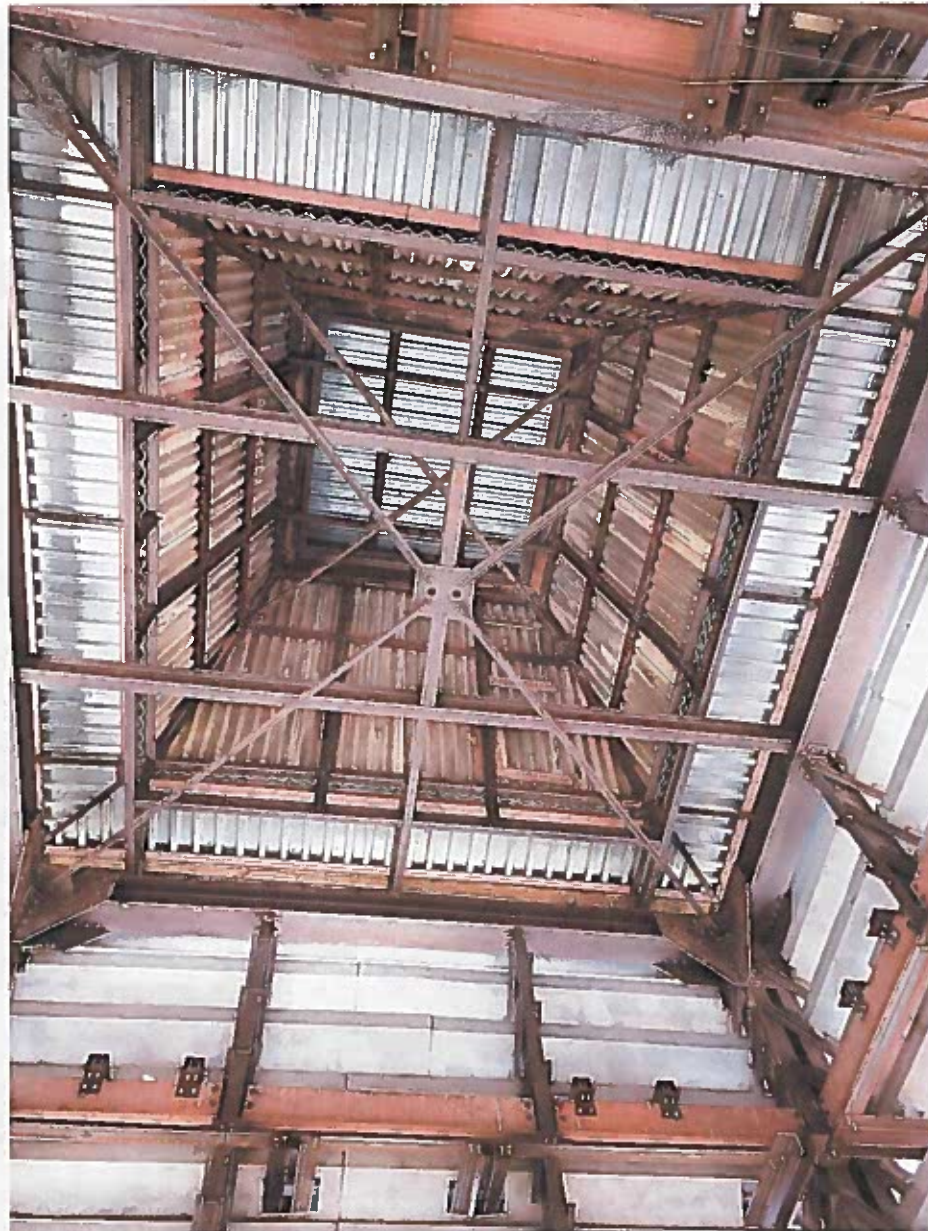
*View of Interior Peak*

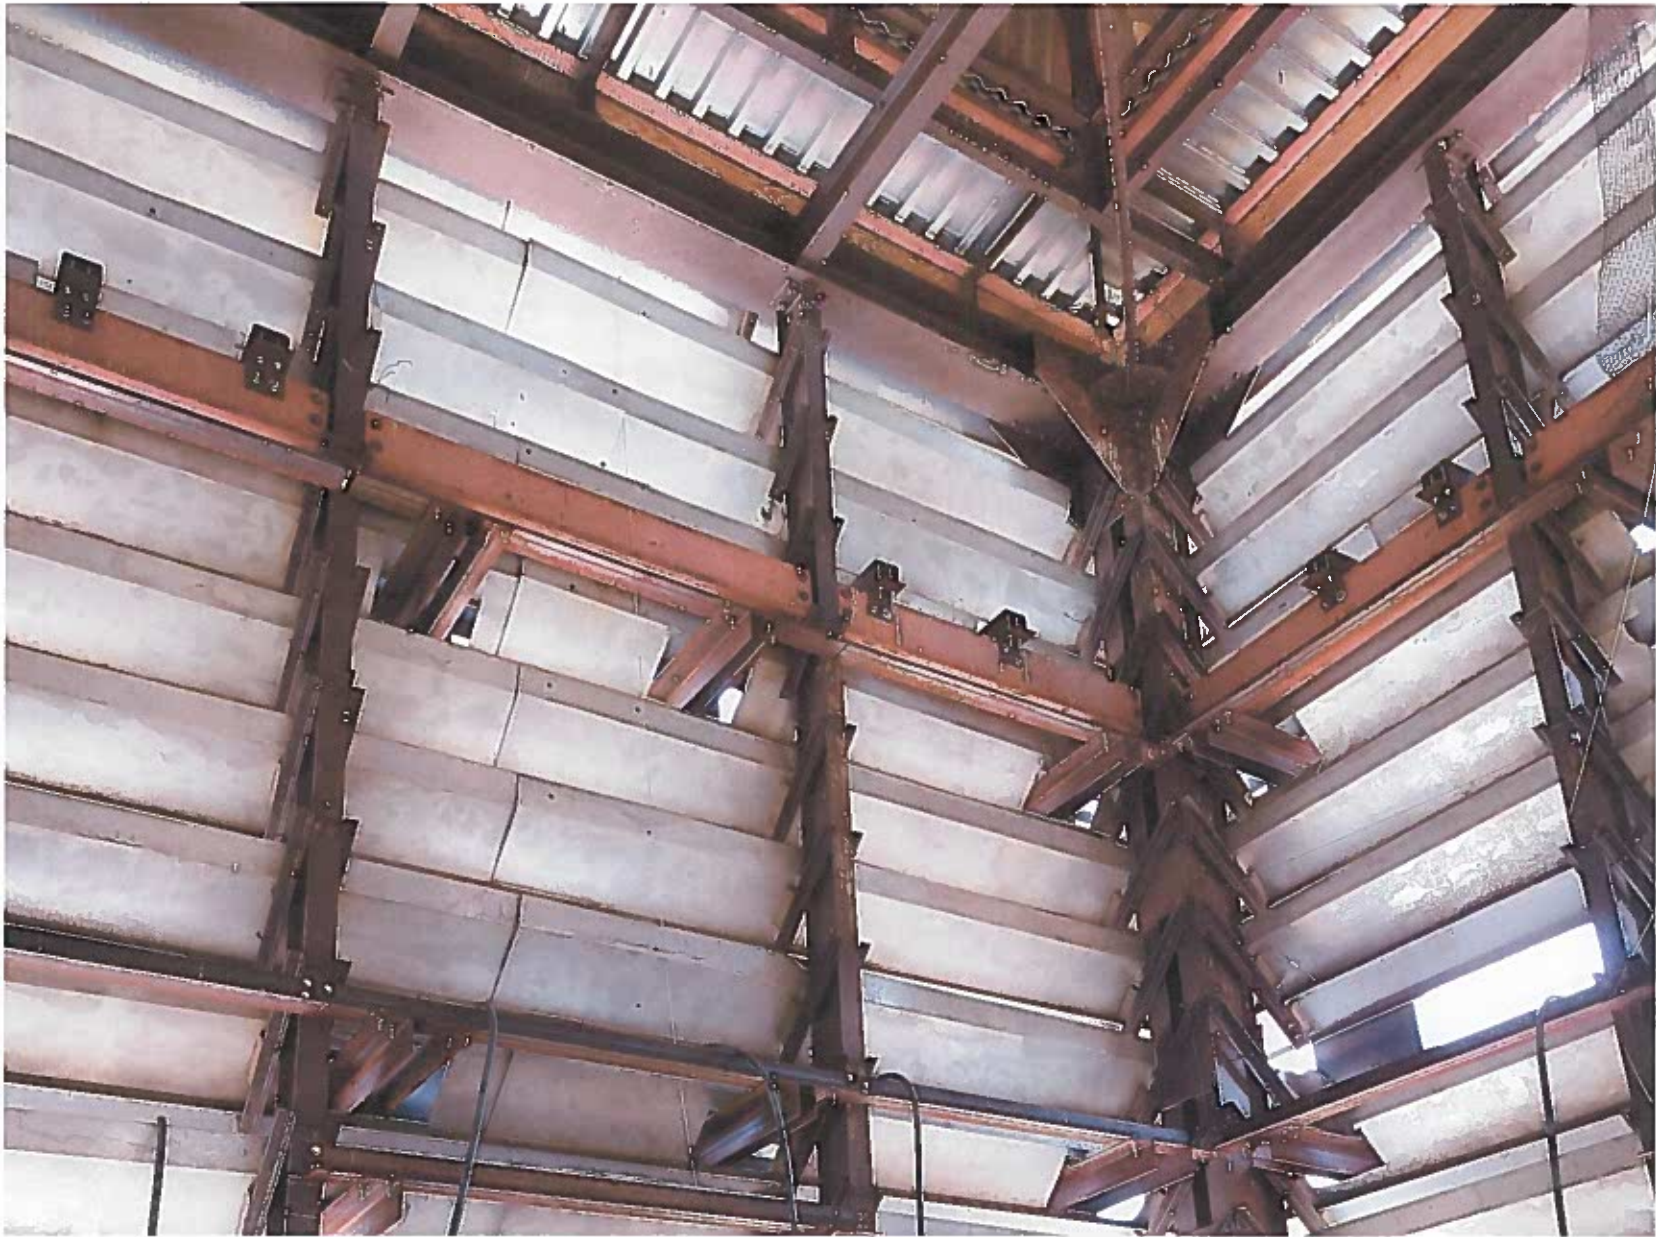
*Connection Details*

5” anodized aluminum sign box with .177mm lexan facing. Sign box is attached to new steel structure with 3/8” stainless allthread. New steel frame bolted to existing frame via flanges welded to existing steel framing.

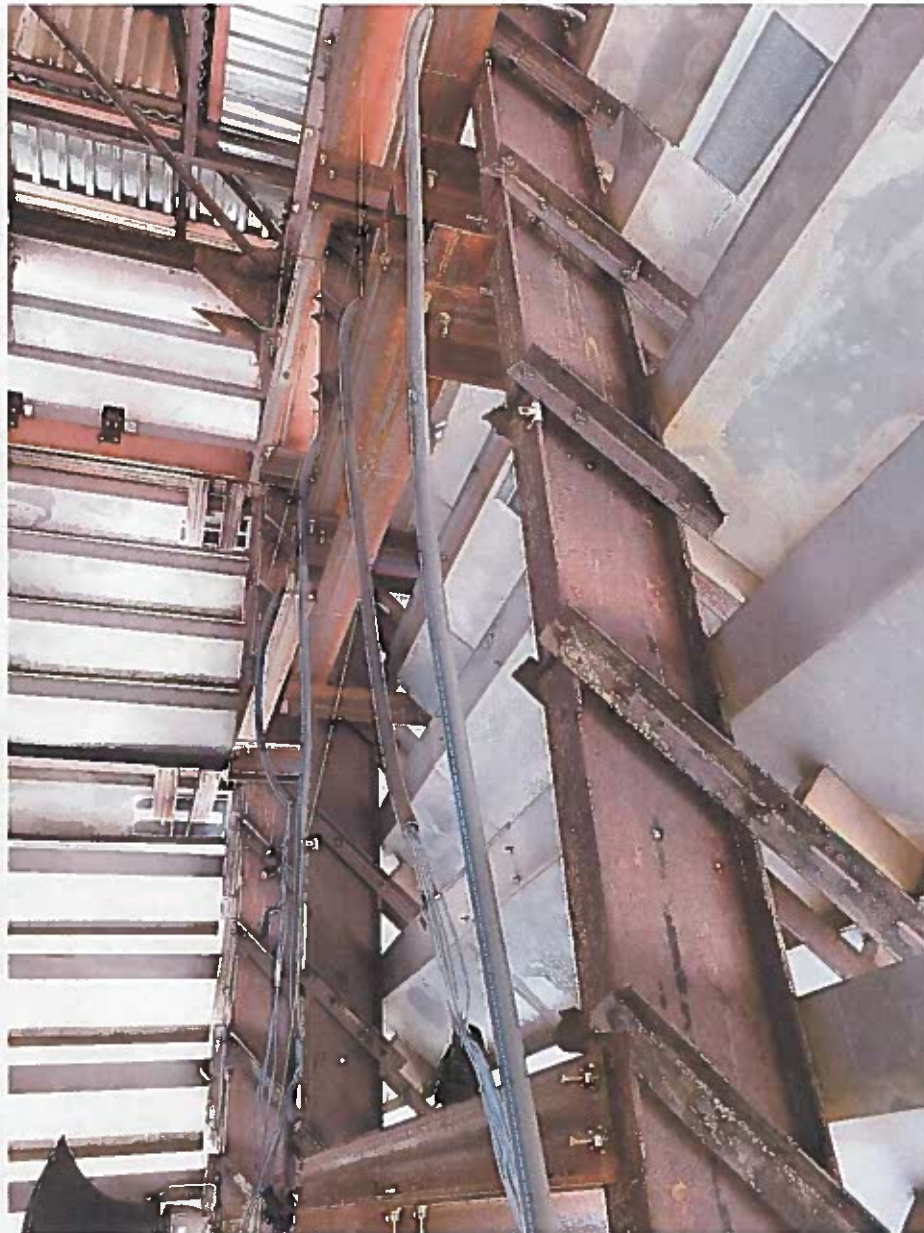
*Existing and New Connection Details*
