9. COA-091349-2021

2501 E. Franklin Street, Unit 8

Commission of Architectural Review

STAFF REPORT

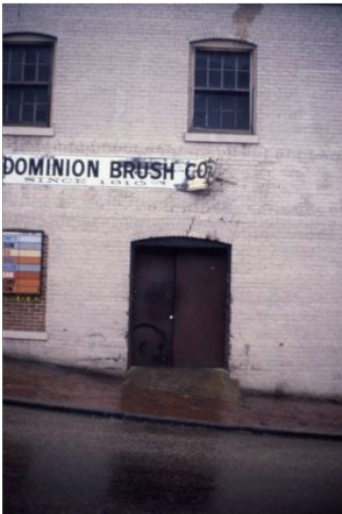
Figure 1. 2501 E. Franklin, 1983, Subject set of doors

The applicant is proposing to replace two existing fixed, single-pane windows on a set of fixed exterior doors on brick building with two operable, four-over-four wooden windows. Staff was able to locate a historic image from 1983 showing a set of doors in this location that does not currently exist, and the applicant has also provided an image to staff which shows that the existing doors are not the original. Staff notes that the existing doors are not original to the building, and recommends approval of the replacement of the existing windows within the doors.

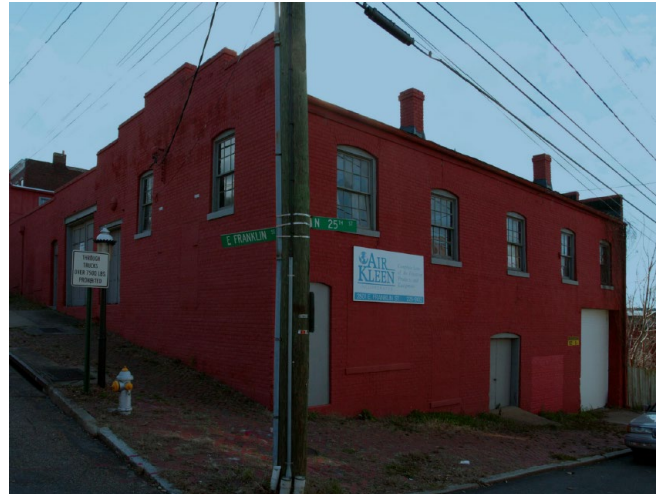
Figure 2. 2501 E. Franklin, date unknown, photo provided by applicant showing past condition of building.

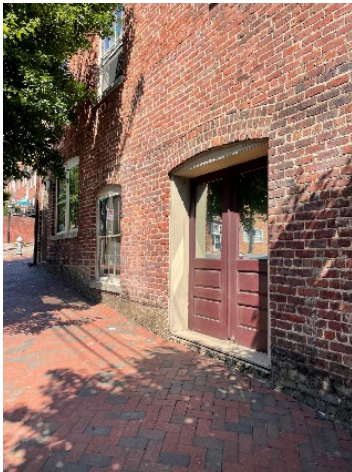
- The applicant proposes to replace two fixed single-pane windows on fixed double doors with two operable four-over-four wooden windows on a brick building circa 1900.
- The set of doors containing the windows proposed for replacement is not original to the building.

Figure 3. 2501 E. Franklin, existing subject doors and single-pane windows

- Staff recommends approval of the replacement of the single-pane windows on the existing set of doors with the condition that that they be fixed and not operable
- Staff also recommends that the replacement windows have a four-light configuration rather than the proposed four-over-four pane configuration, to be compatible with the established fenestration pattern present on the building.

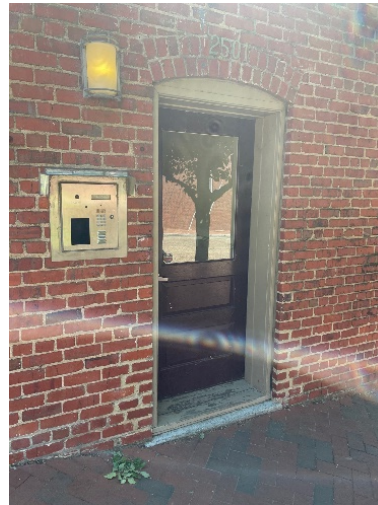
On a site visit, staff observed several exterior doors on the building, including single doors and sets of doors. Staff noticed that the single doors utilized fixed single-pane windows, and that the sets of doors utilized fixed four-light windows. Staff recommends approval of the replacement of the single-pane windows on the existing set of doors with the condition that they be fixed and not operable, as it is not common for doors on this building or within the district to utilize operable windows. Staff also recommends that the replacement windows have a four-light configuration rather than the proposed four-over-four pane configuration, to be compatible with the existing fenestration pattern present on the building.

Figure 4. 2501 E. Franklin, existing conditions, other door on subject building.

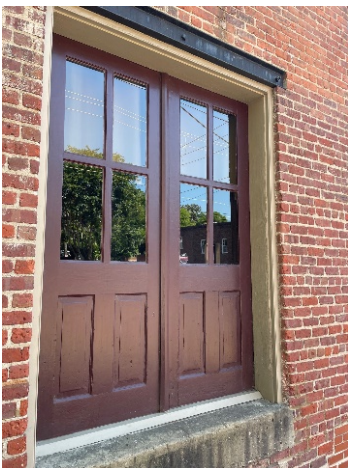
Figure 5. 2501 E. Franklin, existing conditions, other set of doors on subject building.
