COMMISSION OF ARCHITECTURAL REVIEW

APPLICATION FOR CERTIFICATE OF APPROPRIATENESS

Address 511 W Marshall ST Richmond VA 23220
Historic district Jackson Ward

**HISTORIC PRESERVATION CERTIFICATION APPLICATION
PART 2 – DESCRIPTION OF REHABILITATION**

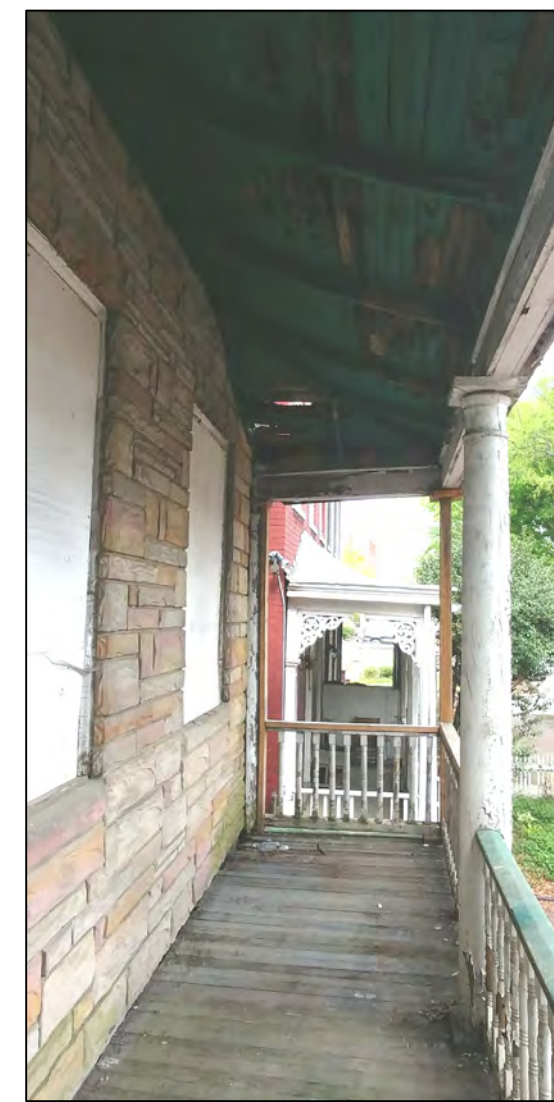
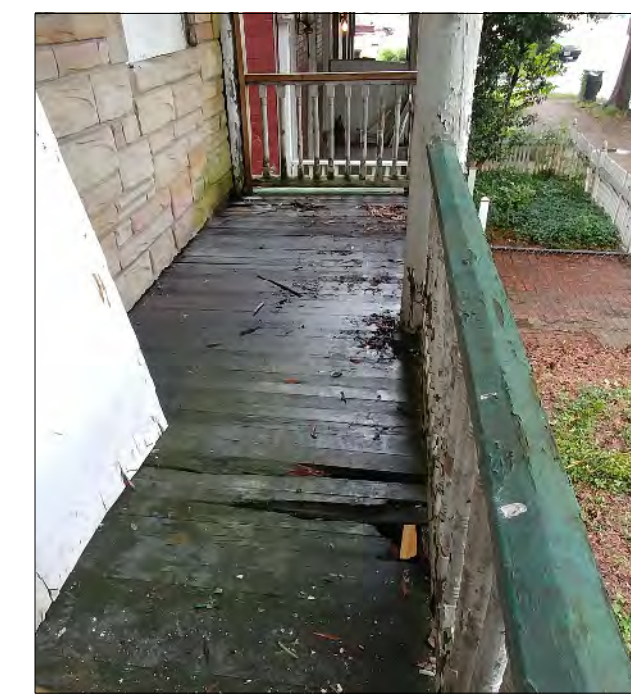
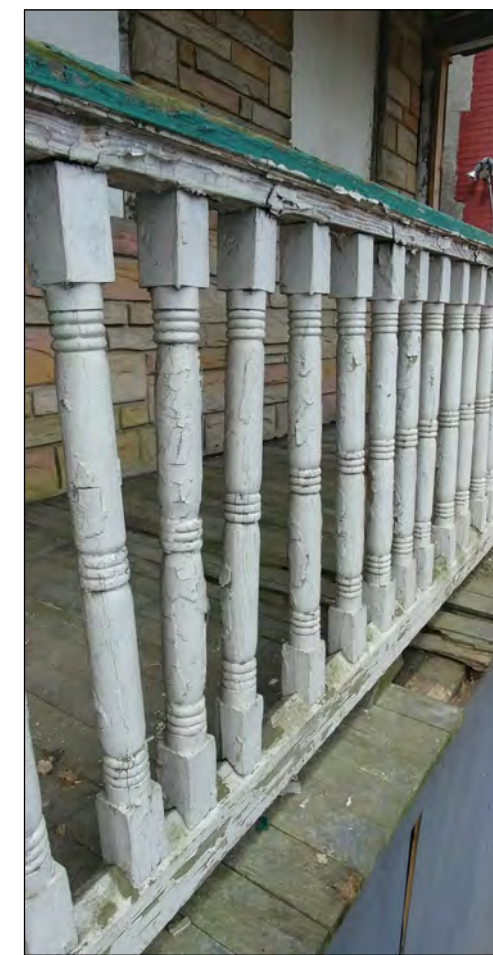
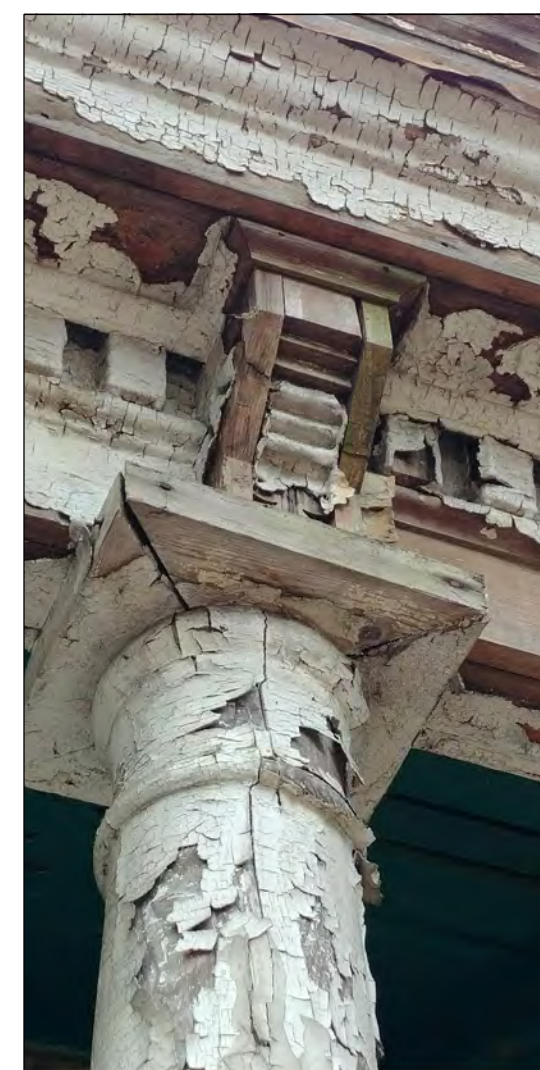
SHEET TITLE
EXISTING FRONT PORCH CONDITION & DETAILS

REPAIR AND REFINISH EXISTING FENCE AND GATE

EXISTING PORCH COLUMN AND RAIL B

EXISTING PORCH FACIA A

Item 4, Front porch: All materials and design elements in existing front porch will be retained, patched and repaired where possible. All missing elements will be replaced to match existing. See sheet AX4.0. Missing column will be replaced to match with existing three. (please note that existing basement columns are steel pipes, not brick piers as noted on original Part 2 application.)

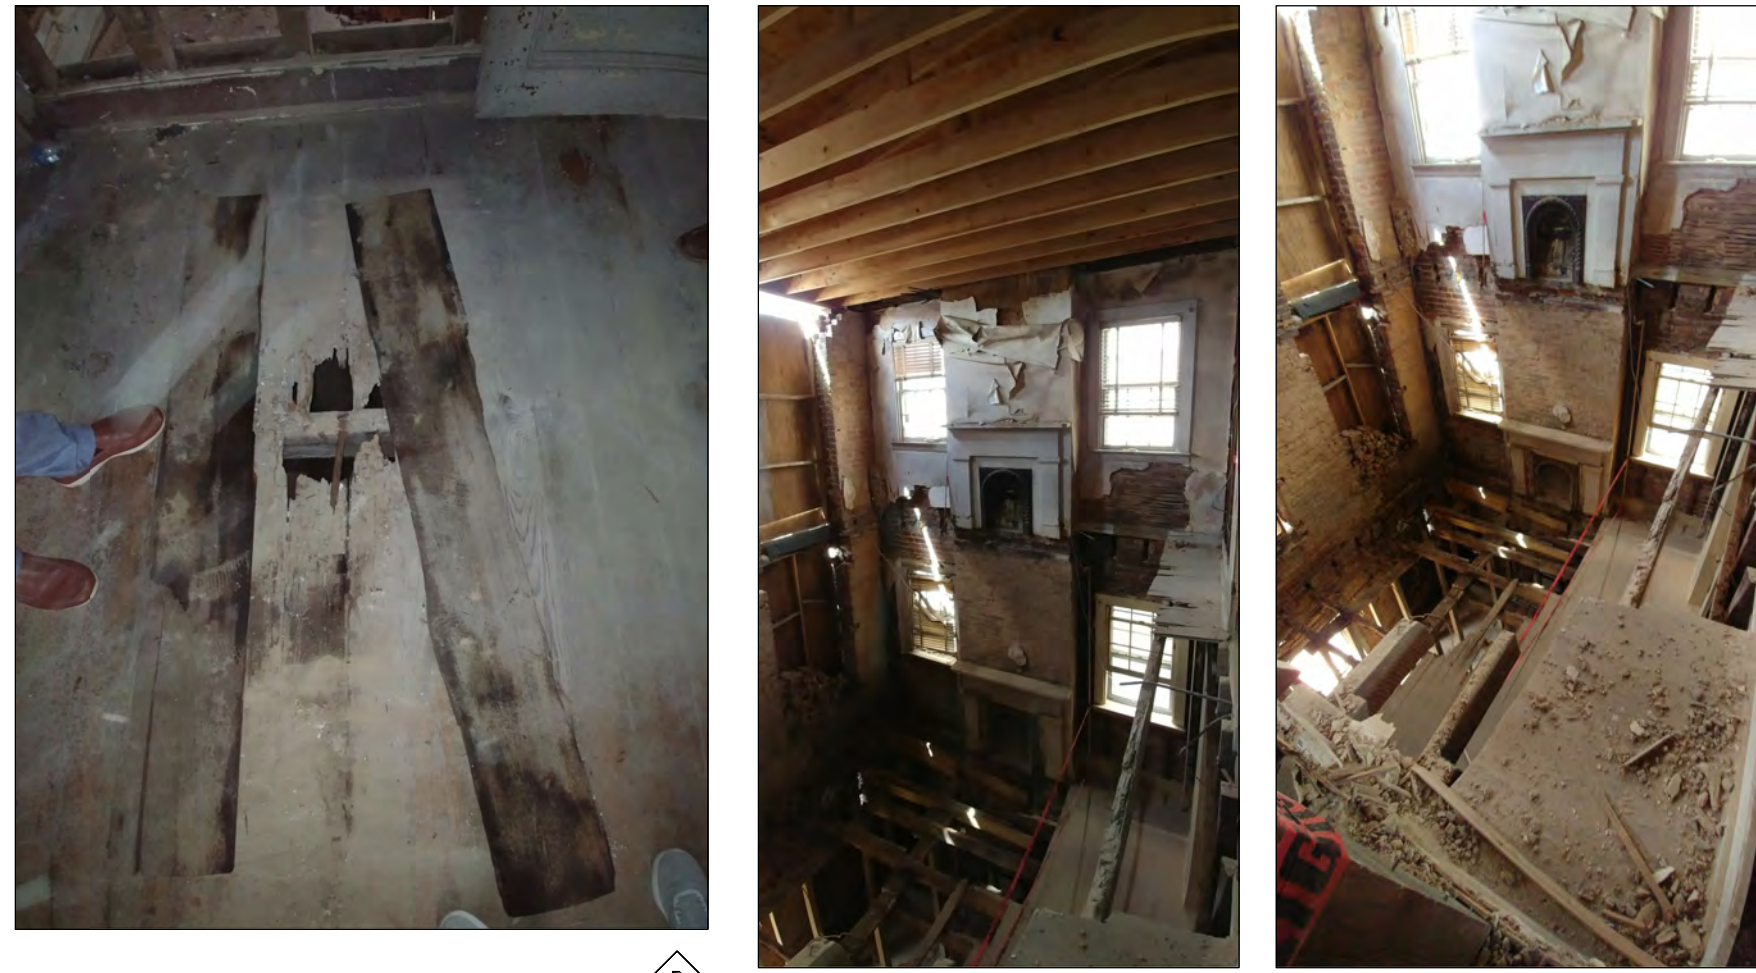
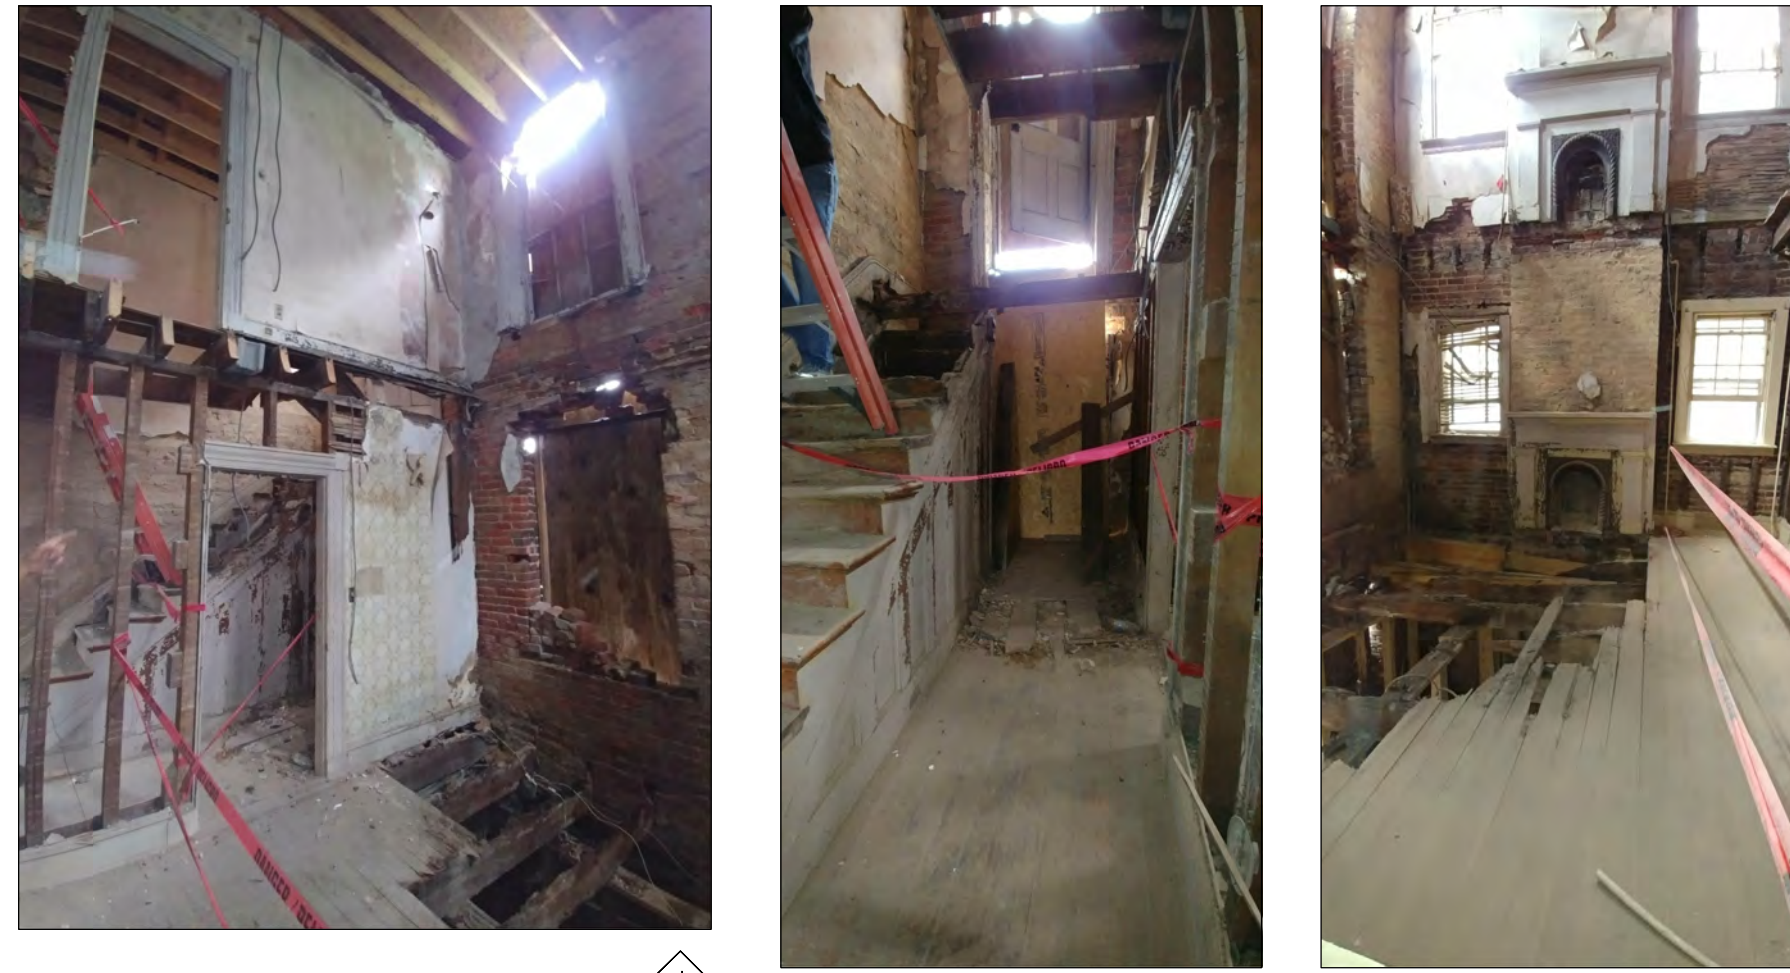
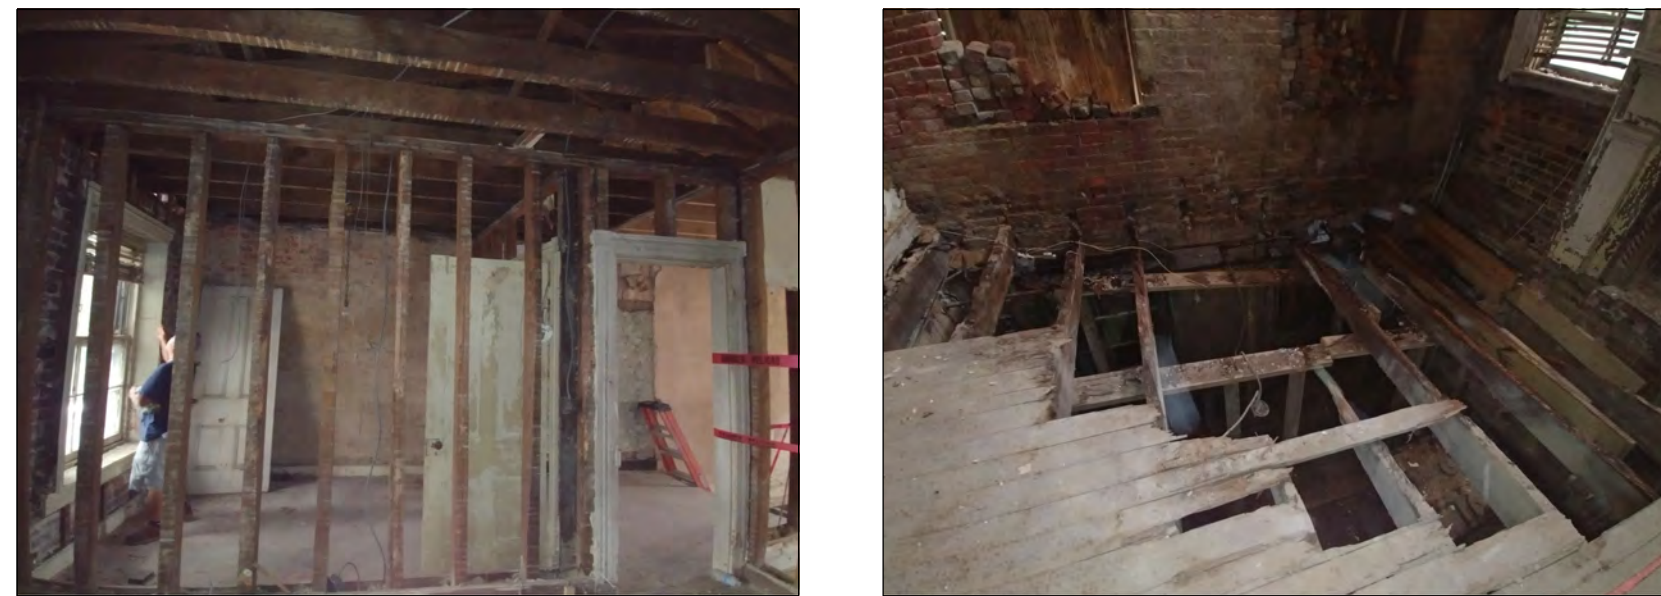
EXISTING SECOND FLOOR WALL AND CEILING CONDITIONS 3
NTS

EXISTING FIRST FLOOR WALL AND CEILING CONDITIONS 2
NTS

Item 10, Walls and ceiling finishes: See AX5.0 for all wall, ceiling and floor conditions with corresponding photos to illustrate the extent of existing plaster on walls and ceiling. plaster is present in the basement and on second floor, but all areas that do have plaster are quite compromised in their makeup and we respectfully request that all new wall and ceiling finishes be gypsum wall board.

Item 17, Floors: See AX5.0 for all wall, ceiling and floor conditions with corresponding photos to illustrate the extent of existing conditions of the floors. Wood flooring will be replaced to match existing type and widths in original structure.

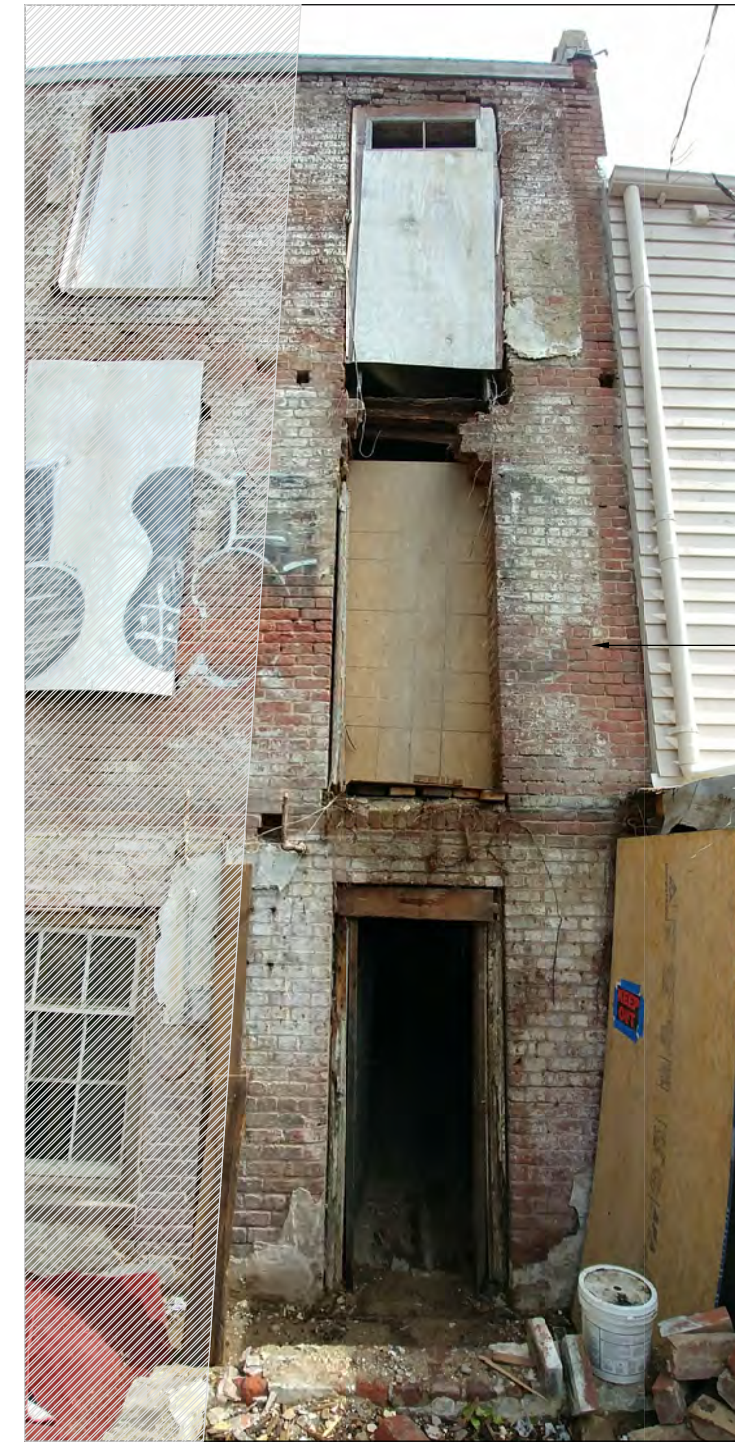
SECTION TO BE REPOINTED **D5**
NTS

EXISTING BRICK TO BE RE-POINTED. EXISTING BRICK LOOSE FROM FIRE DAMAGE TO BE USED TO INFILL AREAS WHERE BRICK IS MISSING.

Item6, Exterior Walls/Masonry: See sheet D2.0 showing areas to be repaired and repointed.

Item 6, Exterior Walls/Masonry: See sheet D2.0 showing areas to be repaired and repointed.

Masonry Repointing – All repointing must follow guidance found in the National Park Service's *Preservation Brief #2: Repointing Mortar Joints in Historic Masonry Buildings*, which can be found at <https://www.nps.gov/tps/how-to-preserve/briefs/2-repoint-mortar-joints.htm>. We strongly suggest submitting an Amendment with a test patch for review and approval prior to the widespread repointing of large areas of the historic structure.

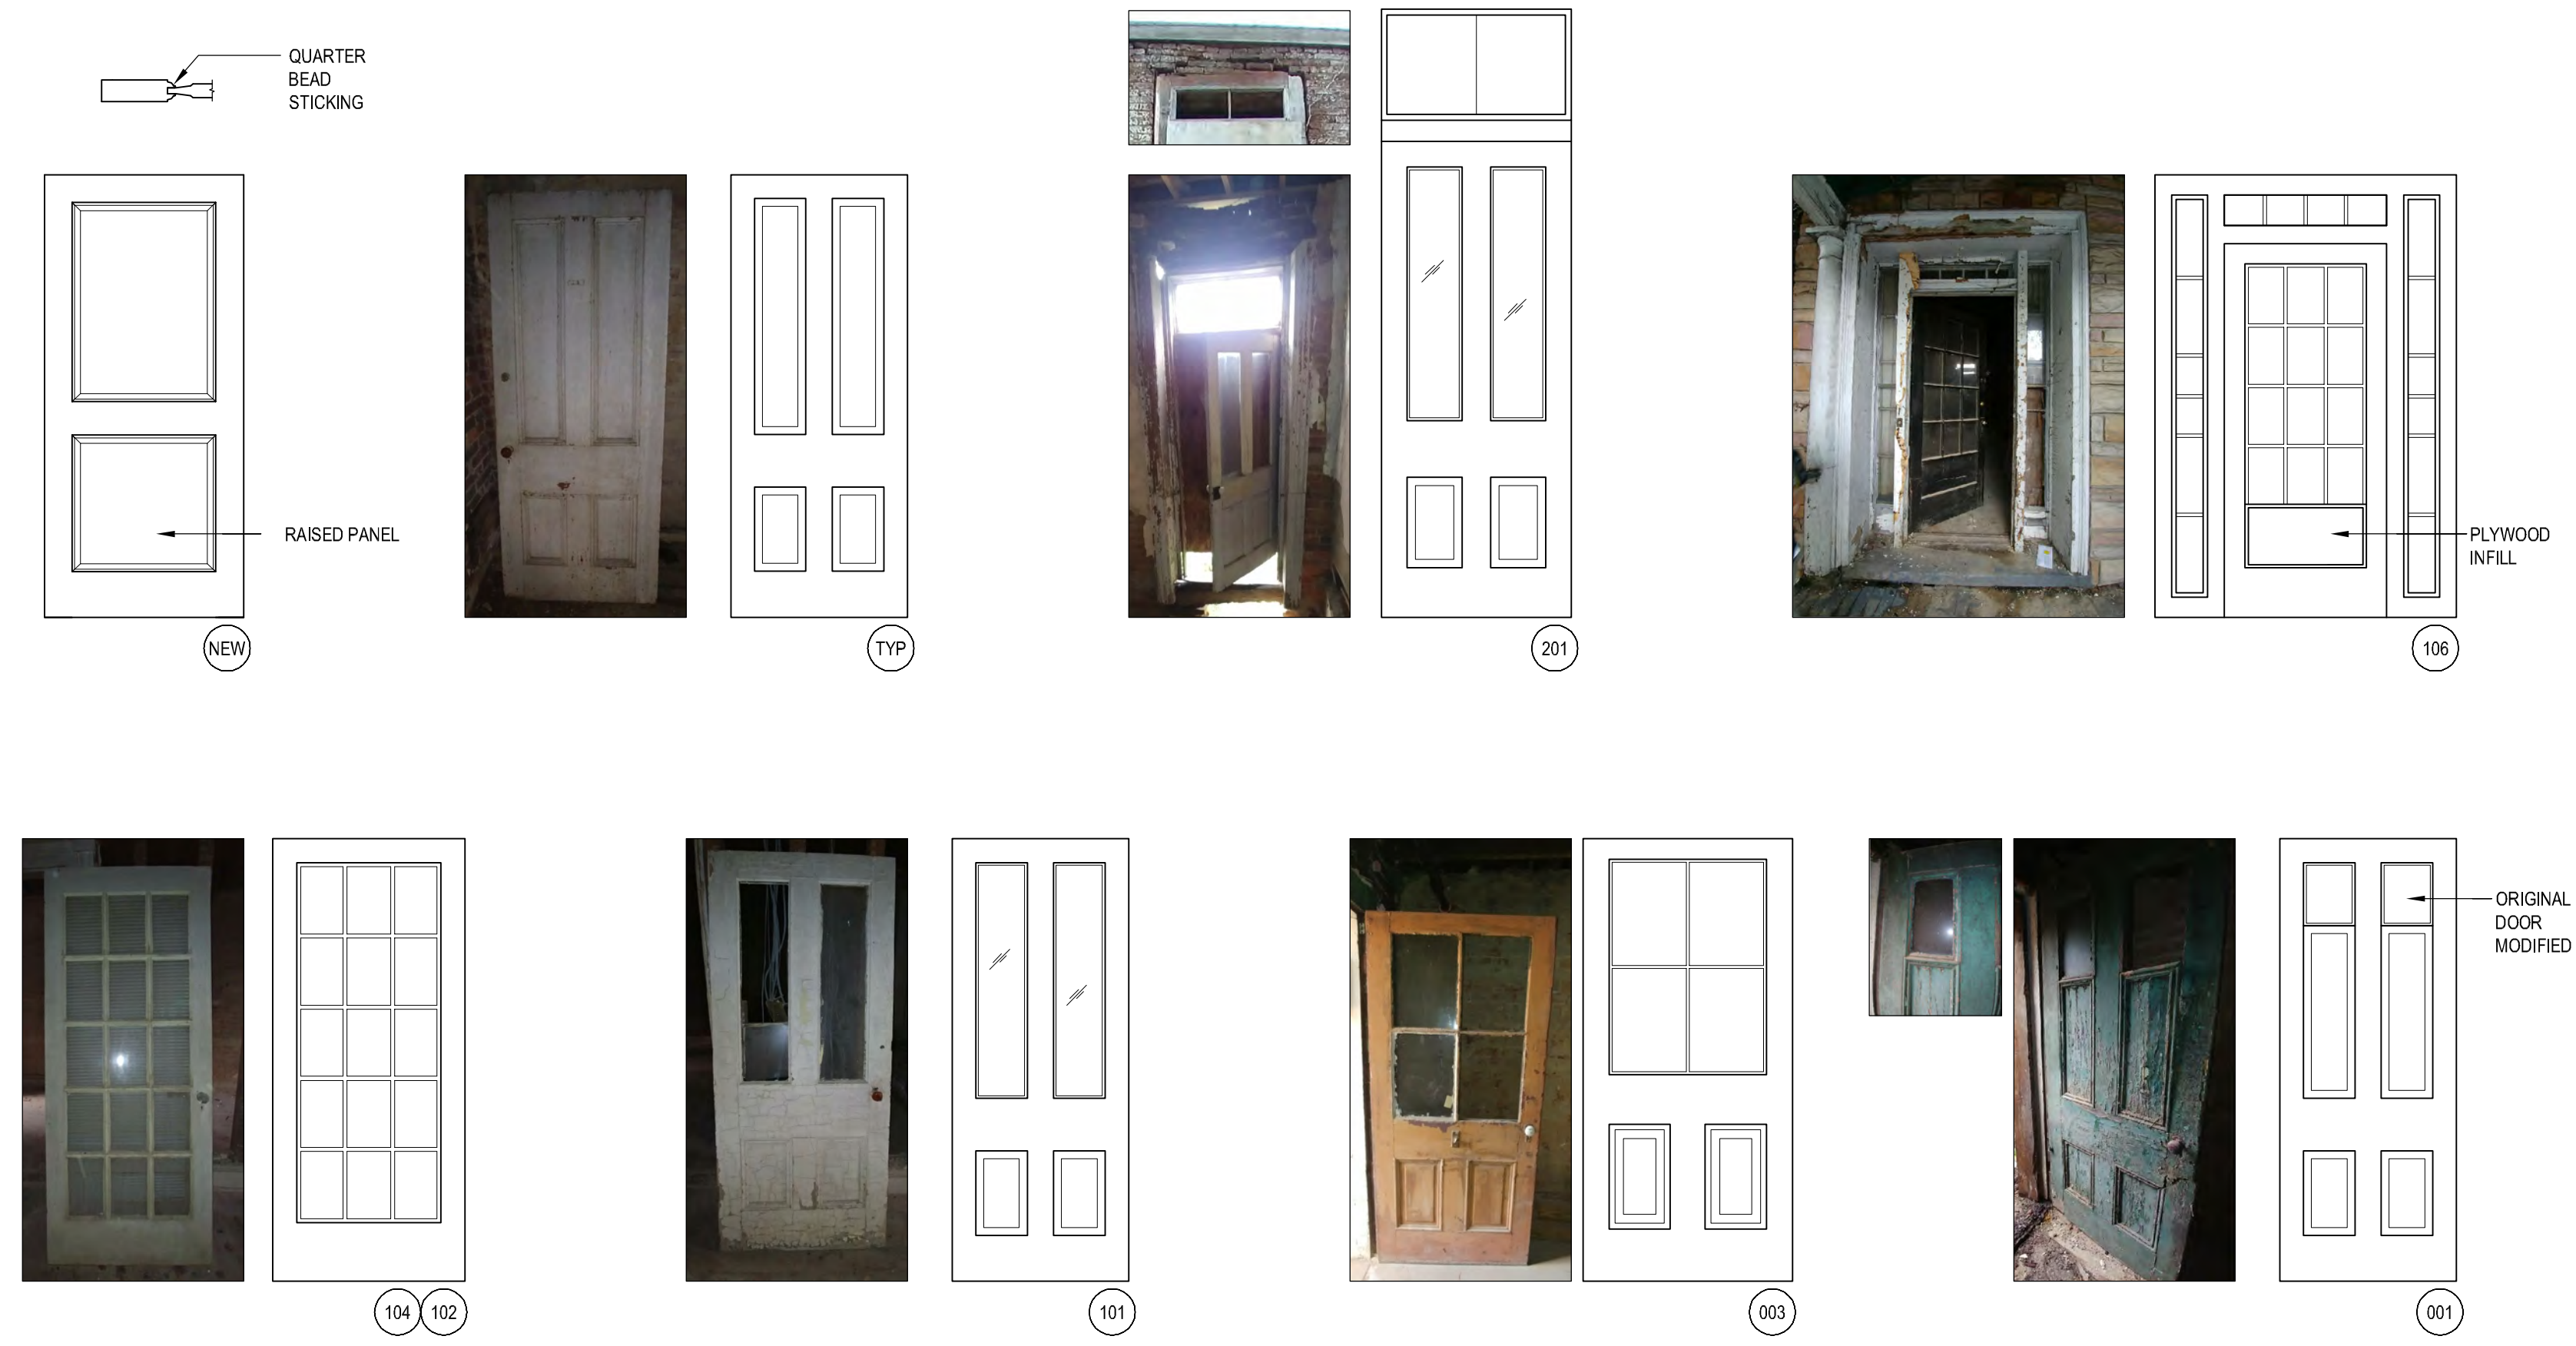
EXISTING DOOR DIAGRAMS
1/4" = 1'-0"

EXISTING DOOR SCHEDULE					
DR #	DOOR			FRAME	
	SIZE (W x H)	MAT'L	GLASS	MT'L	REMARKS
BASEMENT FLOOR					
001	2'-9.75" x 7'-11.5"	WD	YES	WD	EXTERIOR, HINGED, 2/2 PANELS. UPPER PANELS MODIFIED TO ACCOMMODATE WINDOWS. DOOR IN POOR SHAPE. PROPOSE TO REPLACE DOOR IN SIMILAR STYLE IN KEEPING WITH EXISTING DWELLING.
002	2'-9.5" x 7'-10.5"	WD	*	WD	INTERIOR, HINGED, 2/2 PANELS, GOOD CONDITION, PATCH REPAIR, REPAINT
003	3'-0" x 6'-4"	WD	YES	WD	EXTERIOR, HINGED, 1/2 GLASS UPPER WITH 4 PANEL GLASS, 2 VERTICLES PANELS LOW. PATCH REPAIR, REPAINT
004	2'-9.5" x 7'-10.5"	WD	*	WD	INTERIOR, HINGED, 2/2 PANELS, GOOD CONDITION. PATCH REPAIR, REPAINT
005	2'-9.5" x 7'-10.5"	WD	*	WD	INTERIOR, HINGED, 2/2 PANELS, GOOD CONDITION. PATCH REPAIR, REPAINT
006	2'-9.5" x 7'-10.5"	WD	*	WD	INTERIOR, HINGED, 2/2 PANELS, GOOD CONDITION. PATCH REPAIR, REPAINT
010	2'-4" x 6'-8"	WD	*	WD	NEW INTERIOR DOOR, 1/1 PANEL, MDF
011	(2) 1'-6" x 6'-8"	WD	*	WD	NEW INTERIOR DOOR, 1/1 PANEL, MDF

012	3'-0" x 6'-8"	WD	*	WD	NEW INTERIOR DOOR, 1/1 PANEL, MDF
013	(2) 1'-6" x 6'-8"	WD	*	WD	NEW INTERIOR DOOR, 1/1 PANEL, MDF
FIRST FLOOR					
101	CANNOT VERIFY	WD	*	WD	NO DOOR PRESENT, PROPOSE TO REPLACE DOOR IN SIMILAR STYLE IN KEEPING WITH EXISTING DWELLING.
102	2'-10" x 6'-4"	WD	*	WD	INTERIOR, HINGED, 2/2 PANELS, GOOD CONDITION. PATCH REPAIR, REPAINT
103	3'-0" x 8'-2.5"	WD	*	WD	INTERIOR HINGED, FULL LIGHT WITH 15 DIVIDED LIGHTS. GOOD CONDITION. PATCH REPAIR, REPAINT
104	(2) 3'-0" x 7'-10"	WD	*	WD	INTERIOR POCKET DOUBLE DOORS. 2/2 PANEL. DOOR SIN GOOD CONDITION, TRACKS NEED TO BE REPAIRED OR REPLACED. PATCH REPAIR, REPAINT
105	3'-0" x 8'-2.5"	WD	*	WD	INTERIOR HINGED, FULL LIGHT WITH 15 DIVIDED LIGHTS. GOOD CONDITION. PATCH REPAIR, REPAINT
106	3'-0" x 7'-11"	WD	YES	WD	EXTERIOR, HINGED WITH SIDELIGHTS AND TRANSOM. DOOR HAS BEEN REPAIRED. SHOULD BE A FULL LIGHT DOOR WITH 15 DIVIDED LIGHTS. BOTTOM ROW OF WINDOWS BROKEN OUT AND REPLACED WITH PLYWOOD.

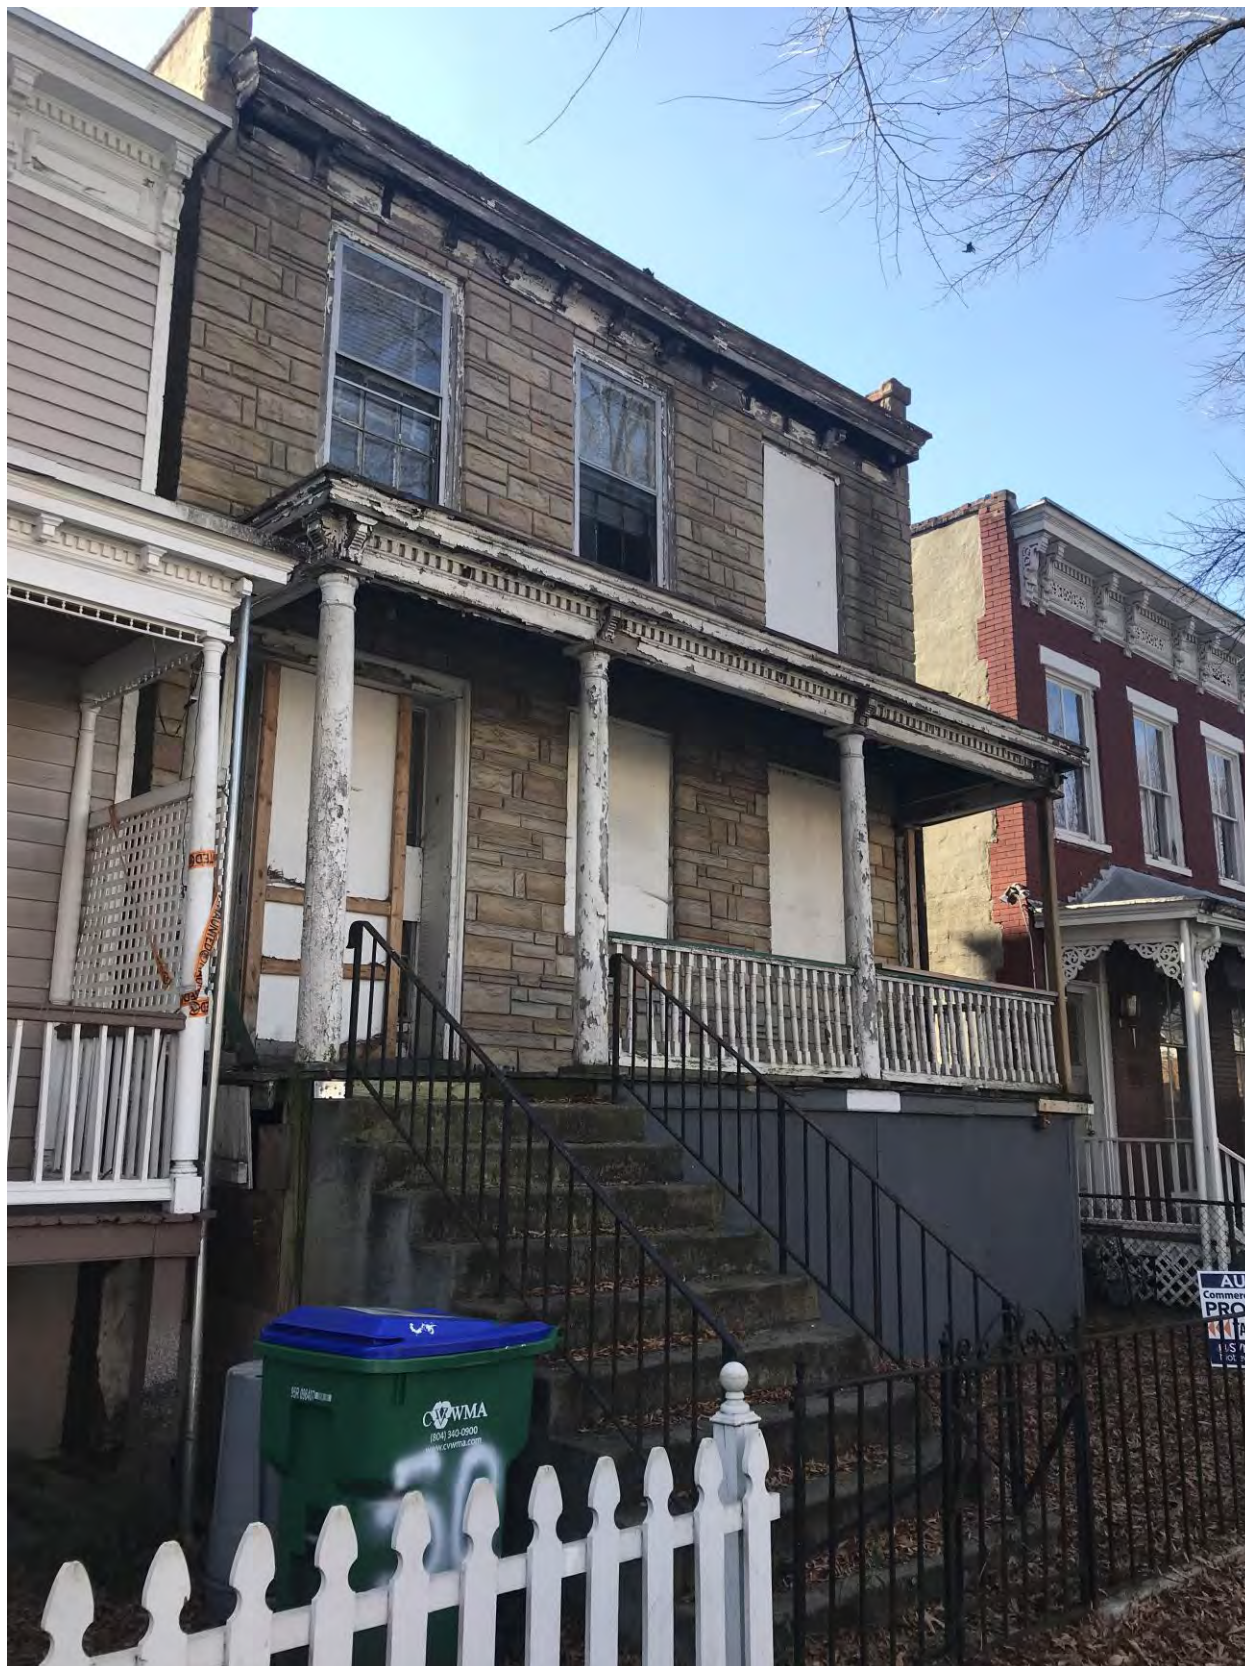
511 West Marshall Street, Richmond, VA
Part 2 Photos; DHR #2018-070; NPS Proj. # Not Yet Assigned
Photo 1.2
Roof; bracketed cornice; Windows

Item 1, Roof: Please confirm that the existing roof will be repaired, rather than replaced, despite an apparent deteriorated condition.

Item1, Roof: The intent is to repair the roof where and replace members on an as needed bases if the structural integrity can be maintained. The roof has been severely damaged by a fire some time ago, and the temporary structure is not sound. See photos at end of this letter. If our engineer determines the structural integrity of the existing roof has been compromised, we would respectfully request that a new roof be built. Any new roofing will match the original pitch and profiles.

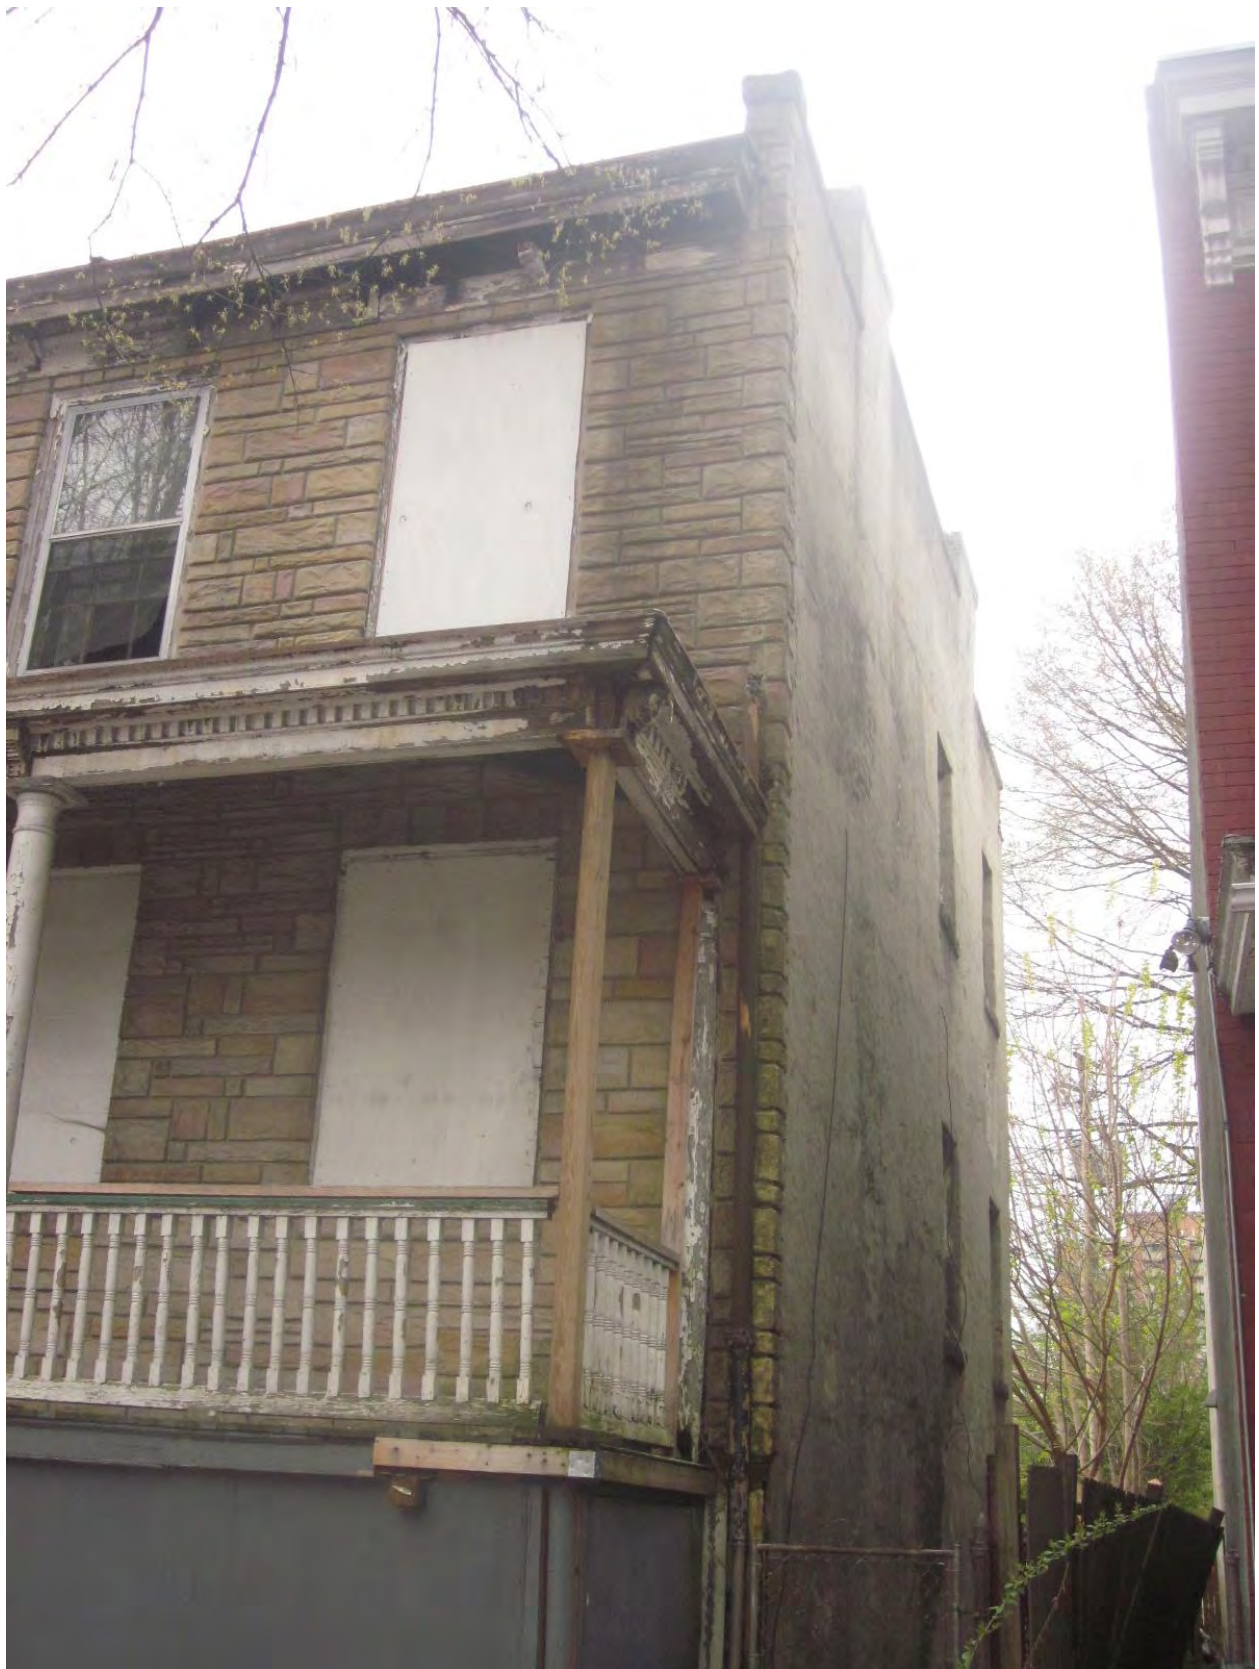
511 West Marshall Street, Richmond, VA
Part 2 Photos; DHR #2018-070; NPS Proj. # Not Yet Assigned
Photo 3.1
Foundation (under Front Porch; Basement front entrance at left); Windows

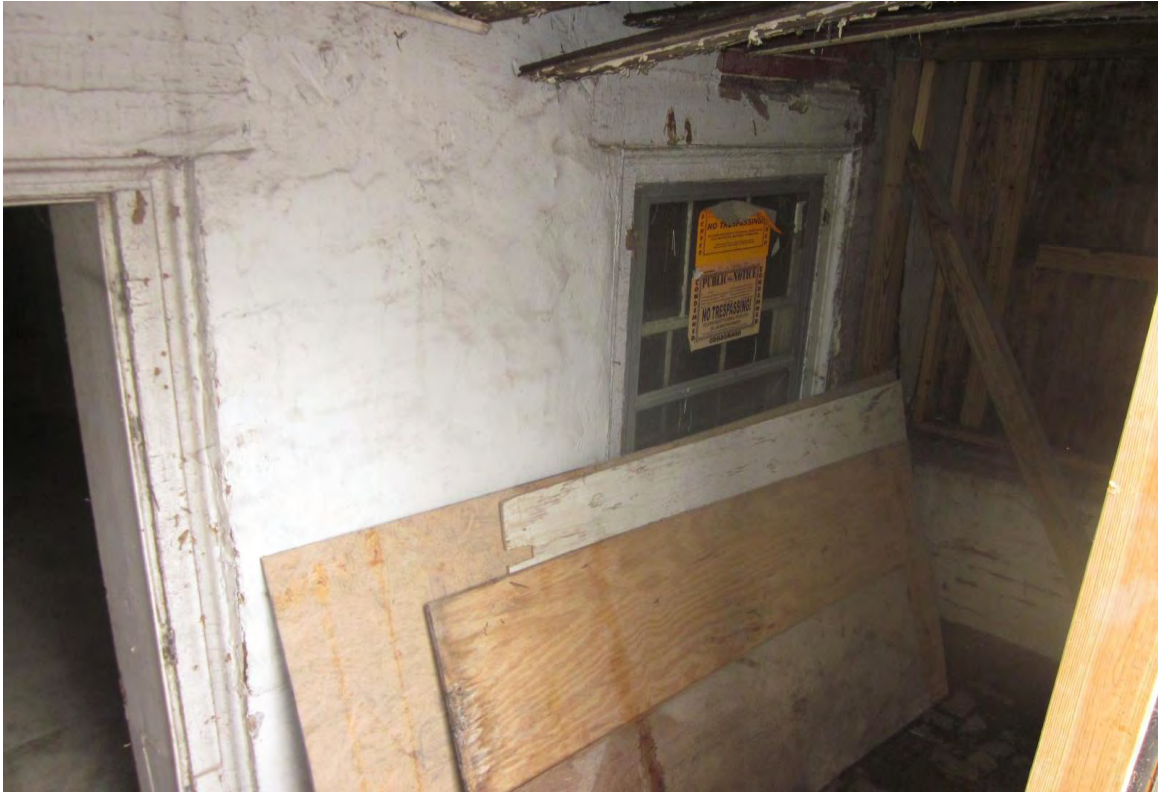
Photo 3.2
Foundation (under Front Porch; Basement front entrance at right); Windows

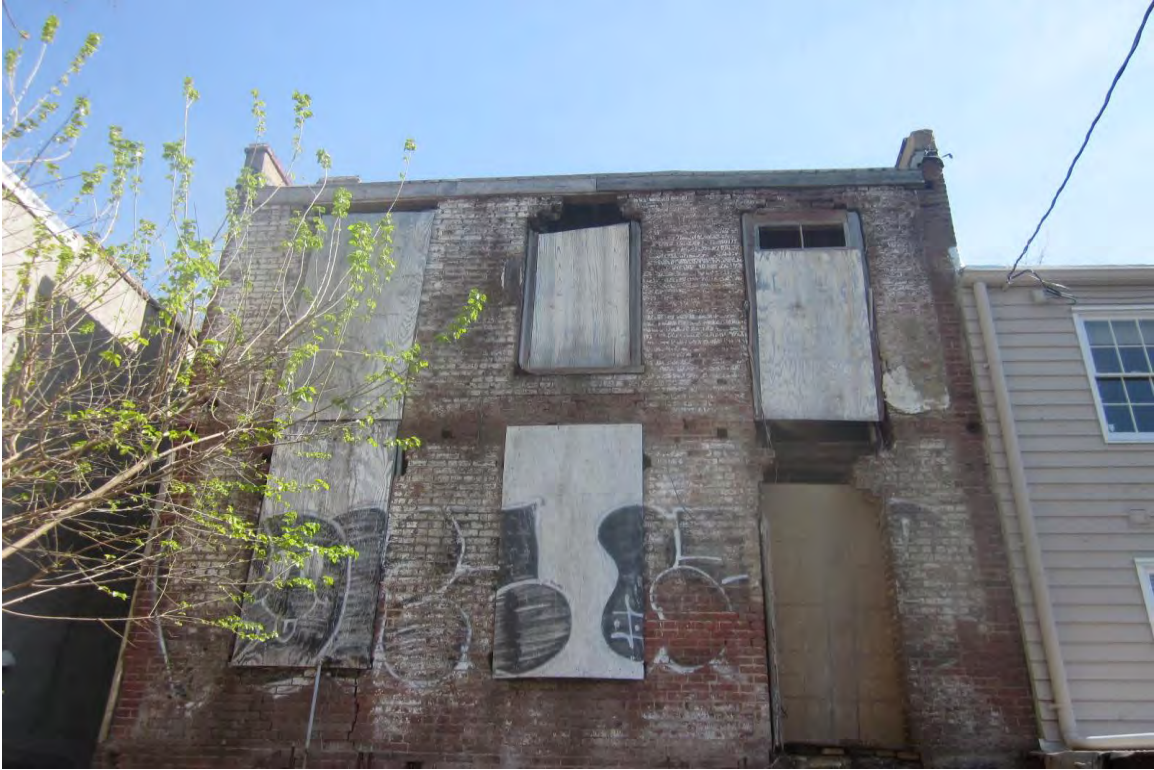
Photo 5.2

Rear Porch and Rear Doors/Entrances (see both existing 2nd Floor entrances at Photos 7.8 and 8.5);
Gutters & Downspouts; Windows; Plan, proposed rear addition will be inset from edge of masonry

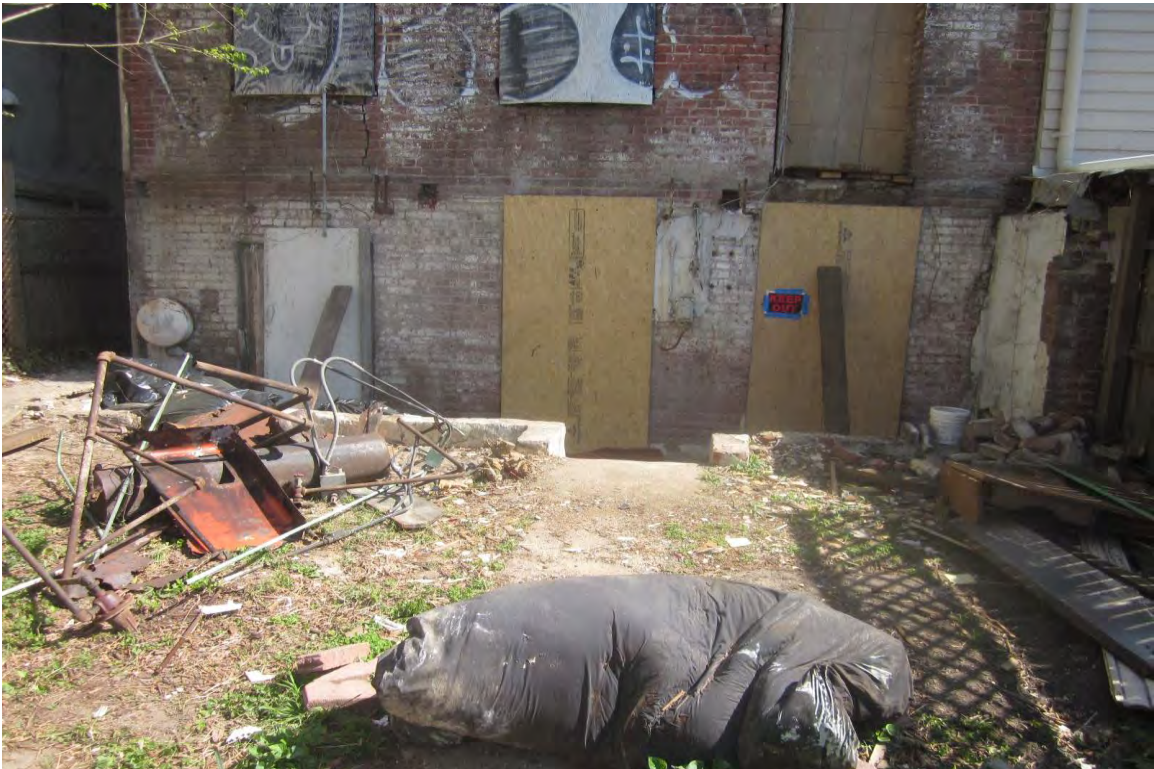
Photo 5.3

Rear Porch; Windows; Doors (Basement rear access (Room 2)); Plan, proposed rear addition will be inset from edge of masonry

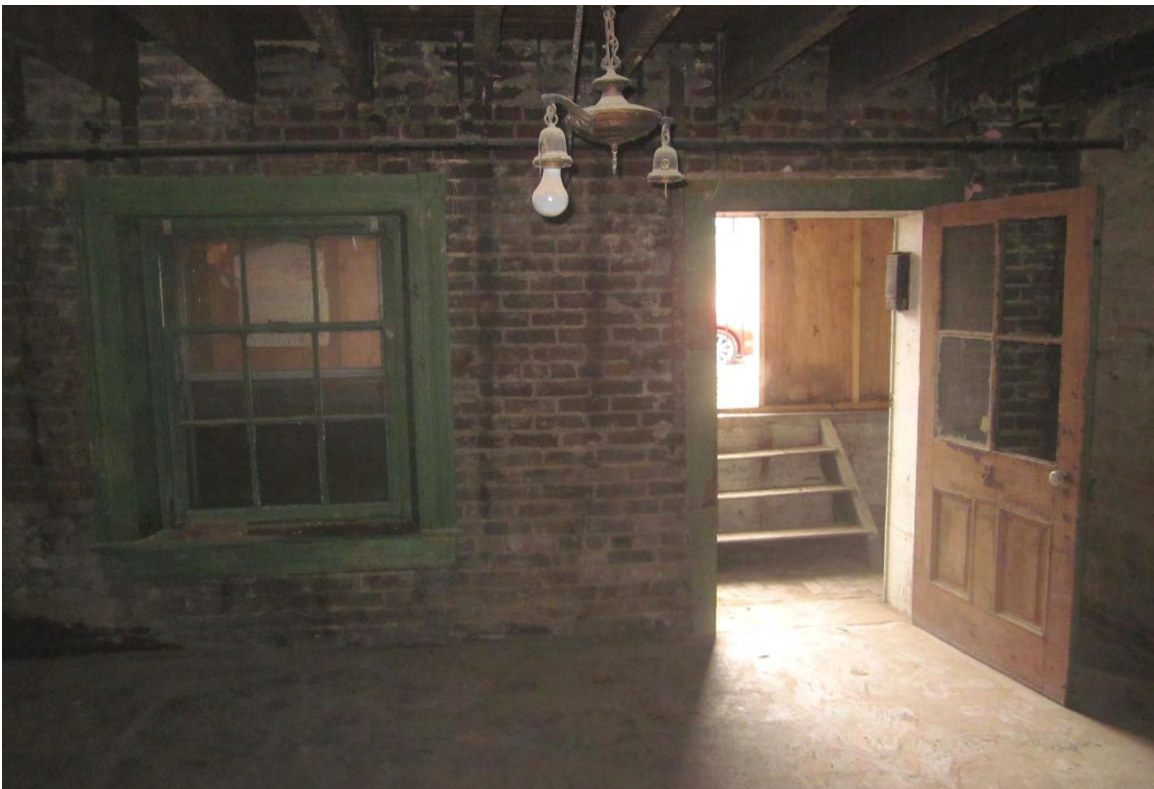
Photo 7.1
Windows, 9 lite window in Basement Room 1 (see also Photo 3.1); Exterior Doors; Plan

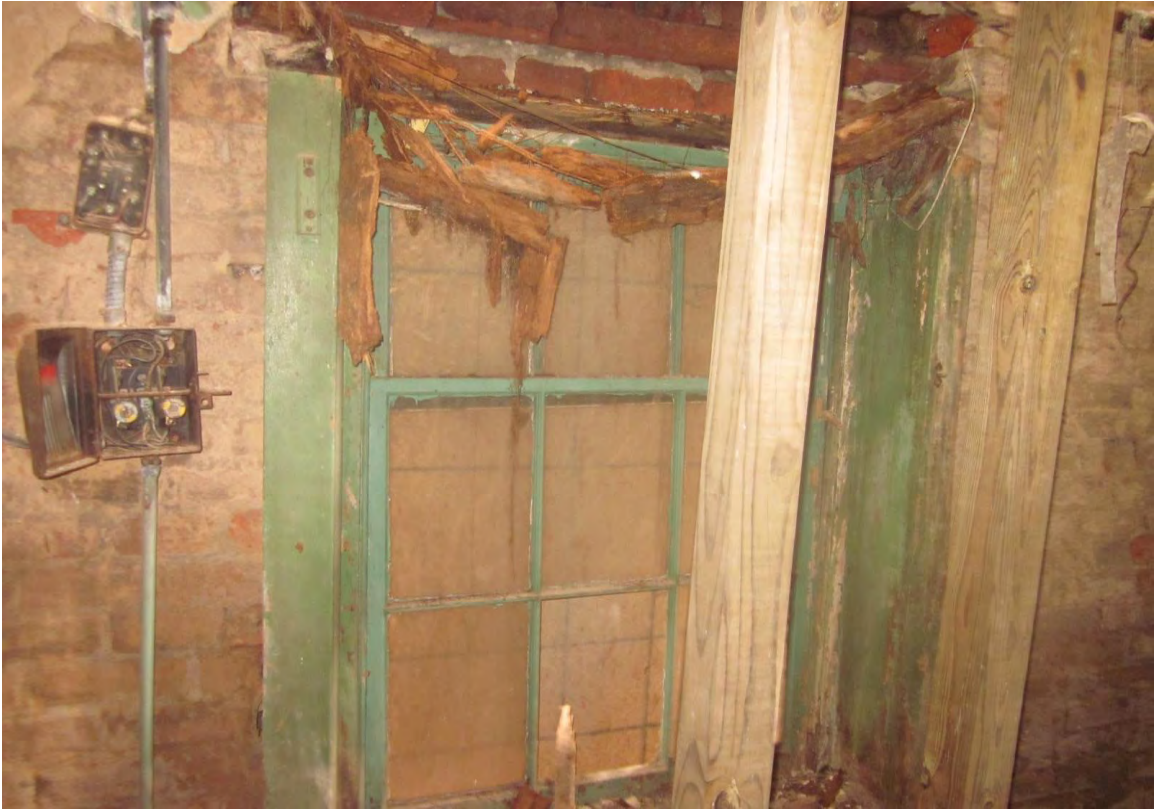
511 West Marshall Street, Richmond, VA
Part 2 Photos; DHR #2018-070; NPS Proj. # Not Yet Assigned
Photo 7.2
Windows, 3/6 window in Basement Room 2 (see also Photo 5.2); Plan

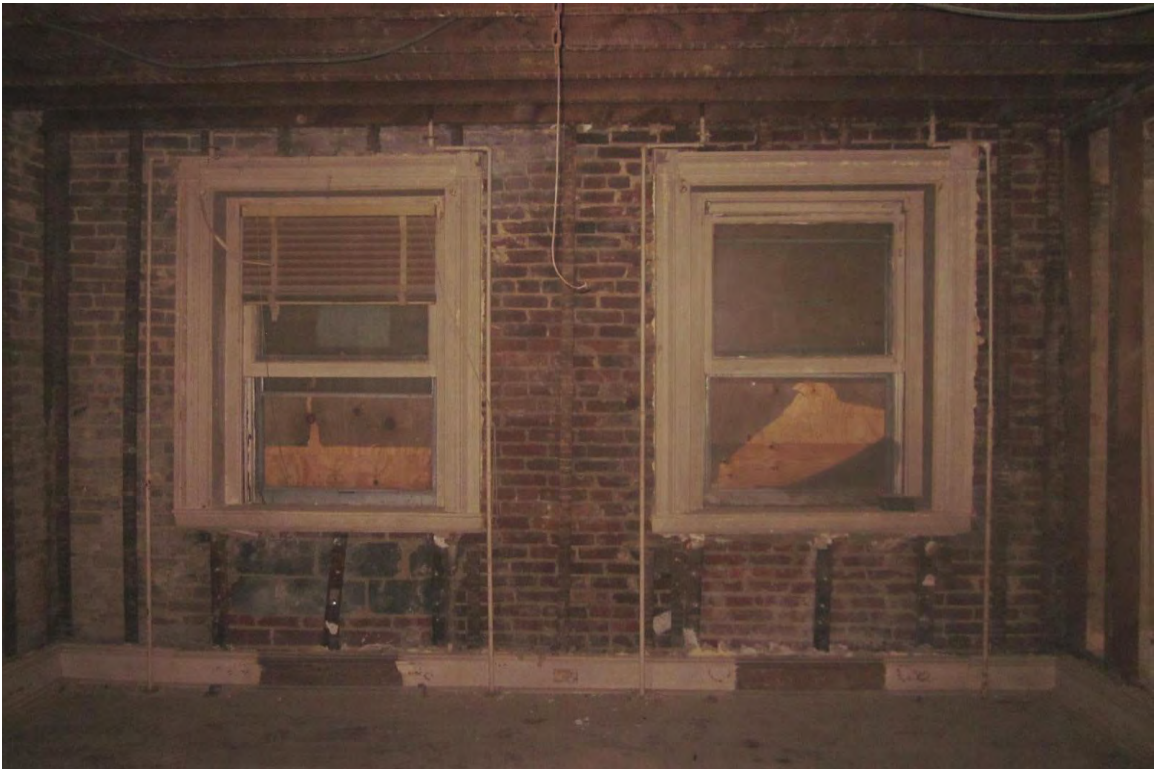
Photo 7.3
Windows, 1/1 original wood windows at Room 3 on the 1st floor of front façade (see Photo 4.1);
Interior Woodwork; Plan (Room 3)
