COMMISSION OF ARCHITECTURAL REVIEW

APPLICATION FOR CERTIFICATE OF APPROPRIATENESS

Address 511 W Marshall ST Richmond VA 23220
Historic district Jackson Ward

**HISTORIC PRESERVATION CERTIFICATION APPLICATION
PART 2 – DESCRIPTION OF REHABILITATION**

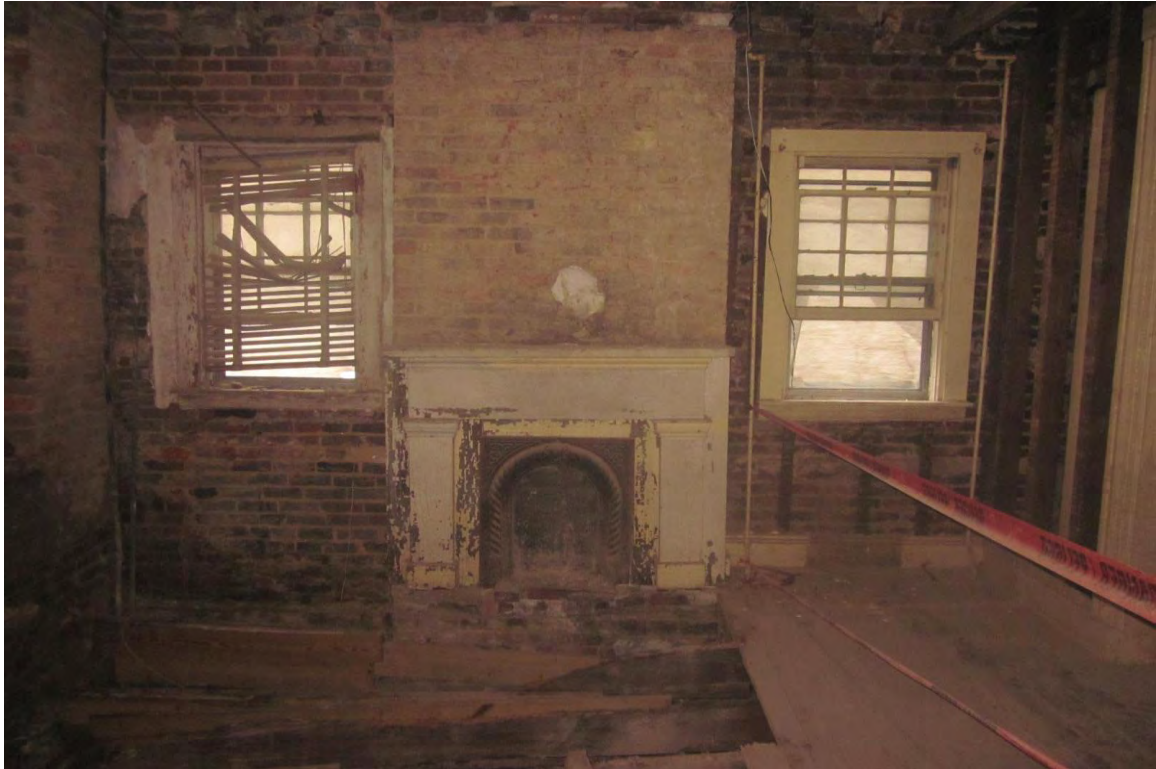
511 West Marshall Street, Richmond, VA
Part 2 Photos; DHR #2018-070; NPS Proj. # Not Yet Assigned
Photo 7.4
Windows, 6/6 original wood windows at Room 4 on the west elevation; Interior Woodwork

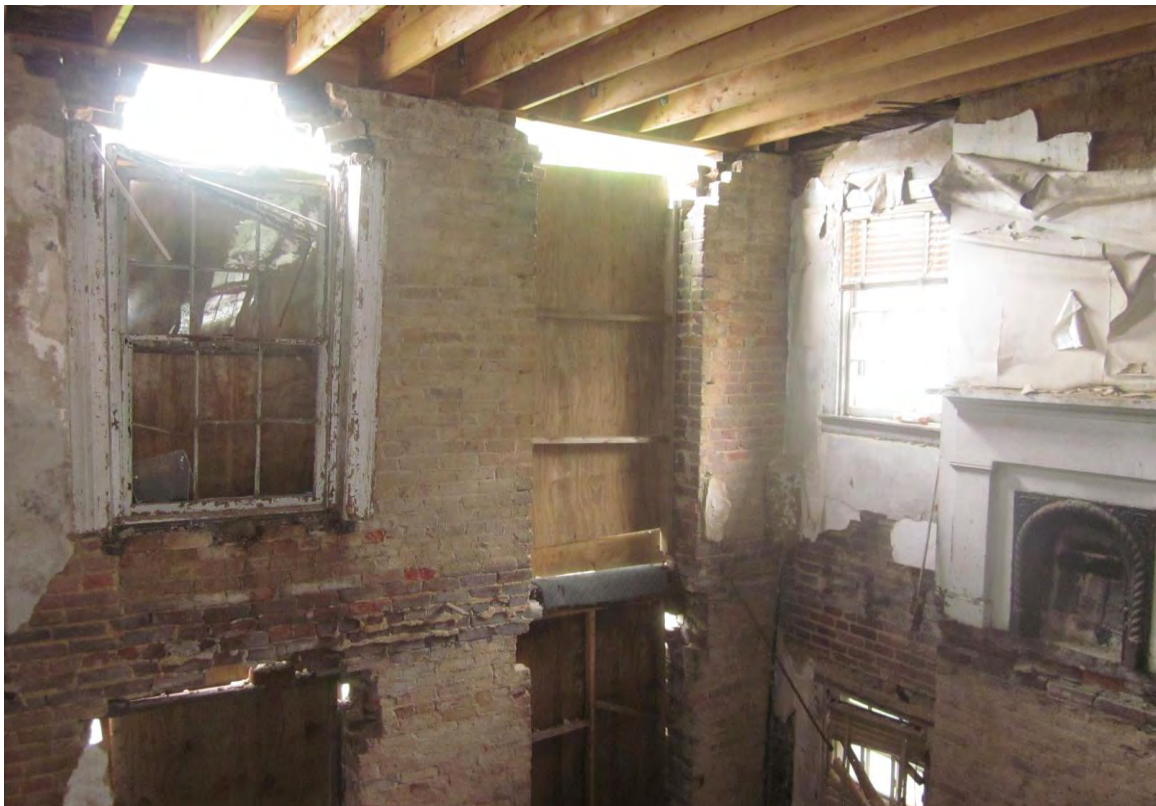
Photo 7.5
Windows, 6/6 original window on left in Room 6; Doors, door missing from opening at right (see Photo 5.2 also)

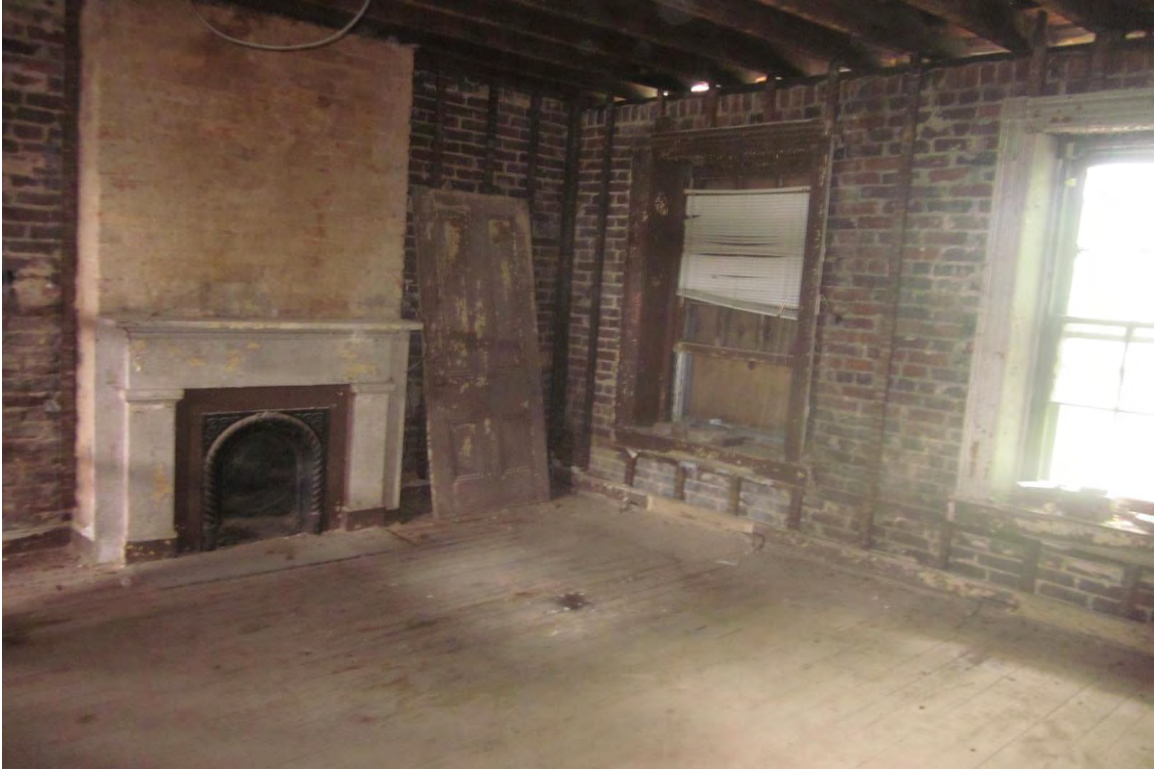
Photo 7.6

Windows, 6/6 windows at Room 5 on the 2nd floor of the front facade (see Photo 1.2 also); Roof (daylight visible in corner of room); Interior Woodwork; Wall and Ceiling Finishes; Floors

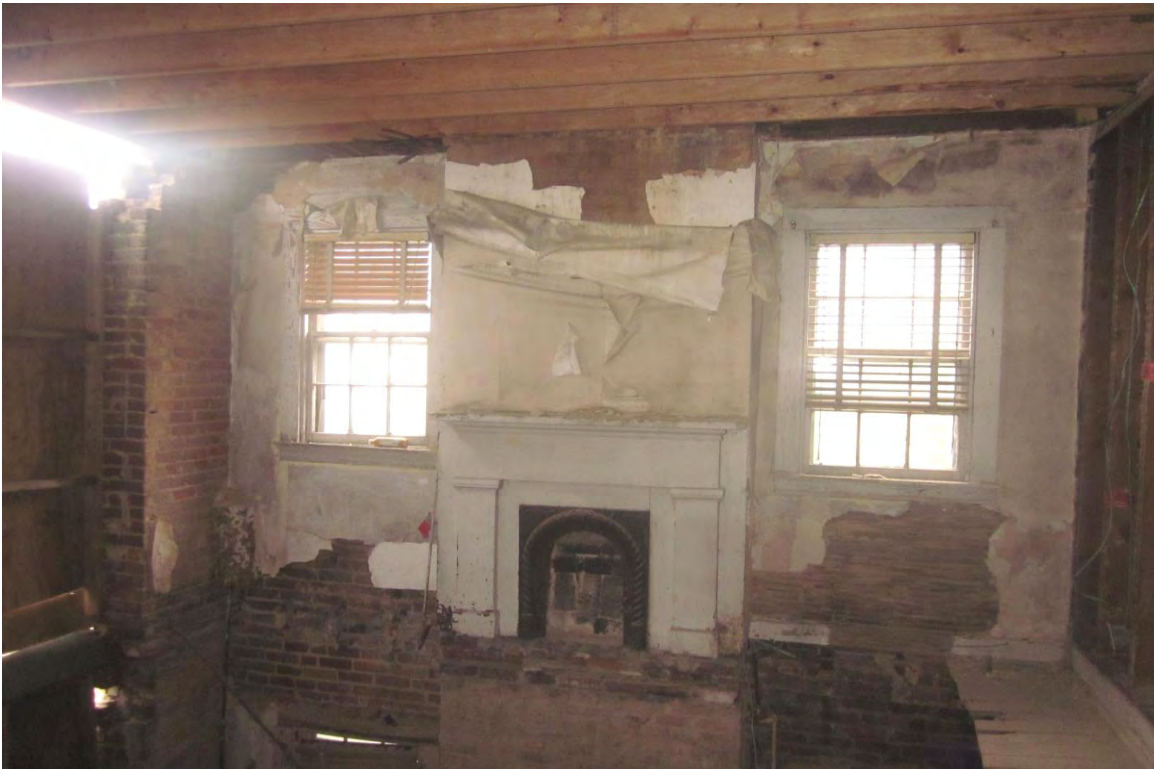
Photo 7.7

Windows, 6/6 original windows at Room 6 on the west elevation; Interior Woodwork; Wall and Ceiling Finishes; Floors

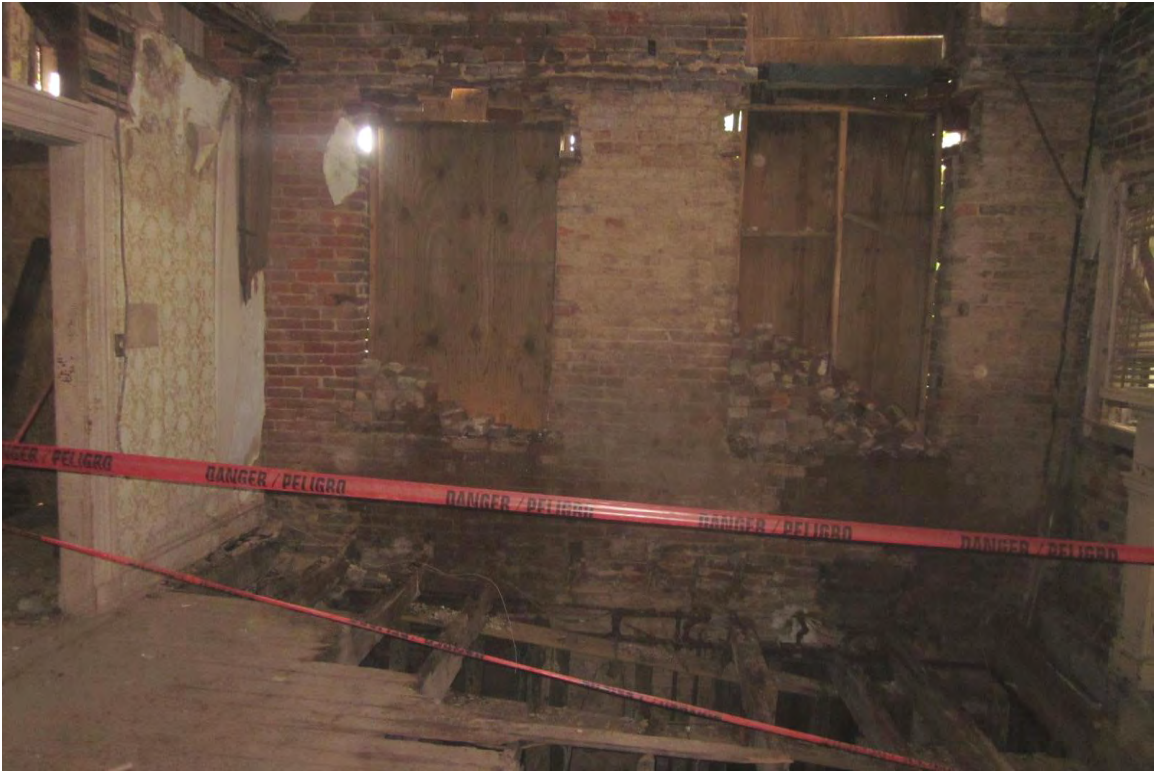
Photo 7.8

Windows, 6/6 window at left in Room 4 on the 1st floor of the rear elevation (see Photo 5.2 also);
Masonry; Doors, rear entrance into Room 4 at right (Photo 5.2); Wall and Ceiling Finishes

EXISTING BRICK TO BE RE-POINTED. EXISTING BRICK LOOSE FROM FIRE DAMAGE TO BE USED TO INFILL AREAS WHERE BRICK IS MISSING.

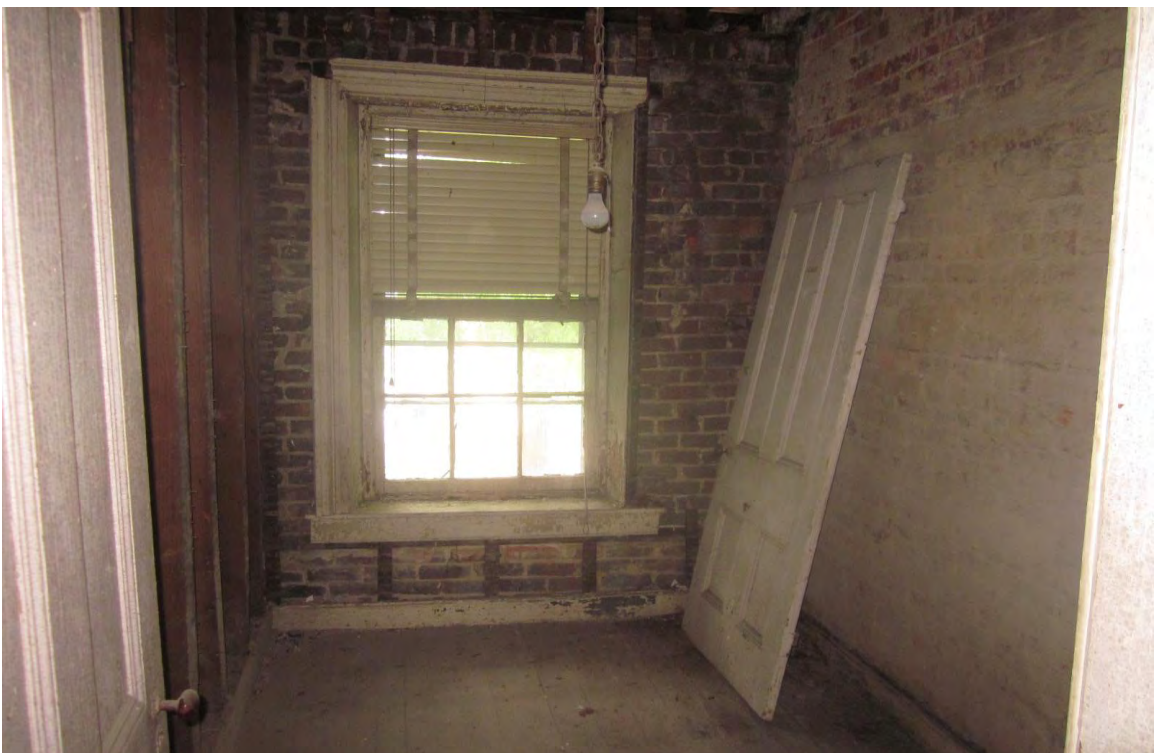
Photo 7.9

Windows, 6/6 window at Small Room on the 2nd floor of the front facade (see leftmost window in
Photo 1.2 also); Interior Doors; Interior Woodwork

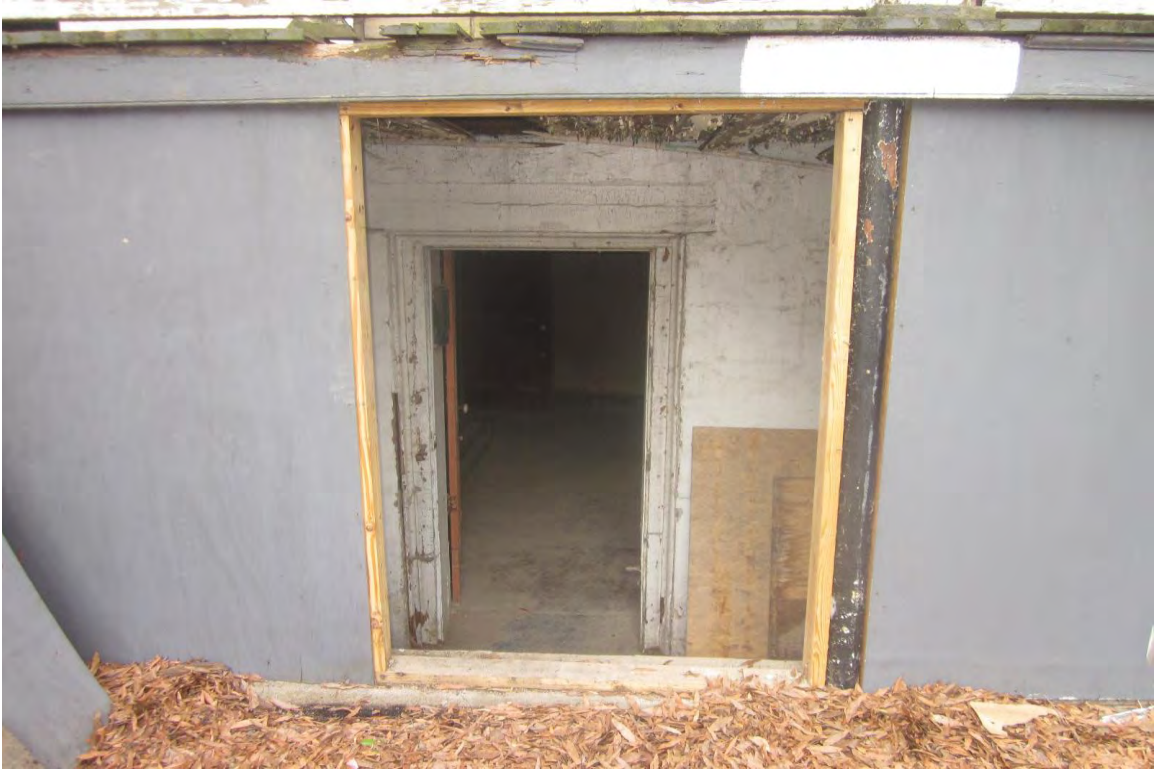
Photo 8.1

Basement Front Door access under Front Porch (see Photos 7.1 and 9.3 also for interior view of Basement Front Door); Front Porch, rotted and sagging deck boards to replaced in-kind

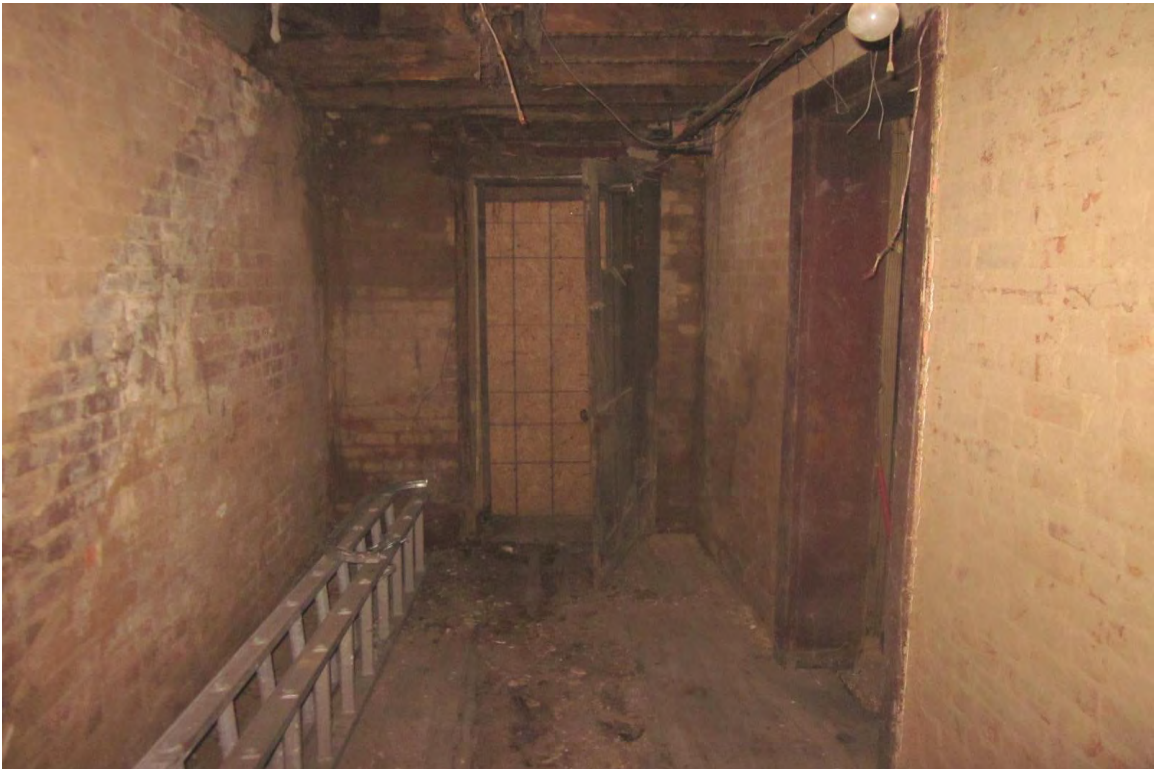
Photo 8.2

Rear Basement Door (see Photo 5.3 also), Room 2 at right; Interior Woodwork; Floors, wood directly on dirt

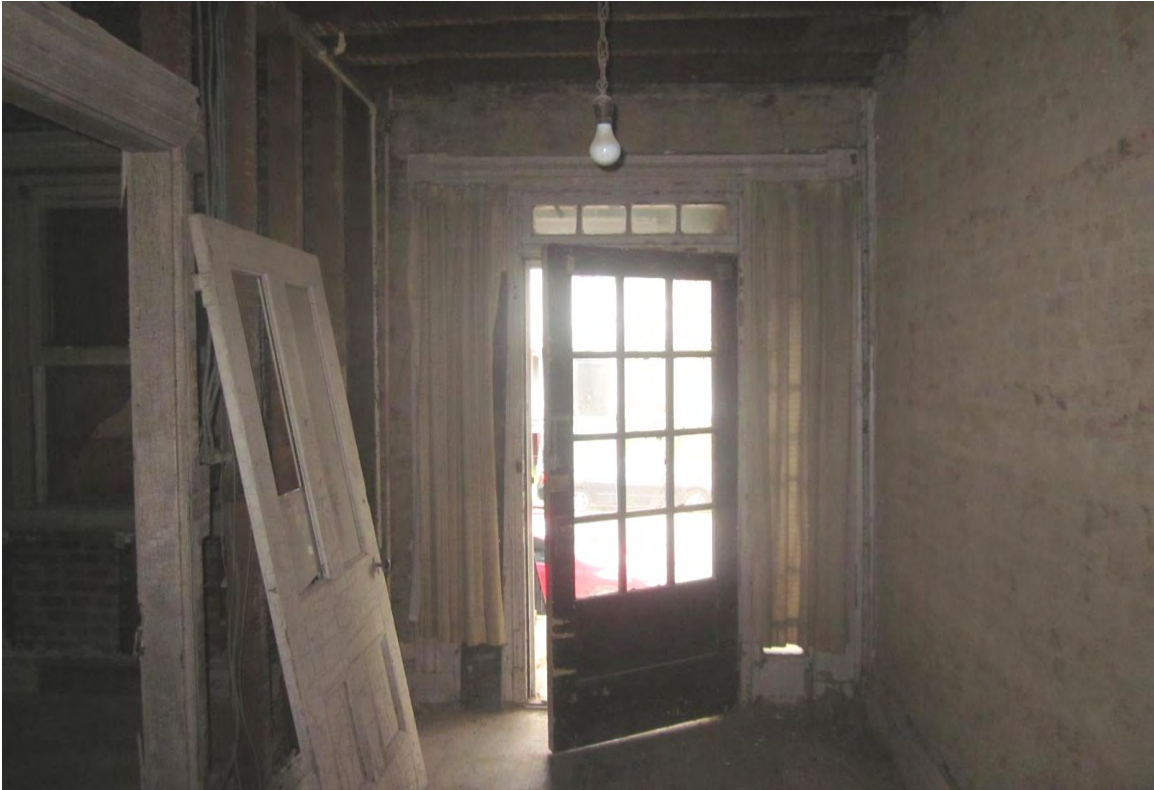
Photo 8.3

Front Door (12 lite original door with sidelights), Room 3 at left; Interior Woodwork; Plan (Hall)

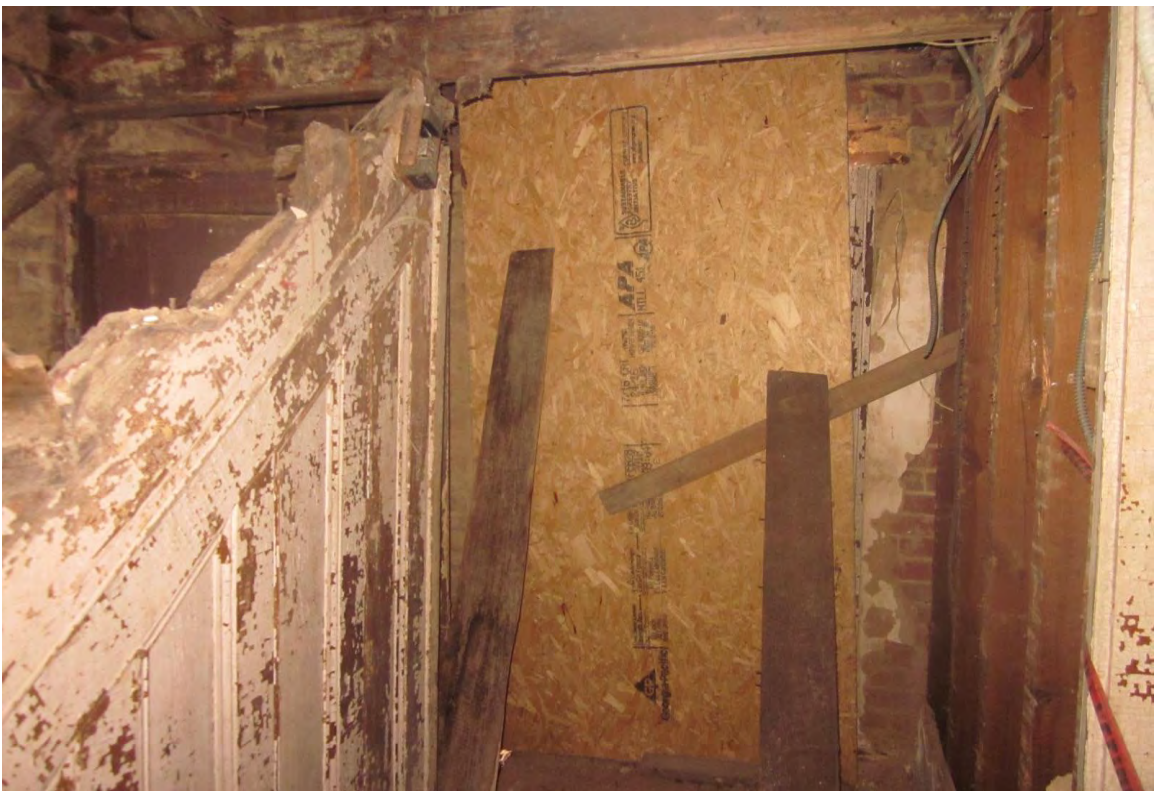
Photo 8.4

Rear Door location on 1st Floor, Room 4 at immediate right; Plan (Hall)

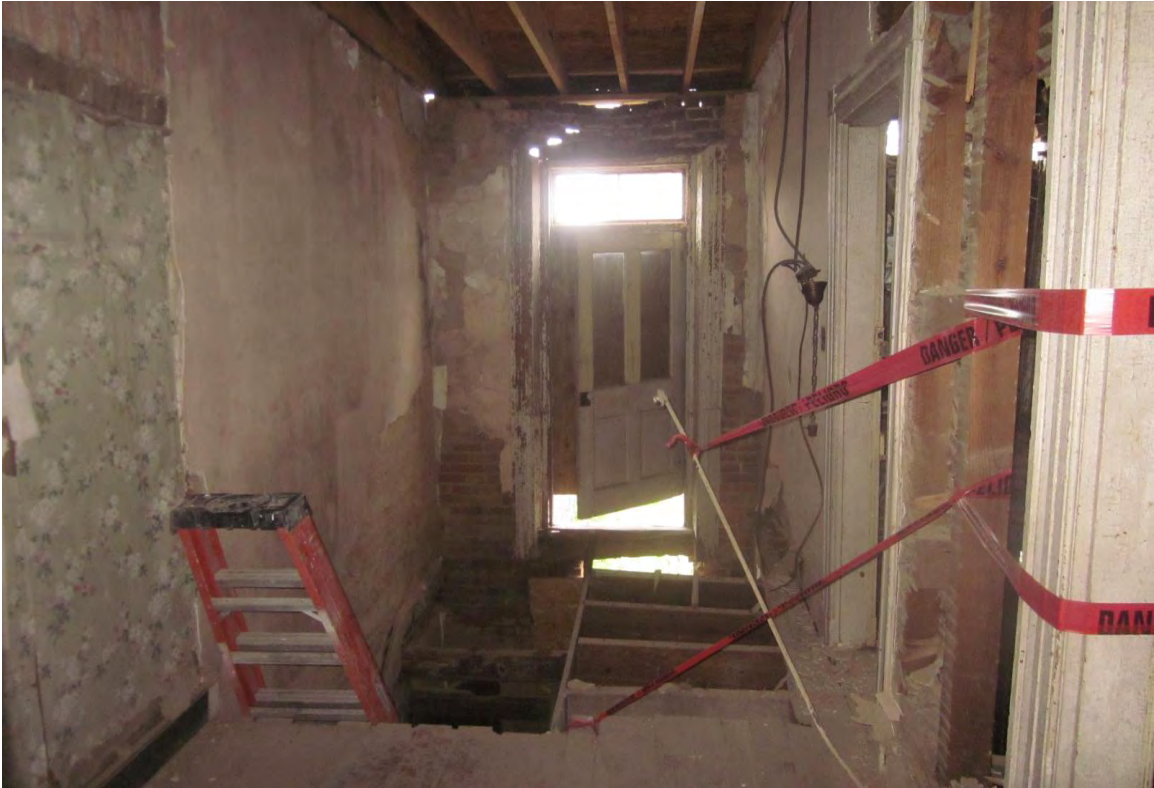
511 West Marshall Street, Richmond, VA
Part 2 Photos; DHR #2018-070; NPS Proj. # Not Yet Assigned
Photo 8.5
Rear Door location on 2nd Floor, Room 6 at right

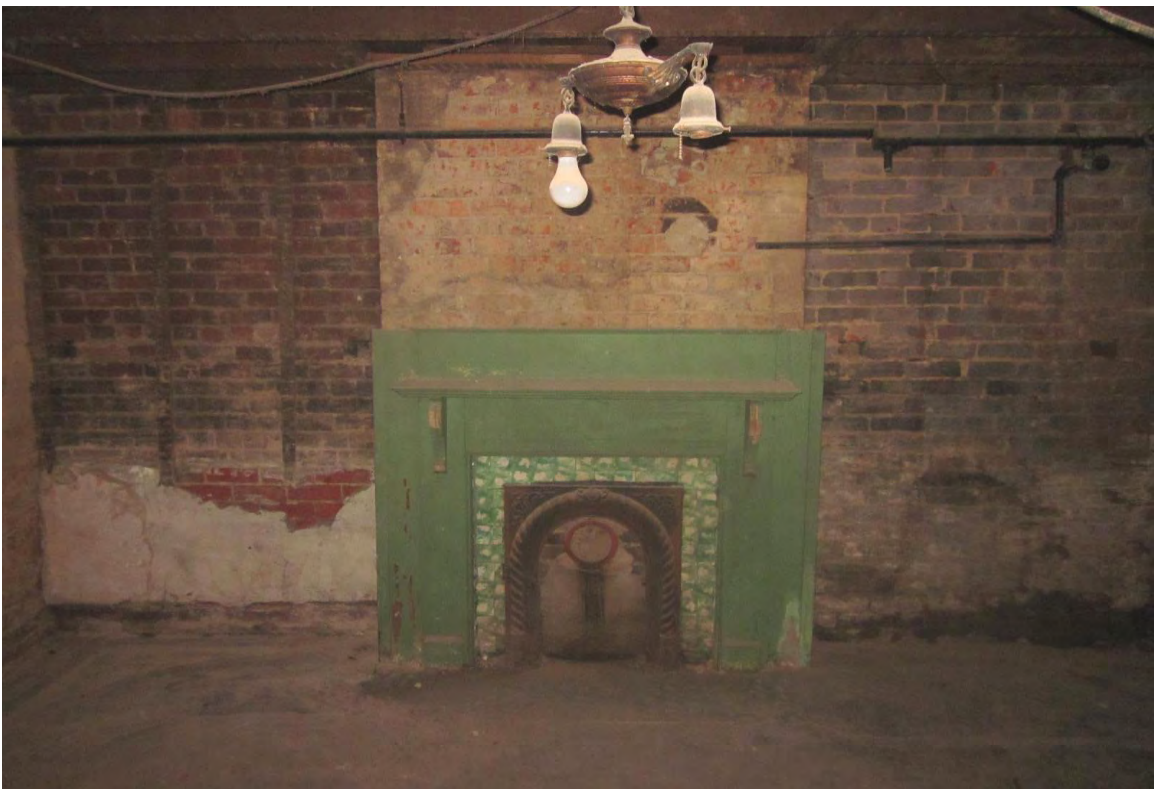
Photo 9.1
Interior Woodwork; Flooring (concrete floor); Plan (Room 1, Basement)

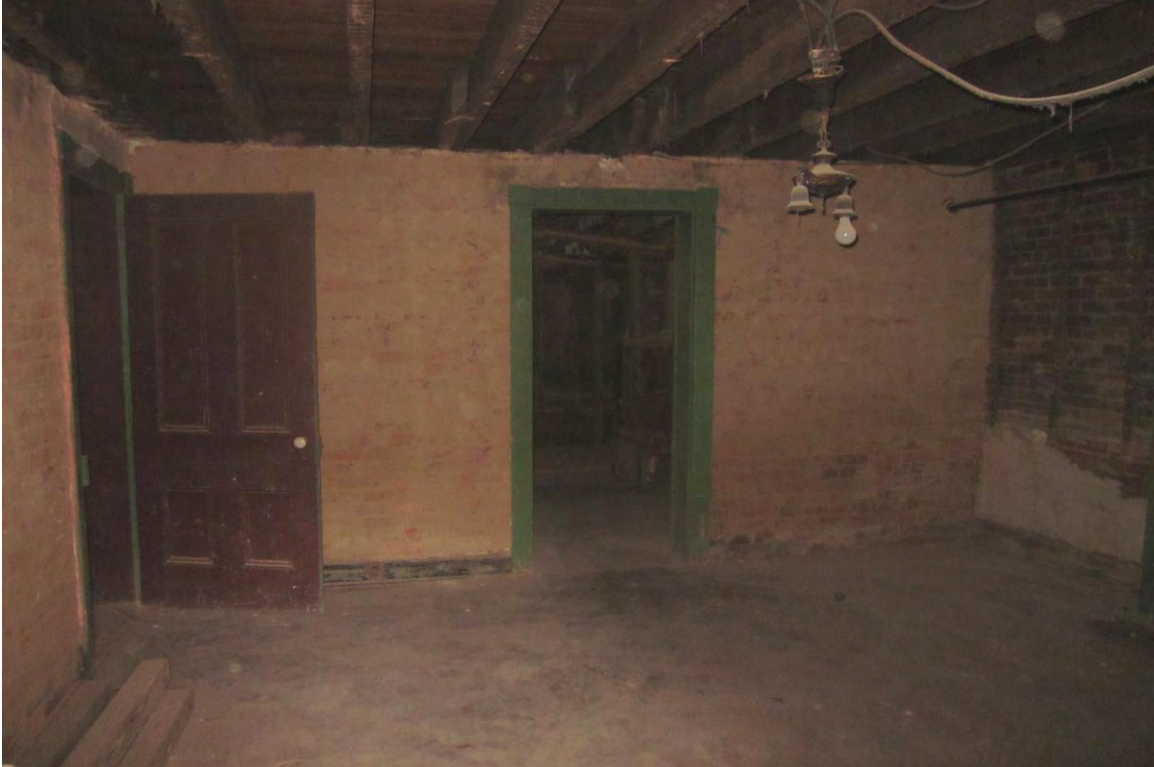
511 West Marshall Street, Richmond, VA
Part 2 Photos; DHR #2018-070; NPS Proj. # Not Yet Assigned
Photo 9.2
Interior Woodwork; Plan (Basement Room 1 looking toward Room 2)

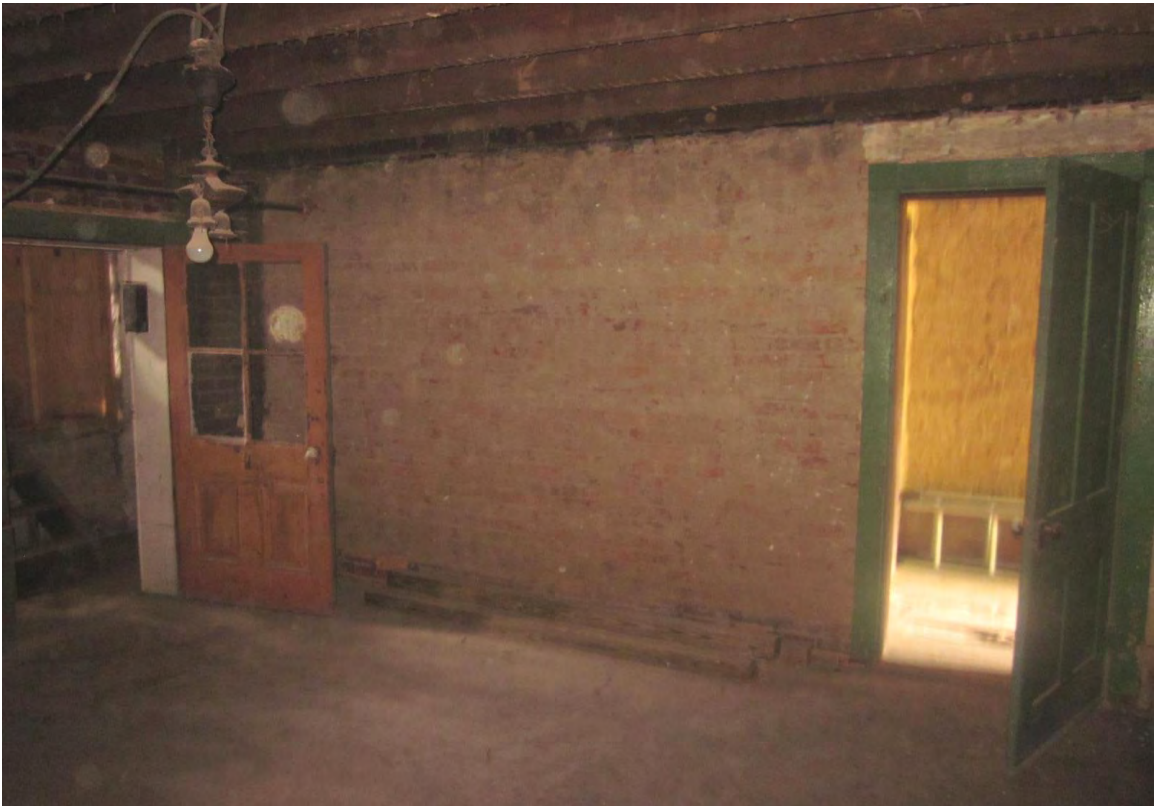
Photo 9.3
Interior Woodwork; Doors; Plan (Basement Room 1, Front Door at left, Hall Door at right)

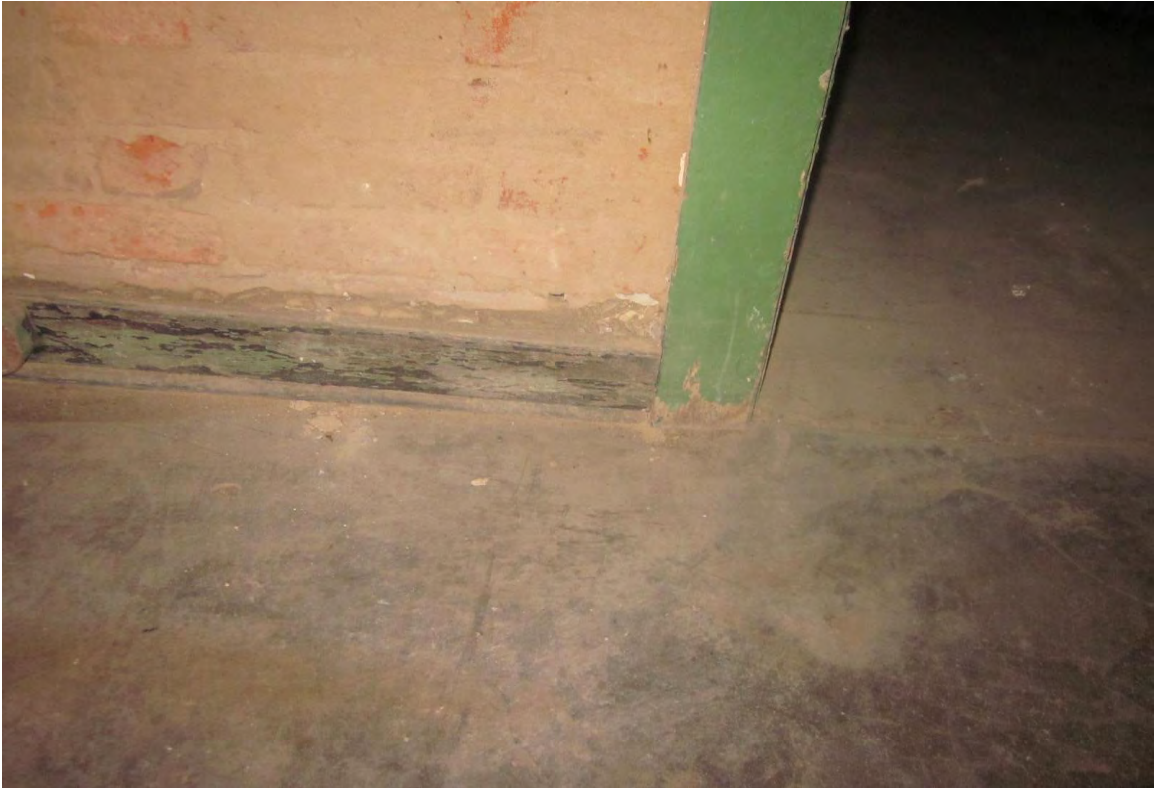
511 West Marshall Street, Richmond, VA
Part 2 Photos; DHR #2018-070; NPS Proj. # Not Yet Assigned
Photo 9.4
Interior Woodwork, simple trim and beaded baseboard in Basement

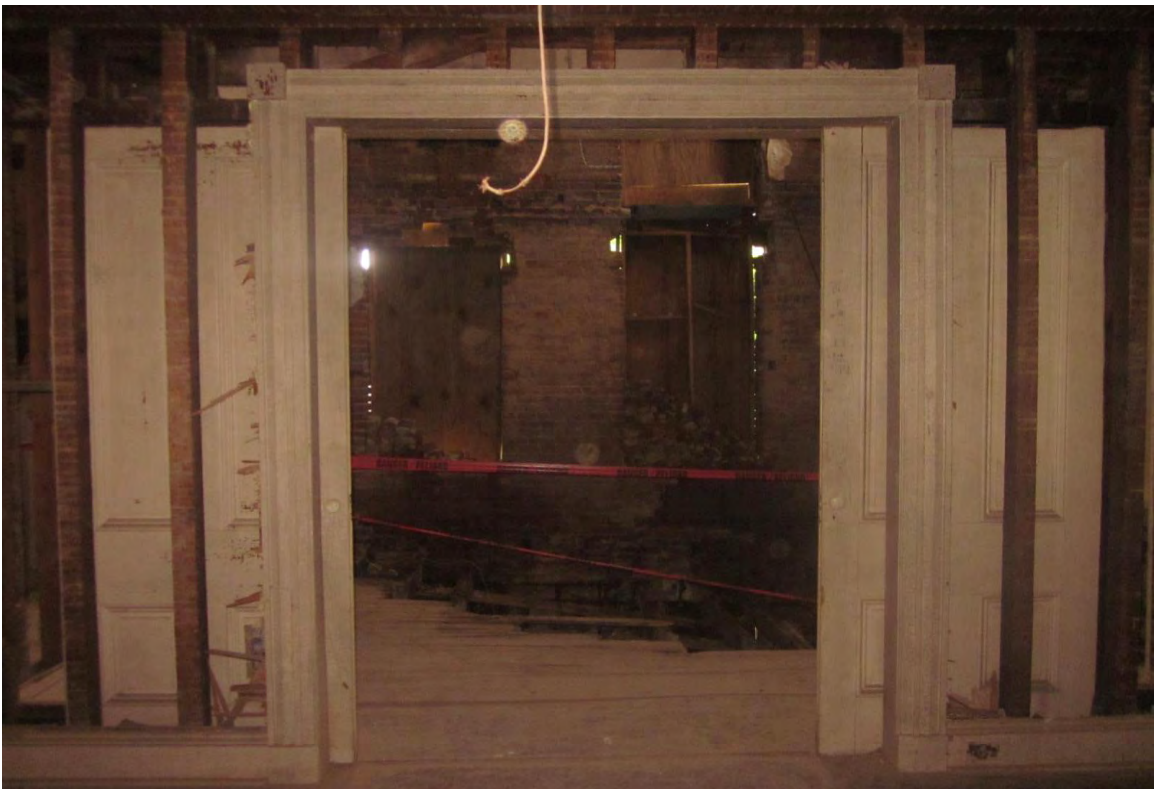
Photo 9.5
Interior Woodwork; Interior Doors, original pocket doors between Room 3 and Room 4 to remain

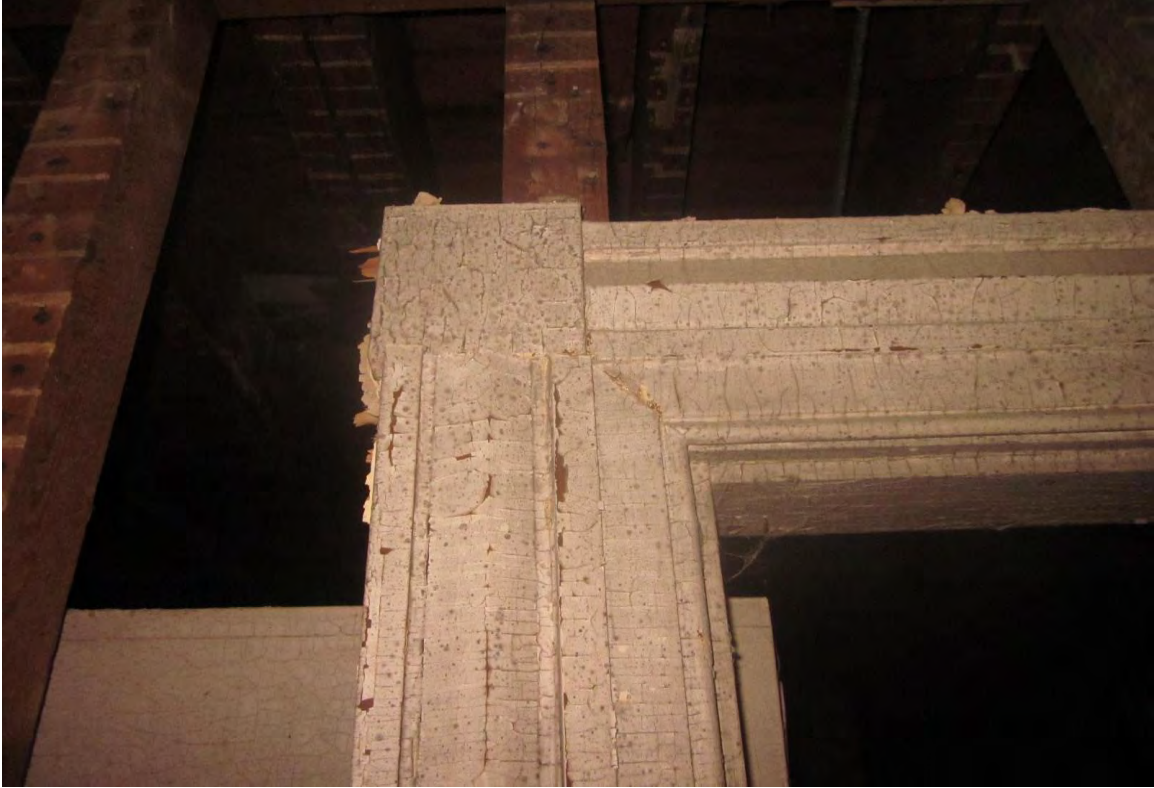
511 West Marshall Street, Richmond, VA
Part 2 Photos; DHR #2018-070; NPS Proj. # Not Yet Assigned
Photo 9.6
Interior Woodwork, Colonial trim with a simple corner block at 1st Floor

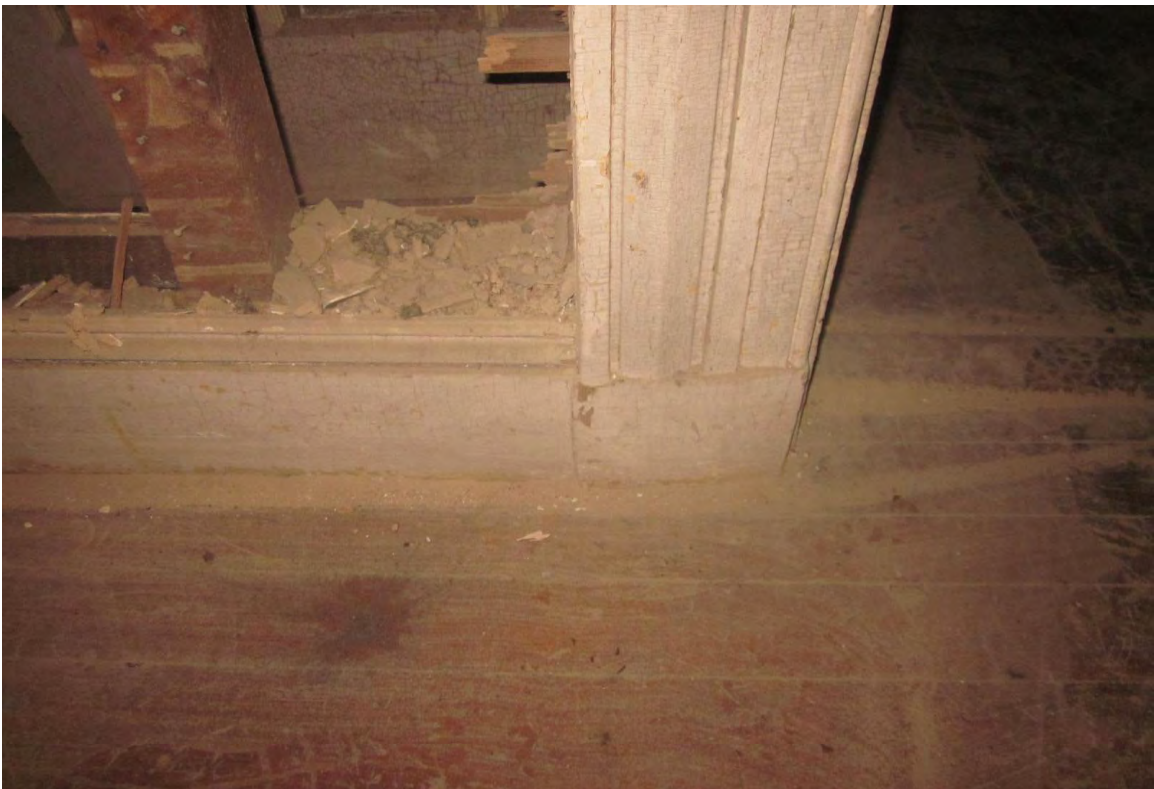
Photo 9.7
Interior Woodwork, plinth block and two member baseboard at 1st Floor

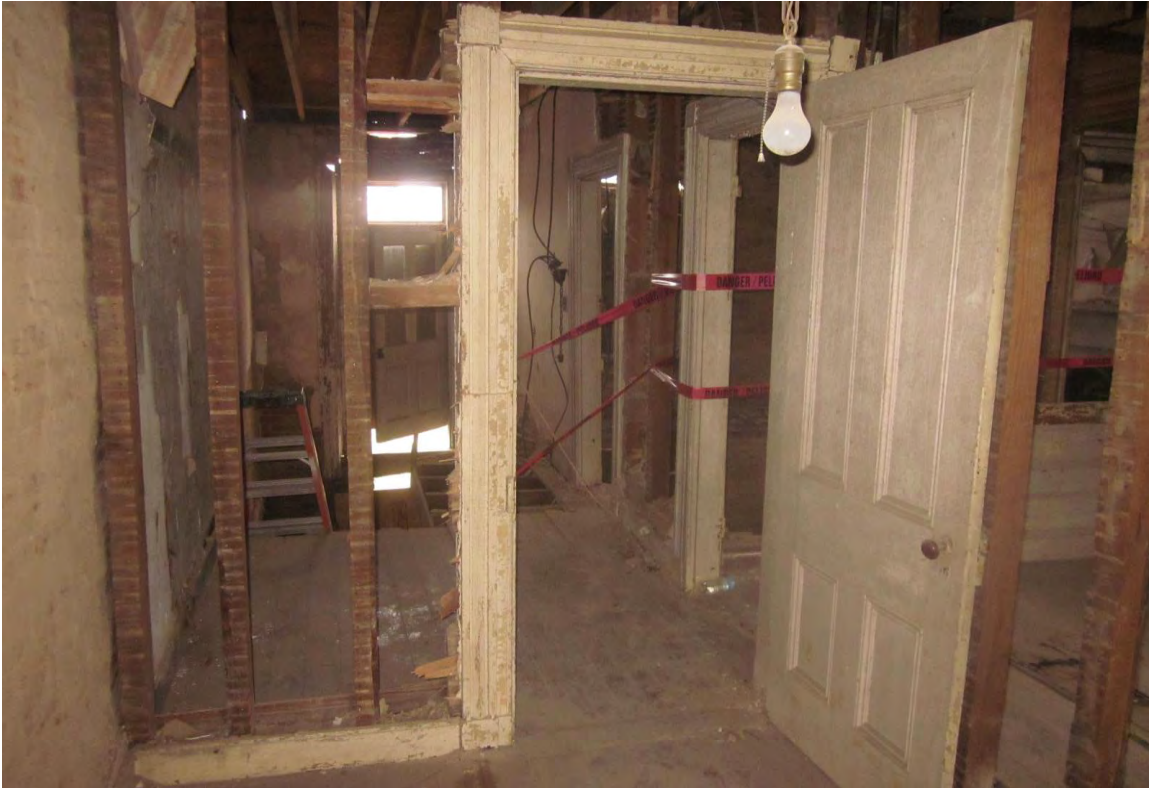
511 West Marshall Street, Richmond, VA
Part 2 Photos; DHR #2018-070; NPS Proj. # Not Yet Assigned
Photo 9.8
Interior Woodwork, Colonial trim with a simple corner block at 2nd Floor; Plan (Small Room)

New Closets in Second Floor Primary Space – Please hold the top of the new closets away from the ceiling, so that they can be clearly read as new features, and so that the full historic volume of the room can be understood. All new trim and doors for these modern doors and walls should be contemporary and compatible, and so should not seek to replicate the historic trim and doors found elsewhere in the structure.

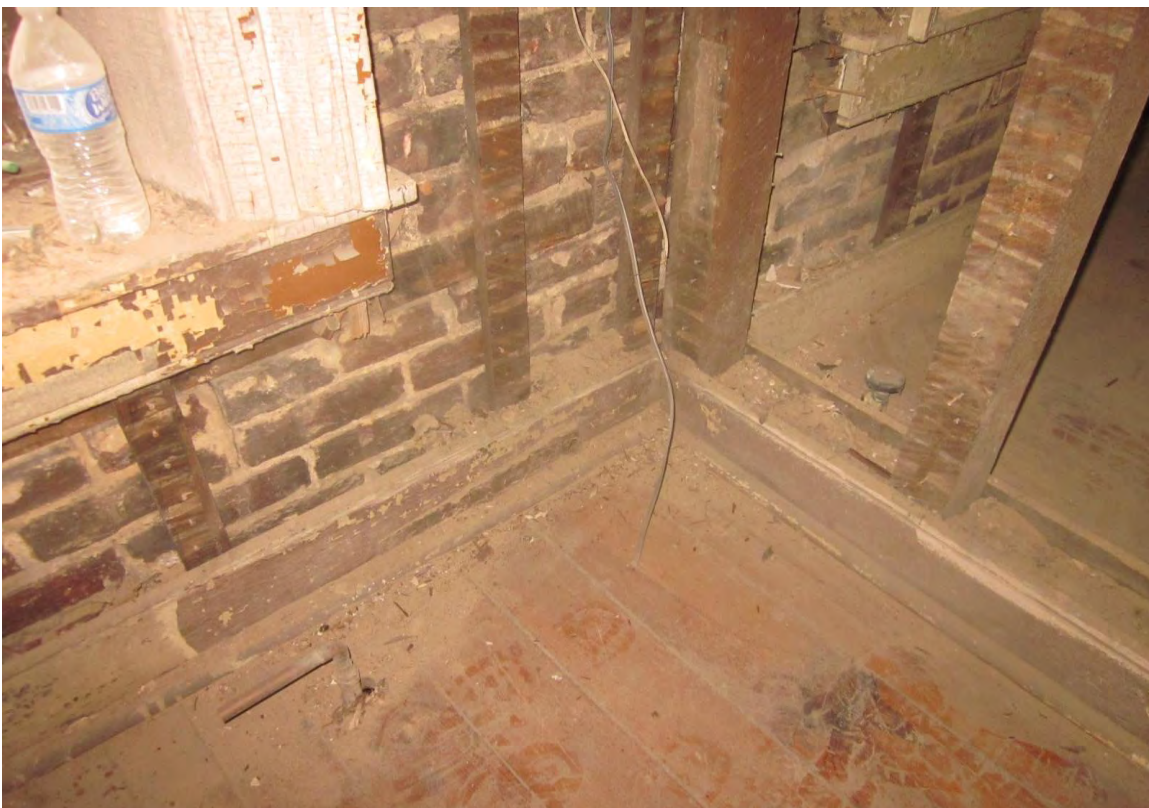
Photo 9.9
Interior Woodwork, beaded baseboard at 2nd Floor

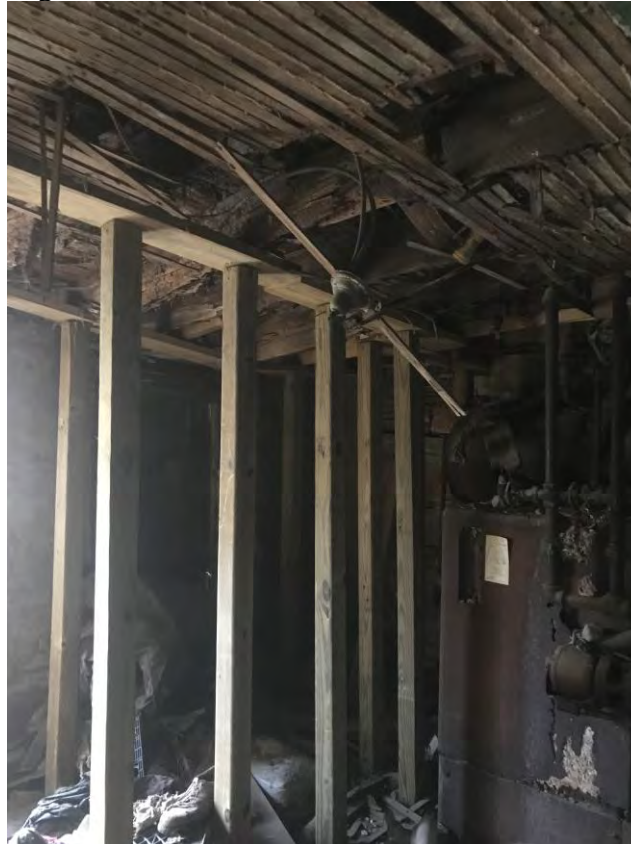
*PHOTOS IN THIS SECTION ARE BEFORE THE PROPERTY WAS CLEANED OF DEBRIS;
THEY ARE MEANT TO SHOW THE CONDITION OF THE UNSALVAGABLE PLASTER*

Photo 10.1, Wall and Ceiling Finishes; Plan (Basement, Room 2)

Item 10, Wall and Ceiling Finishes: Please provide additional information on the condition of the plaster prior to the beginning of the project or its removal. Photos indicate areas of extant plaster in a condition that could be retained and repaired.

Item 10, Walls and Ceiling Finishes: See AX5.0 for all wall, ceiling, and floor conditions with corresponding photos to illustrate the extent of existing plaster on walls and ceiling. Plaster is present in the basement and on the second floor, but all areas that do have plaster are quite compromised in their makeup and we respectfully request that all new wall and ceiling finishes be gypsum wall board.

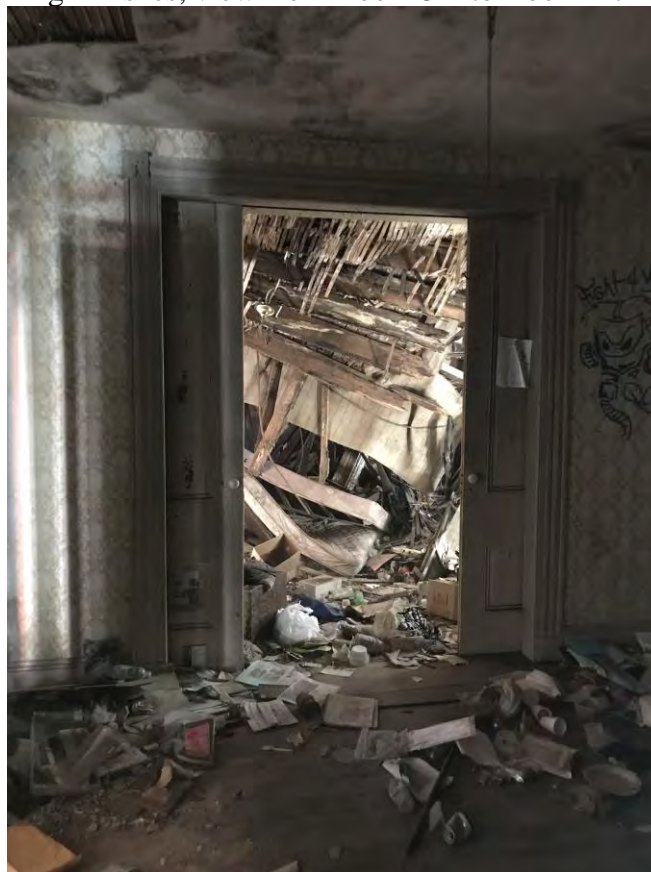
Photo 10.2, Wall and Ceiling Finishes, view from Room 3 into Room 4 through Pocket Doors

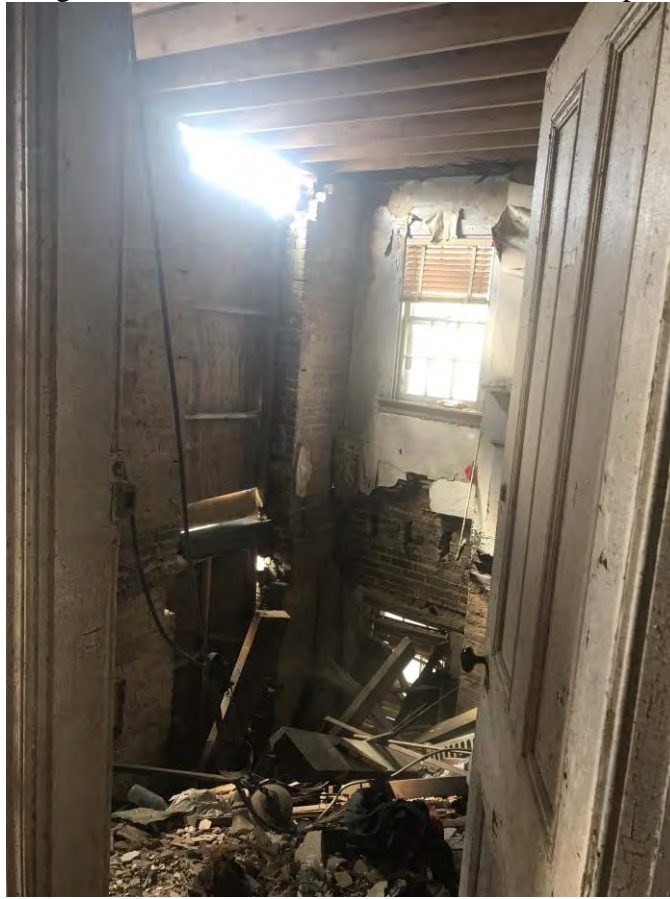
Photo 10.3, Wall and Ceiling Finishes; Hall view of boarded rear door opening at left in Room 6

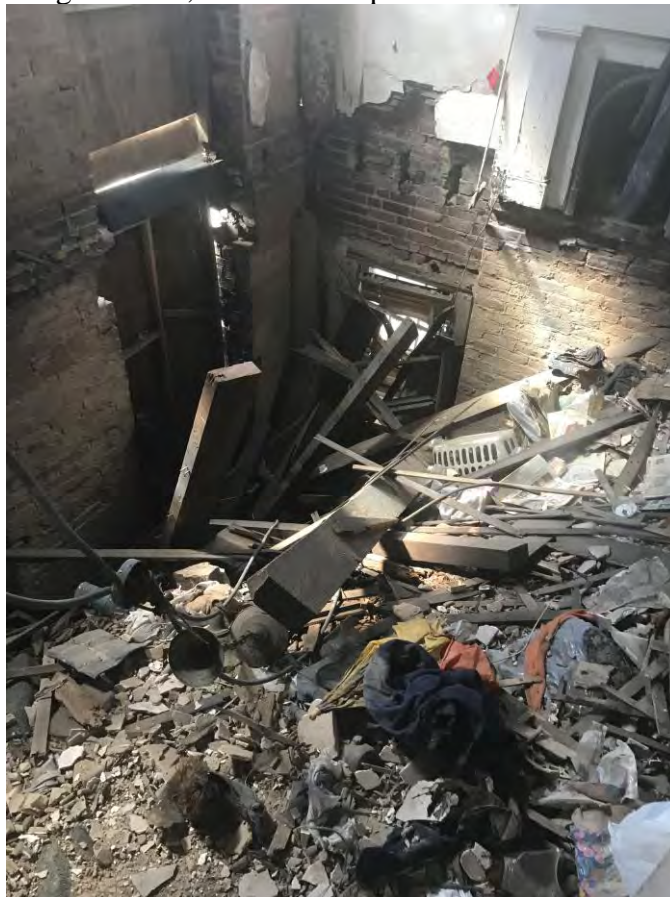
Photo 10.4, Wall and Ceiling Finishes, view of collapsed 2nd Floor down to collapsed 1st Floor

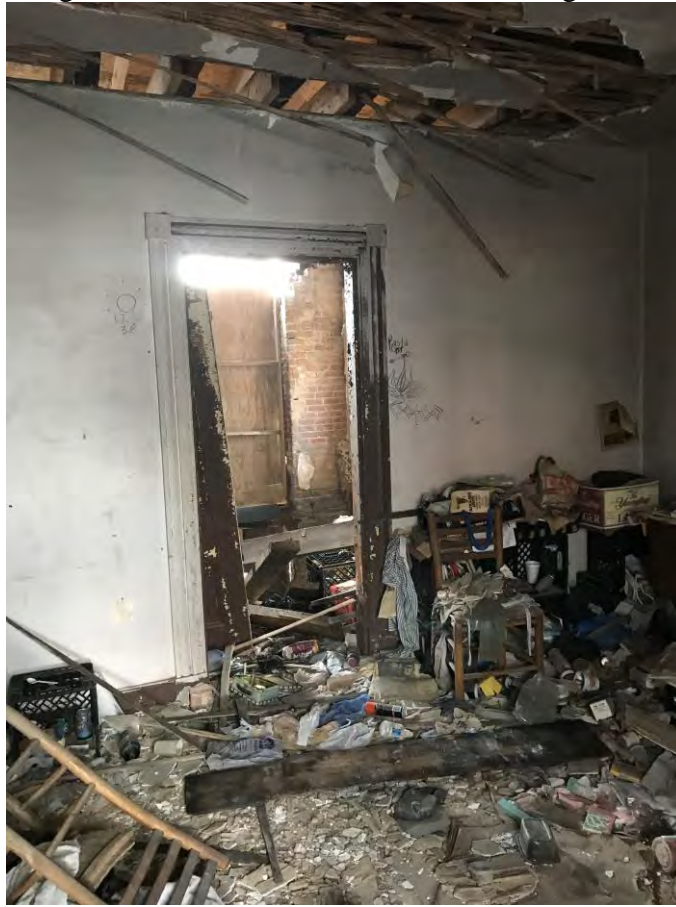
511 West Marshall Street, Richmond, VA
Part 2 Photos; DHR #2018-070; NPS Proj. # Not Yet Assigned
Photo 10.5, Wall and Ceiling Finishes; 2nd Floor, in Room 5 looking into Room 6

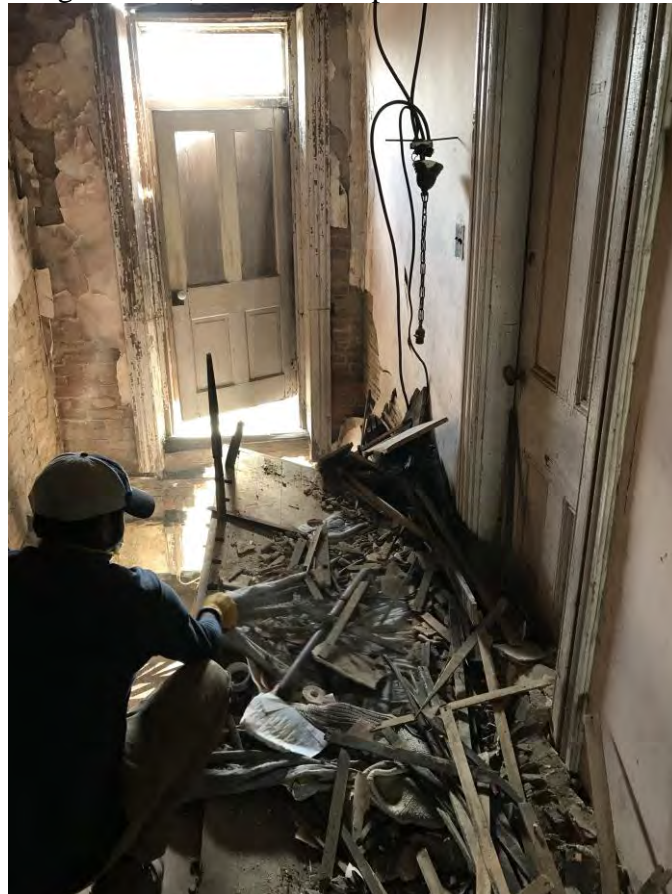
Photo 10.6, Wall and Ceiling Finishes, view of collapsed 2nd Floor at rear Hall entrance
