COMMISSION OF ARCHITECTURAL REVIEW

APPLICATION FOR CERTIFICATE OF APPROPRIATENESS

Address 511 W Marshall ST Richmond VA 23220
Historic district Jackson Ward

**HISTORIC PRESERVATION CERTIFICATION APPLICATION
PART 2 – DESCRIPTION OF REHABILITATION**

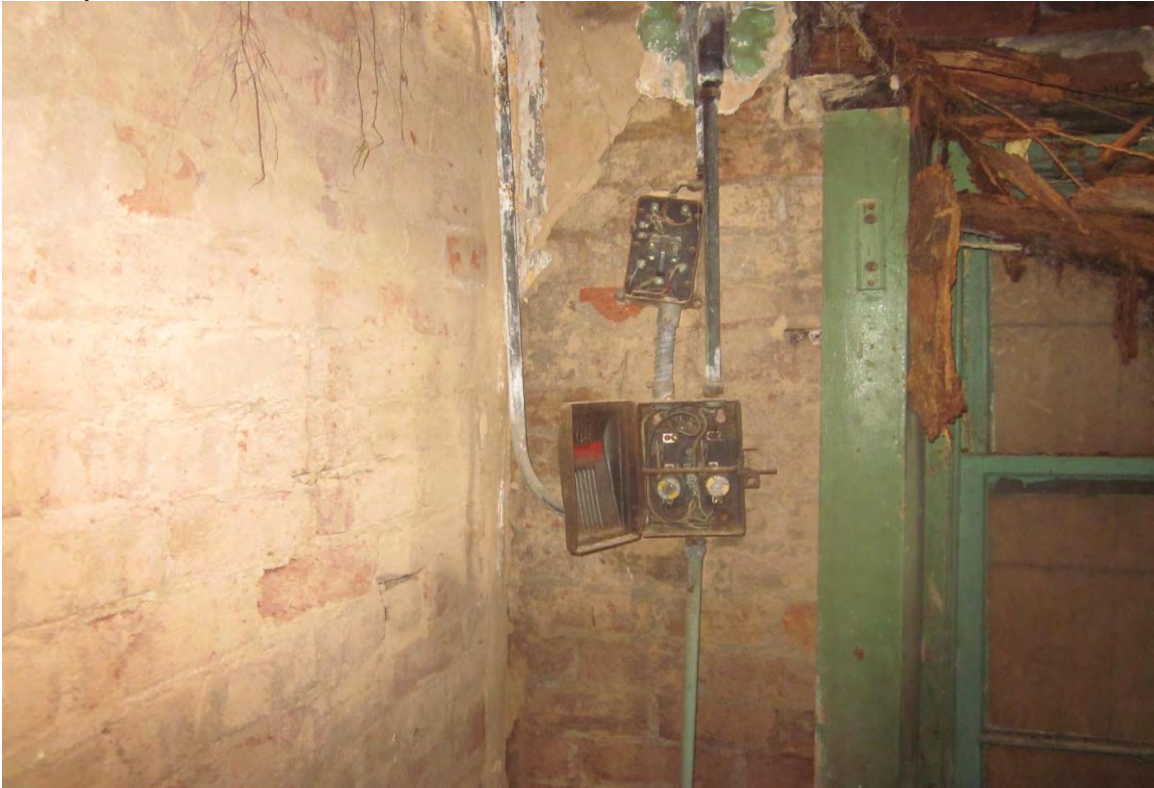
511 West Marshall Street, Richmond, VA
Part 2 Photos; DHR #2018-070; NPS Proj. # Not Yet Assigned
Photo 11.1
Electrical System, fuse box in Basement

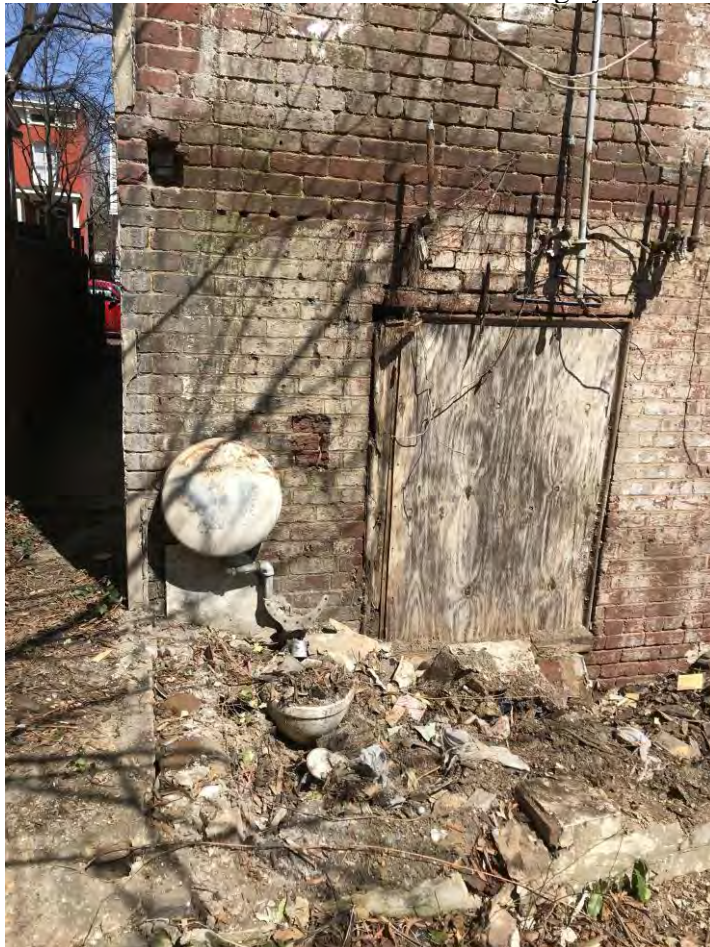
Photo 12.1
Plumbing System; toilet is outside underneath former stair/landing system to 1st and 2nd Floors

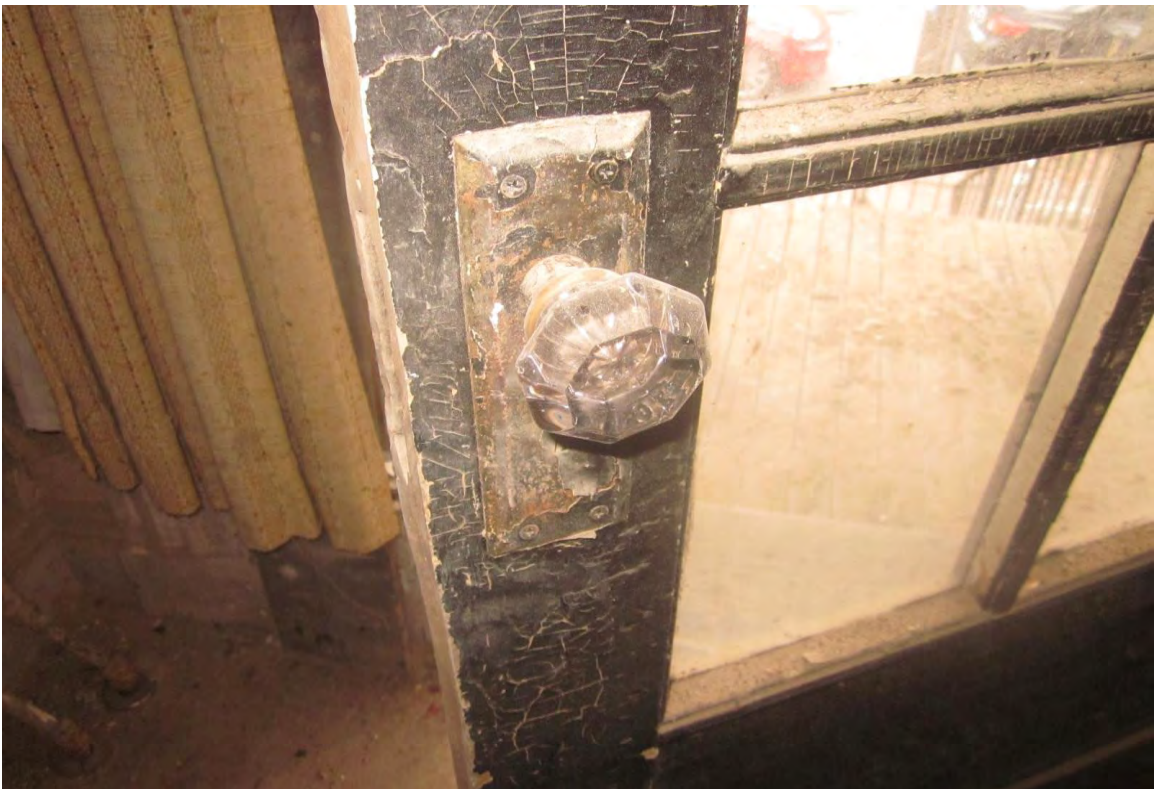
Photo 14.1
Hardware; Exterior Doors (1st Floor Front Door)

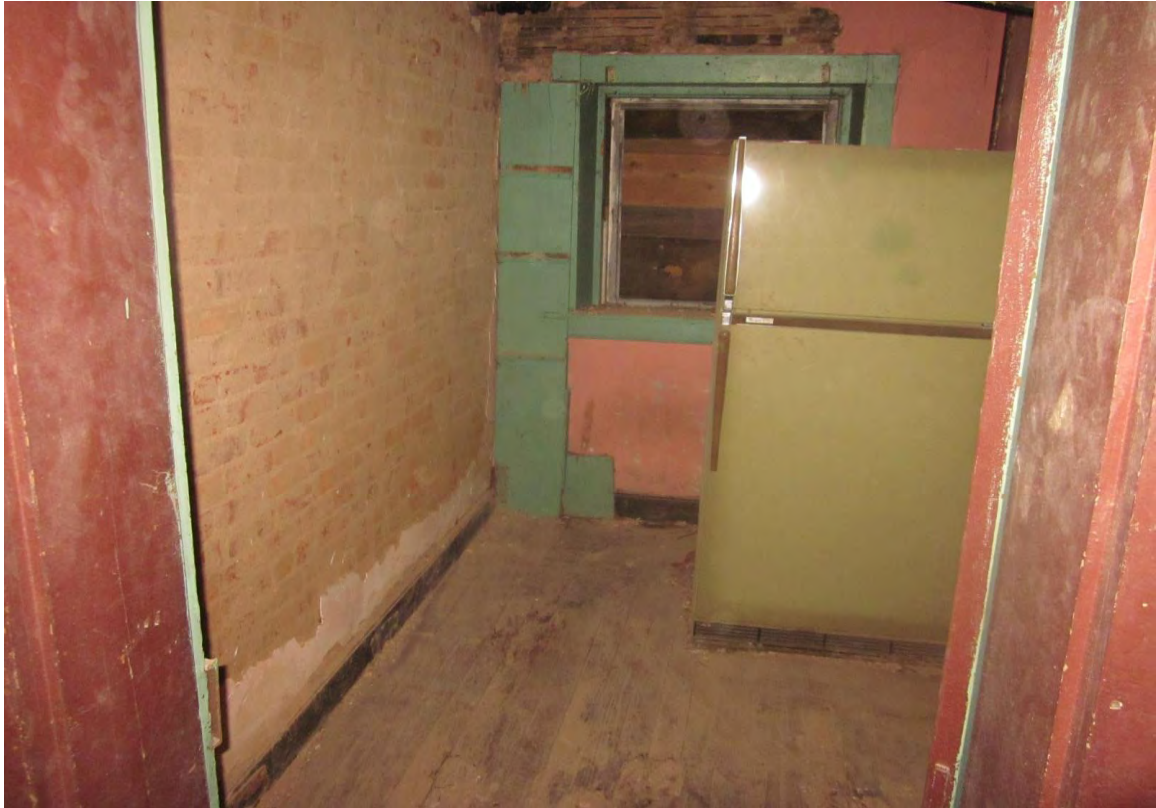
Photo 15.1

Typical Kitchen, Basement Room at Front Façade accessed via Hall; Windows; Floors

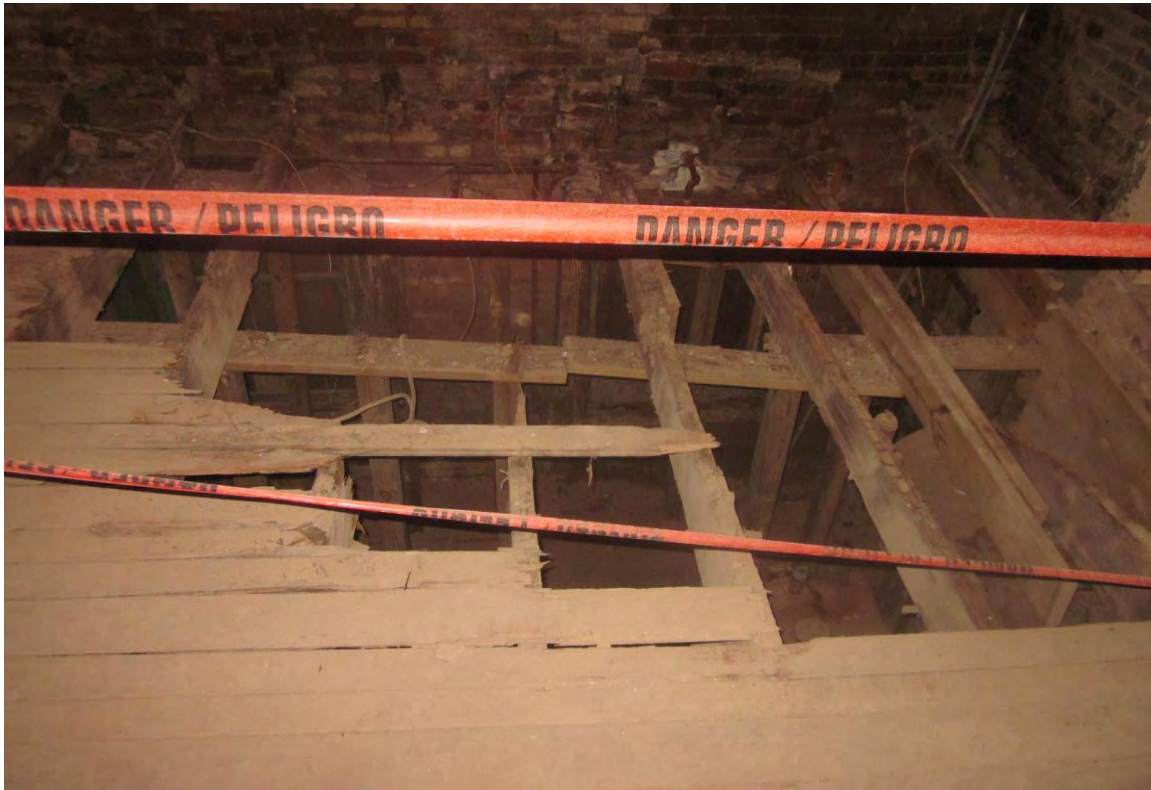
511 West Marshall Street, Richmond, VA
Part 2 Photos; DHR #2018-070; NPS Proj. # Not Yet Assigned
Photo 17.1
Floors, 1st Floor, Room 4

Item 17, Floors: Replacement of missing or deteriorated hardwood flooring throughout the building must match the historic flooring in width, direction, and color. Please provide additional information on and close-up photos of the existing wood flooring in the Basement.

Item 17, Floors: See AX5.0 for all wall, ceiling, and floor conditions with corresponding photos to illustrate the extent of existing condition of the floors. Wood flooring will be replaced to match existing type and widths in original structure.

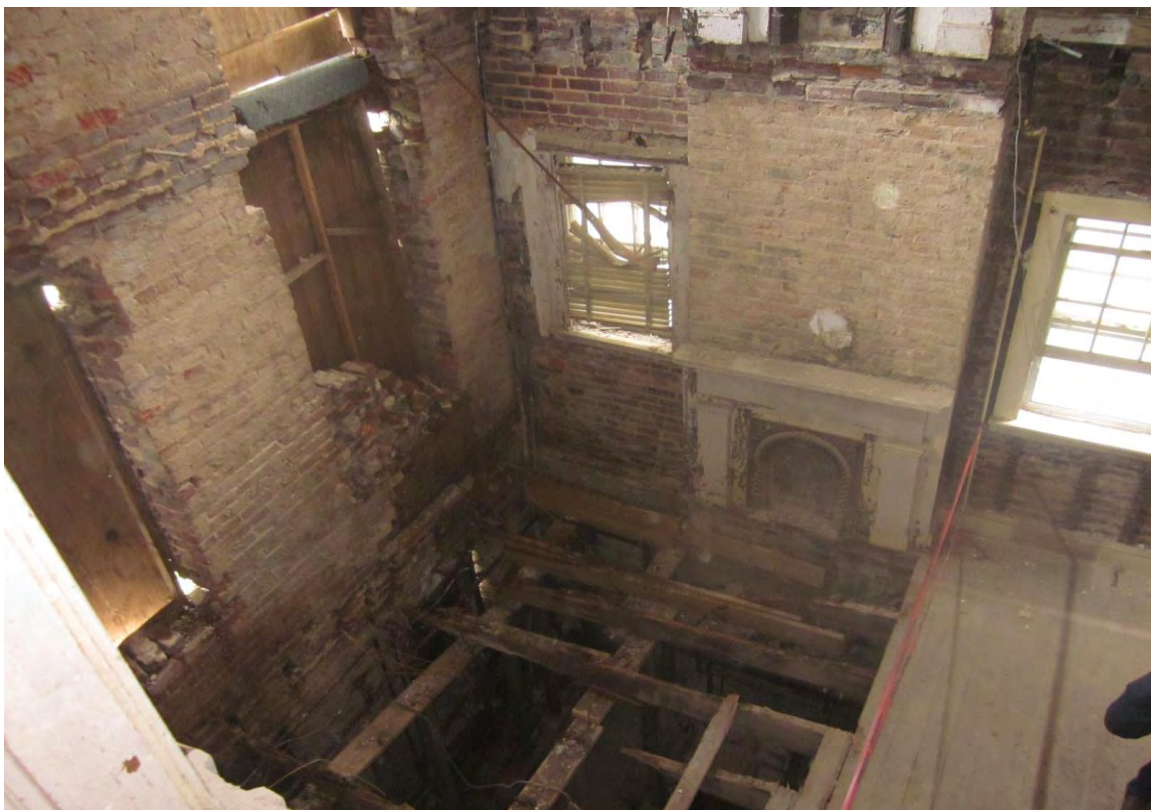
Photo 17.2
Floors, 2nd Floor, view from Hallway outside Room 6 on 2nd Floor down to floor at Room 4

NOTE:
REFINISH WOOD FLOORS, REPLACE DAMAGED
OR ROTTEN BOARDS WITH LIKE MATERIALS

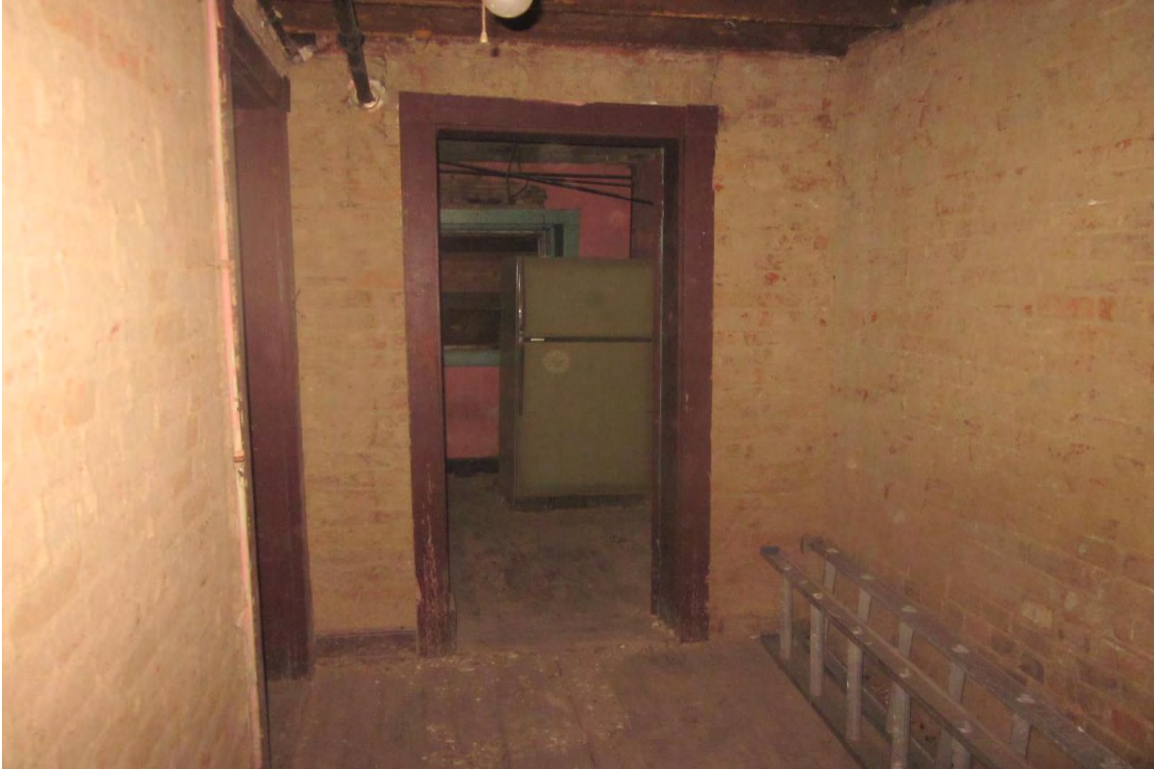
Photo 18.1

Basement, Hall with entrance to Room 1 at left (see Photo 9.3); Floors, wooden floor atop dirt in Basement Hall

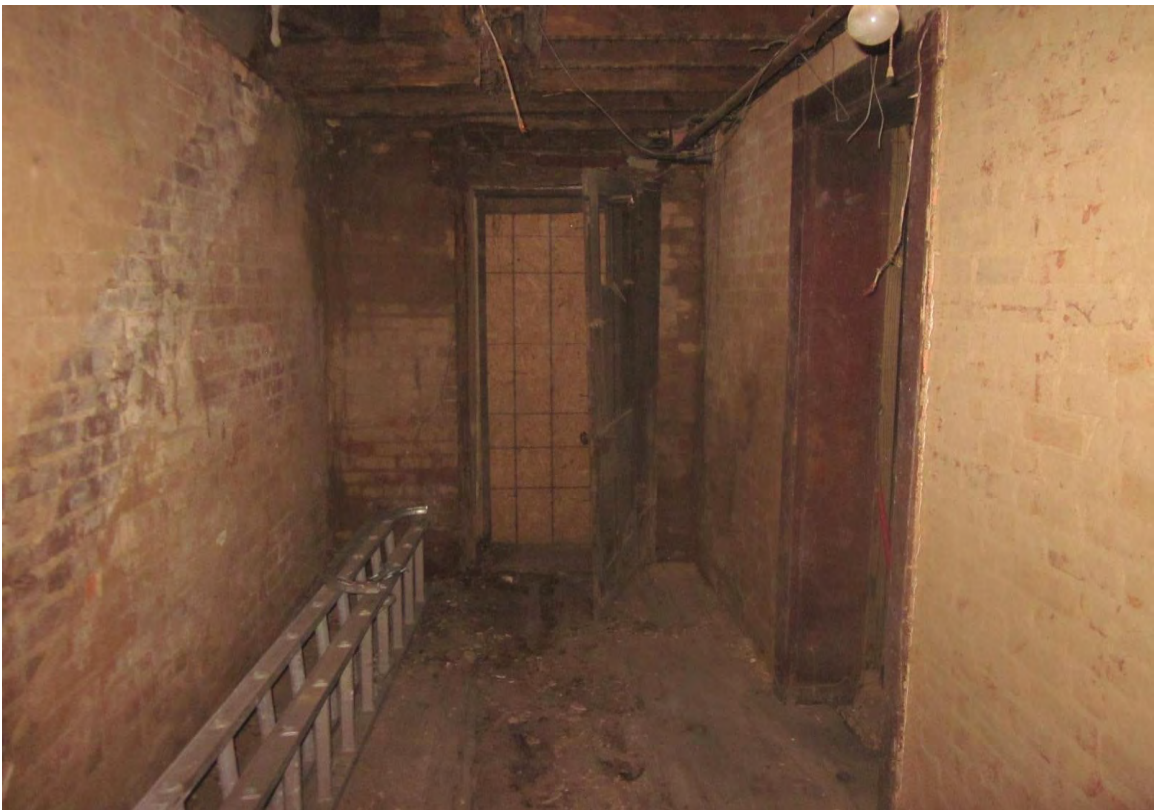
Photo 18.2

Basement, Hall with entrance to Room 2 at right, rear entrance at center; Wall and Ceiling Finishes

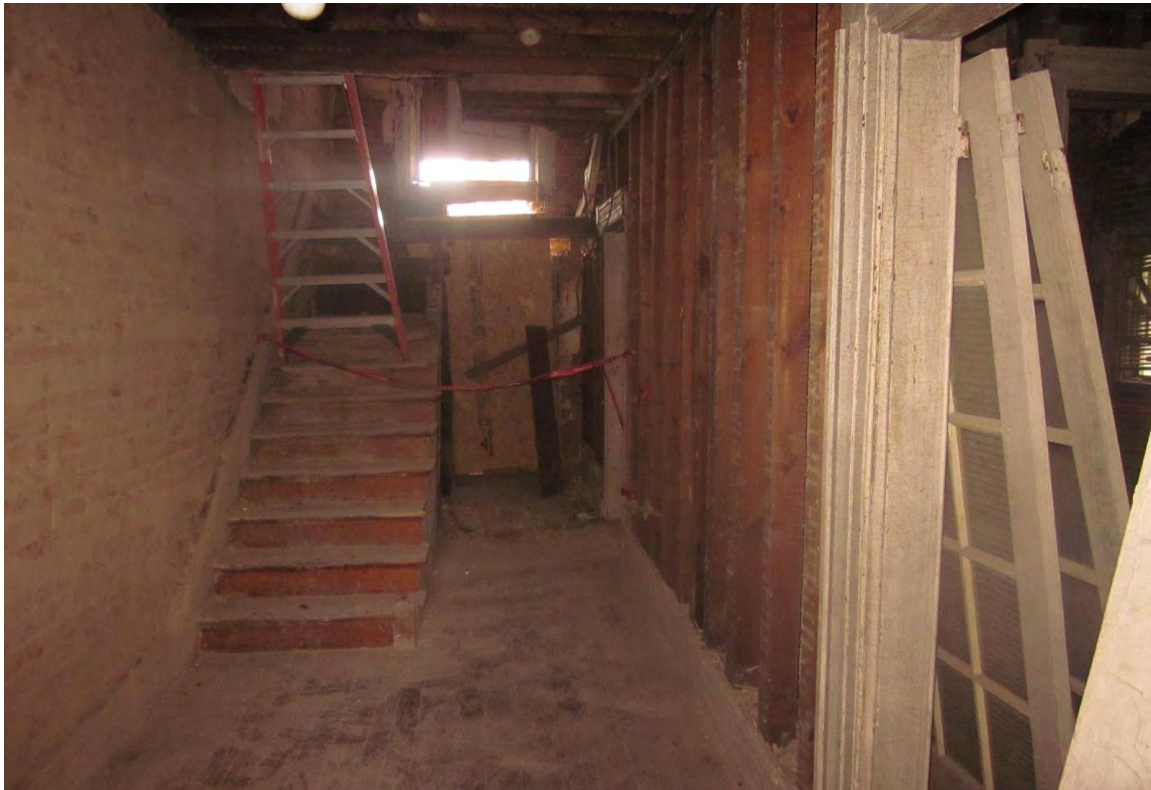
511 West Marshall Street, Richmond, VA
Part 2 Photos; DHR #2018-070; NPS Proj. # Not Yet Assigned
Photo 18.3
Hall at 1st Floor, Room 3 entrance at right

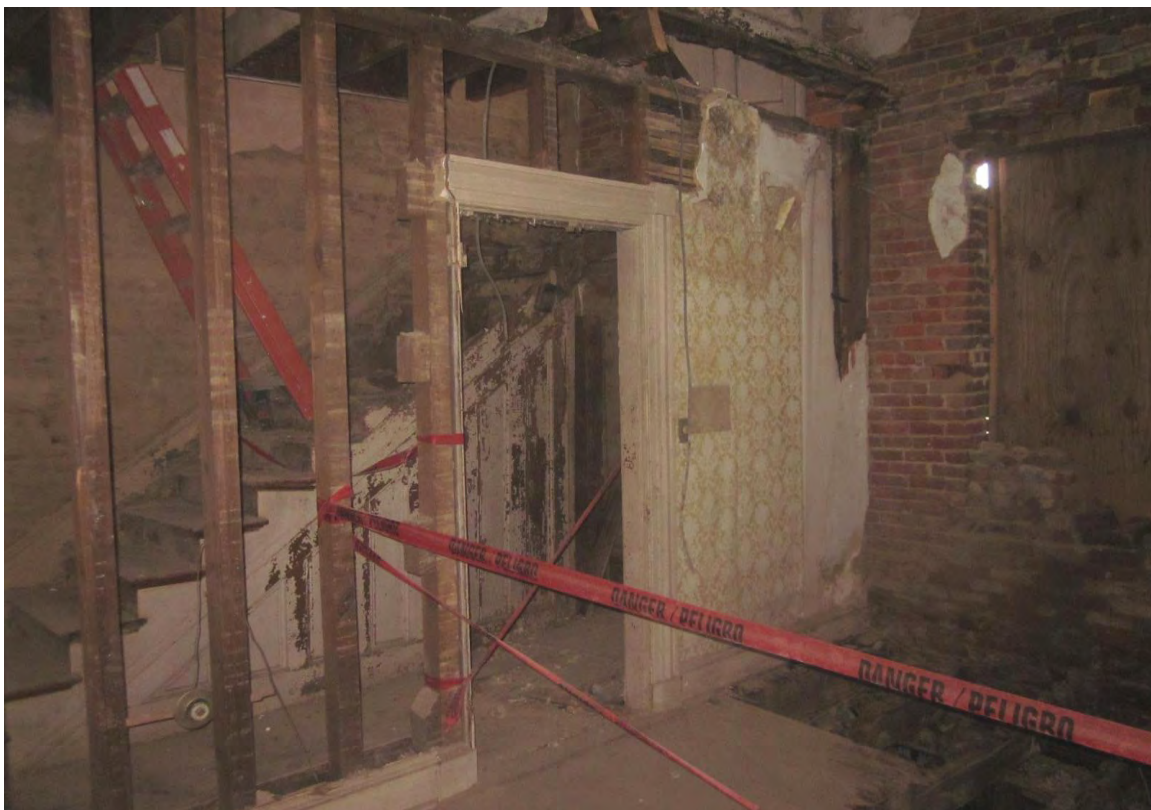
Photo 18.4
Room 2 entrance from Hall at left; Wall and Ceiling Finishes

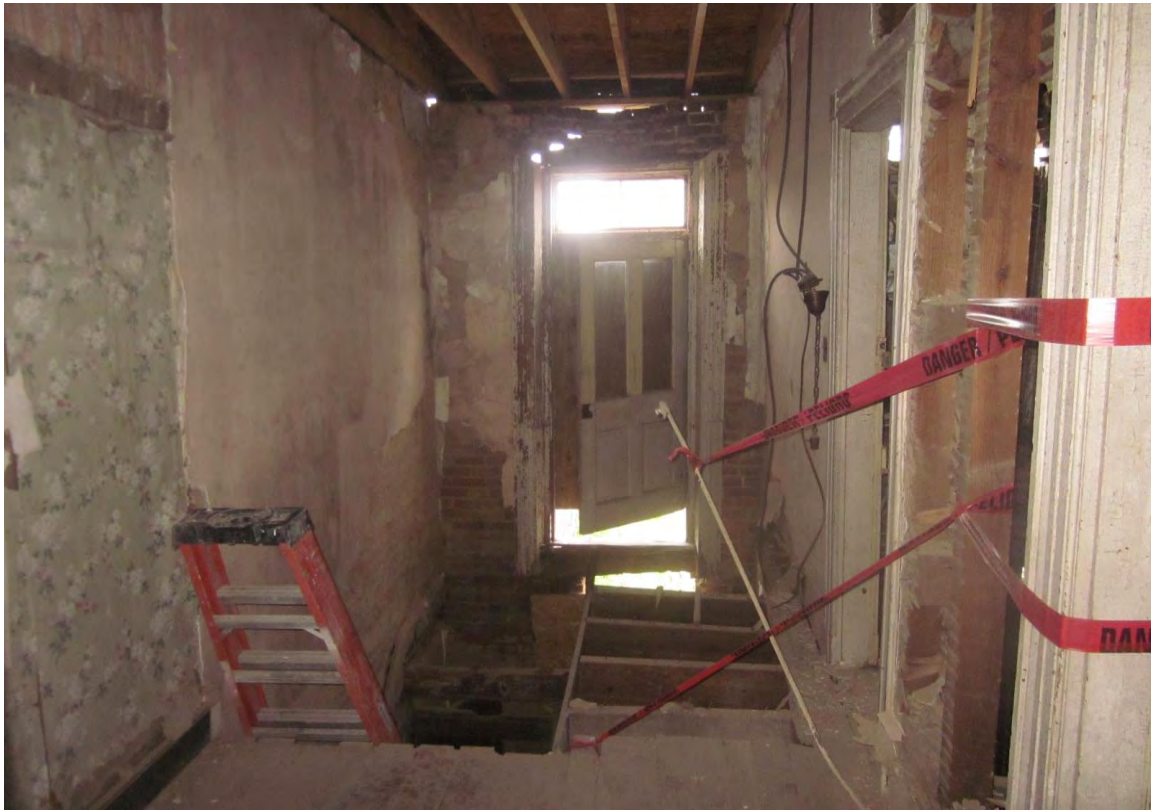
Photo 18.5

2nd Floor Hall; Room 5 at immediate right; rear Hall entrance at center; Room 6 entrance at far right

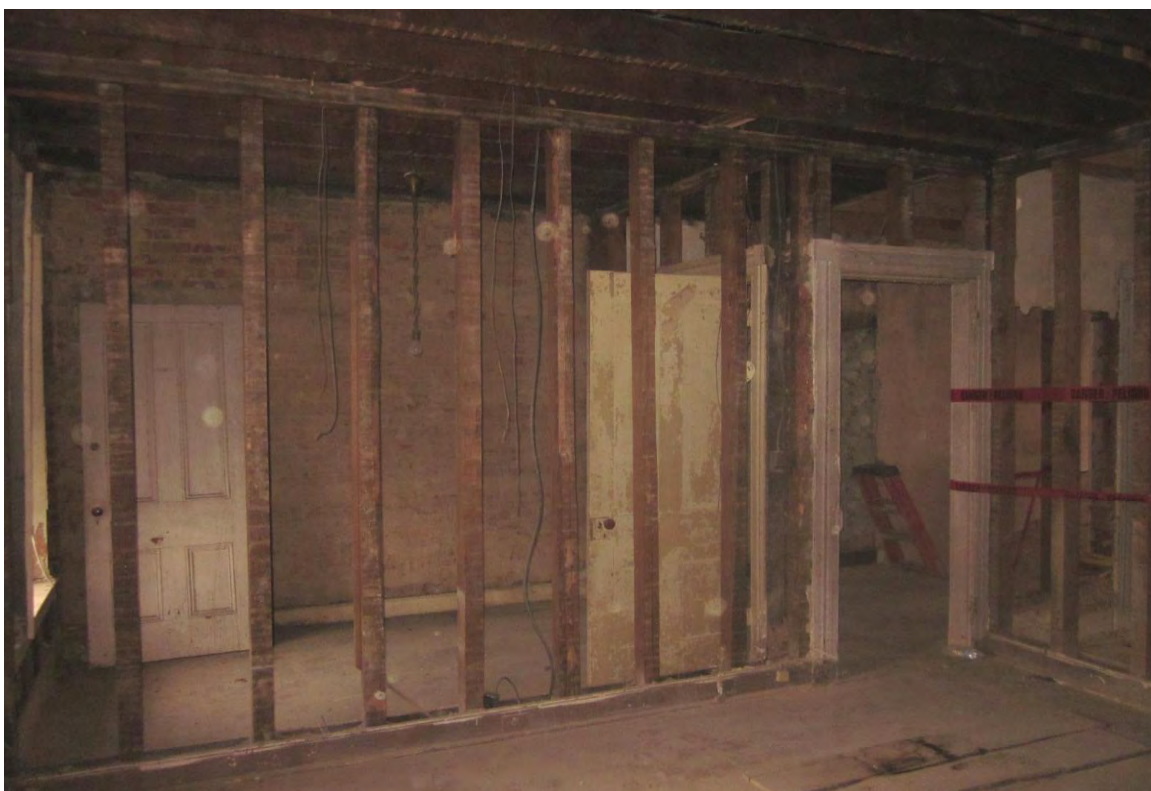
Photo 18.6

Room 5 entrance at right

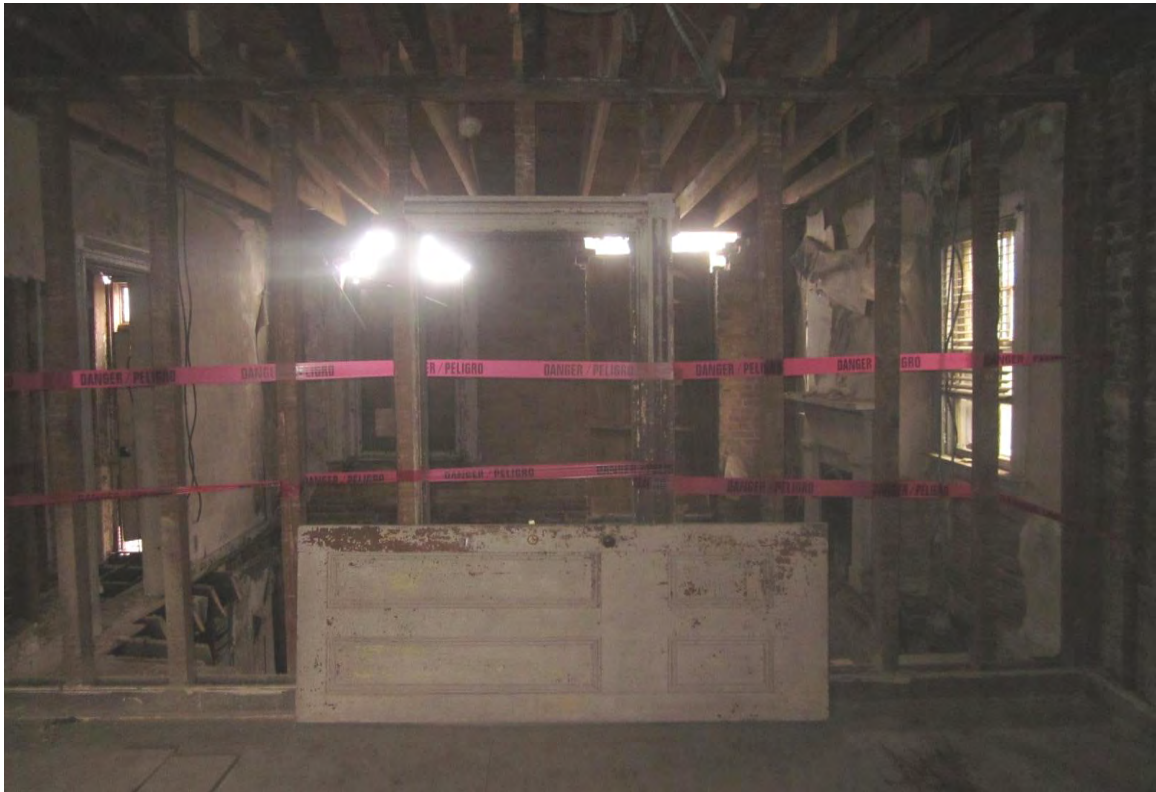
511 West Marshall Street, Richmond, VA
Part 2 Photos; DHR #2018-070; NPS Proj. # Not Yet Assigned
Photo 18.7
Room 5 with view toward Room 6; Interior Doors

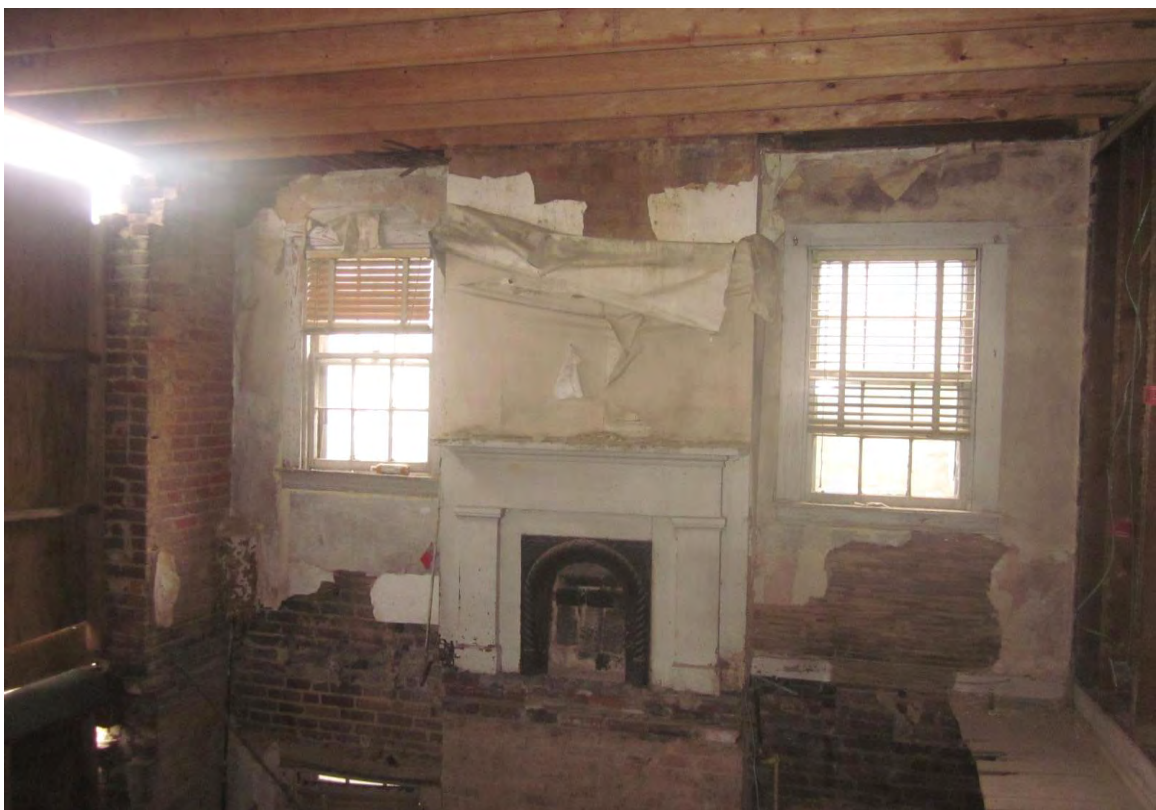
Photo 18.8
Room 6, view from Hall; Heating and Cooling

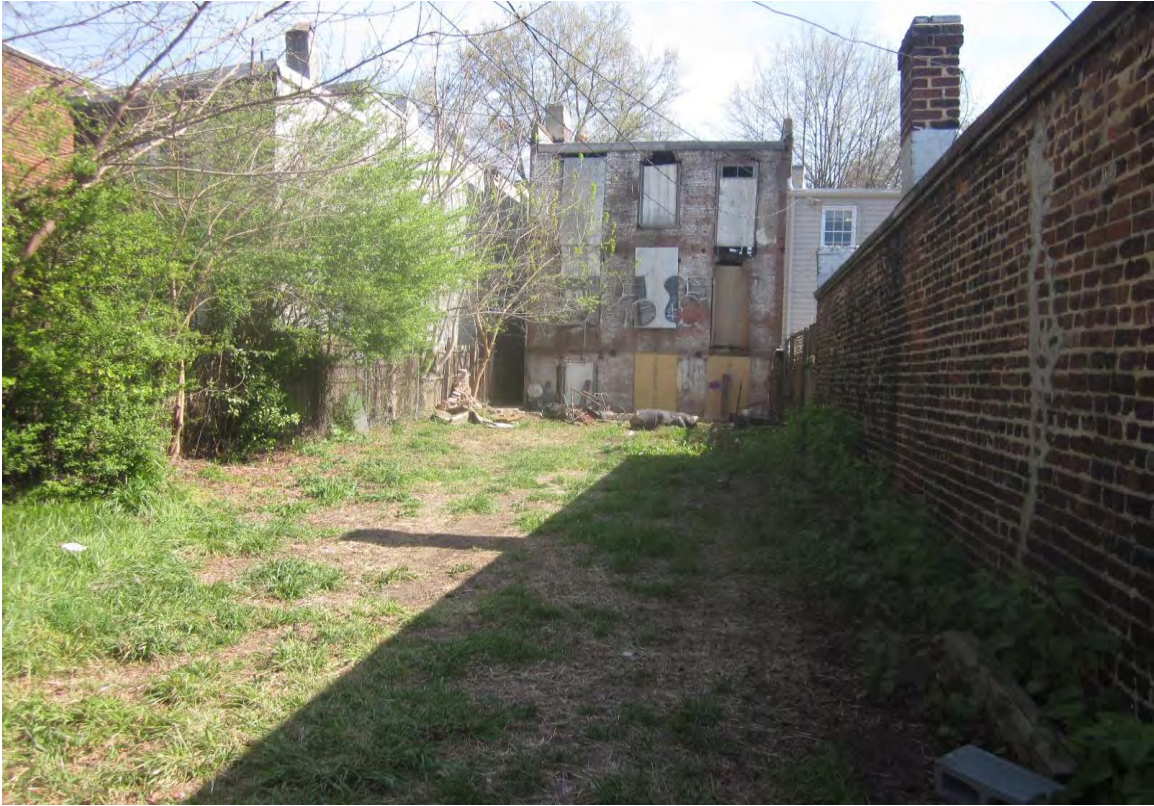
511 West Marshall Street, Richmond, VA
Part 2 Photos; DHR #2018-070; NPS Proj. # Not Yet Assigned
Photo 19.1
Site (rear, view from alley)

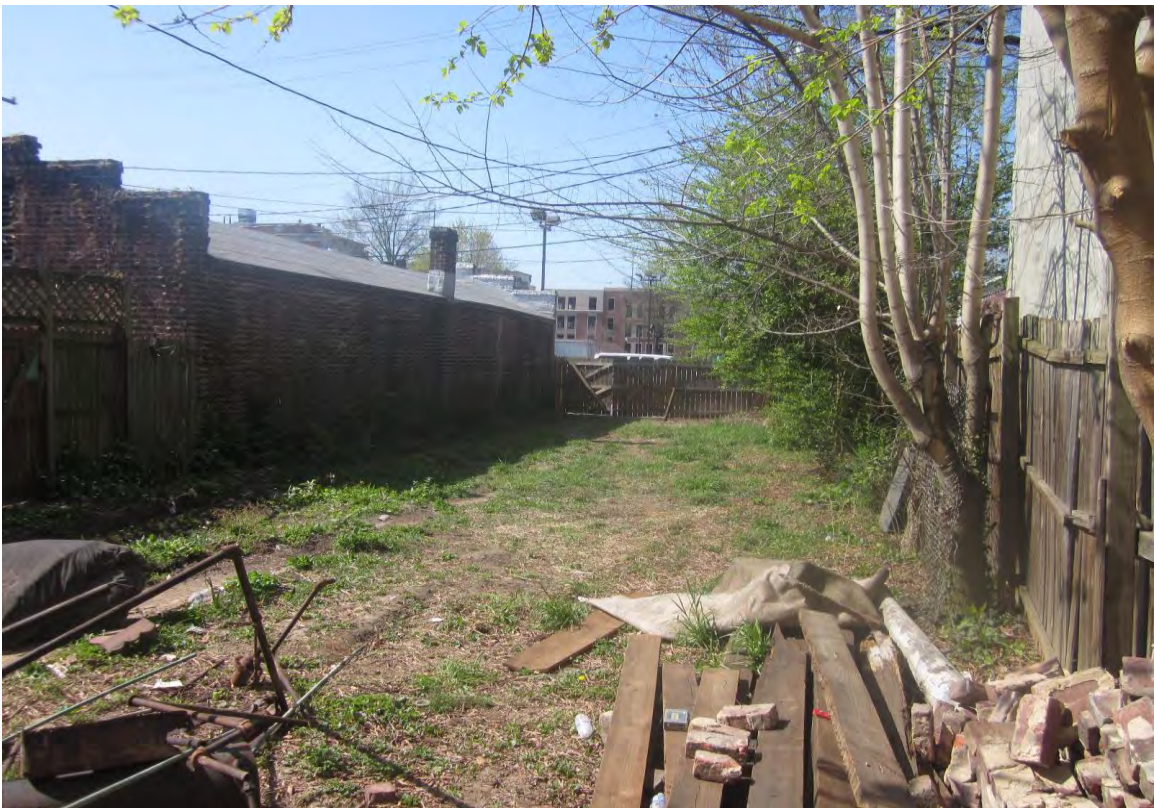
Photo 19.2
Site (rear, view to alley), area of proposed parking; garages belong to neighboring property Owner
