Staff Report
City of Richmond, Virginia

Commission of Architectural Review

4. COA-126435-2023	Final Review	Meeting Date: 3/28/2023
Applicant/Petitioner	Walid Daniel	
Project Description	Replace barrel tile with asphalt shingles.	
Project Location		
Address: 905 N. Belmont Avenue		
Historic District: Monument Avenue		
<p>High-Level Details: Applicant proposes to replace barrel tile with asphalt shingles.</p> <p>This work has been completed without the issuance of a COA. This application is the result of a Notice of Violation issued on December 20, 2022.</p> <p>Applicant has submitted a quote to install Brava synthetic barrel tile.</p>		
Staff Recommendation	Partial Approval	
Staff Contact	Alex Dandridge, alex.dandridge@rva.gov , (804) 646-6569	
Previous Reviews	None.	
Conditions for Approval	<p><i>Staff recommends denial of:</i></p> <ul style="list-style-type: none"> The installation of asphalt shingles. <p><i>Staff recommends approval of:</i></p> <ul style="list-style-type: none"> The installation of Brava Synthetic Barrel Tile.

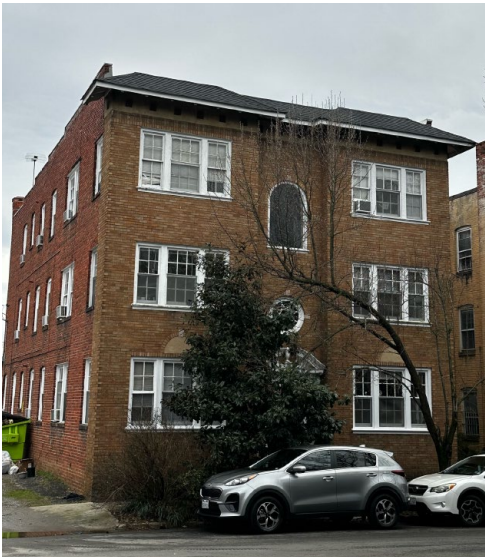
Figure 3. Existing roof condition, asphalt shingles

inappropriate material for this historic building as noted in the <i>Guidelines</i> . <u>Staff recommends the denial of the use of asphalt shingles on the pitched, visible portion of the roof on the front façade.</u>
Building Elements, p. 66, #3	<i>Substitute materials may be used if the same kind of material is not technically feasible because the material is no longer being made. Substitute materials should match the original style and form as much as possible.</i>	Based on the city of Richmond's assessor's office, the original roof material of the building is metal/tin on the flat portion, and barrel tile on the visible pitched portion on the front façade facing N. Belmont Avenue. Barrel tile is an available product still being produced, and qualified craftsman are available.
Substitute Materials, p. 60-61, #1, #2, #3	<p><i>When and where to use substitute materials is a decision to be reached only after careful consideration for the consequences to an historic structure and not before more appropriate preservation options have been explored. As with other proposed exterior changes, the use of substitute materials within a designated Old and Historic District is subject to Commission review.</i></p> <p><i>#1. Unavailability of Historic Materials. ...If that source cannot produce an appropriate match, substitute materials such as dry-tamp cast stone or textured pre-cast concrete may be appropriate alternatives as long as the detail, color and texture of the original stone are matched as closely as possible.</i></p>	<p>All preservation options should be explored thoroughly before substitute materials are used. The use of substitute material may be appropriate in the following circumstances: 1. The unavailability of historic material, 2. unavailability of skilled craftsman, and 3. replacement of poor-quality materials. Barrel tile is an available historic material, and installers exist in the Richmond, Virginia area. The appropriate procedure for the employment of substitute materials was not followed for this property.</p> <p>Given that the portion of roof that featured barrel tile is a limited area of the overall front facade of the building, and that it is relatively "high-up" and can only be viewed from certain angles, Staff would support the installation of a synthetic material that closely resembles the original material in appearance, as it may not be discernable from authentic barrel tile in this location.</p> <p>The applicant is proposing Brava synthetic Barrel tile. <u>Staff finds that this material is similar in dimension and design to the original material and recommends its approval.</u></p>

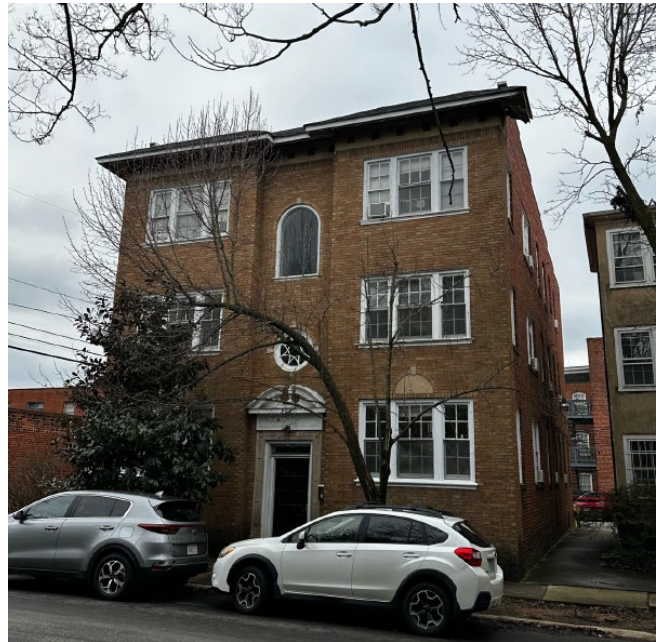
Figure 4. Existing roof condition, asphalt shingles
