Commission of Architectural Review SUBMISSION APPLICATION

HISTORIC PRESERVATION CERTIFICATION APPLICATION PART 2 – DESCRIPTION OF REHABILITATION

802 N 25TH STREET

HISTORIC PRESERVATION PROJECT FOR 802 N 25TH STREET

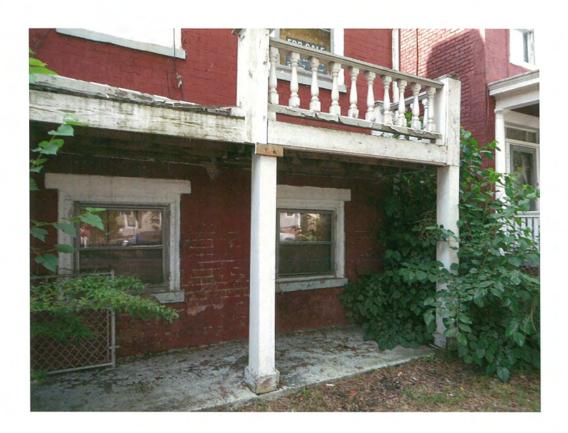
SIMILARLY ENCLOSED BACK PORCH (801 N. 24TH ST)

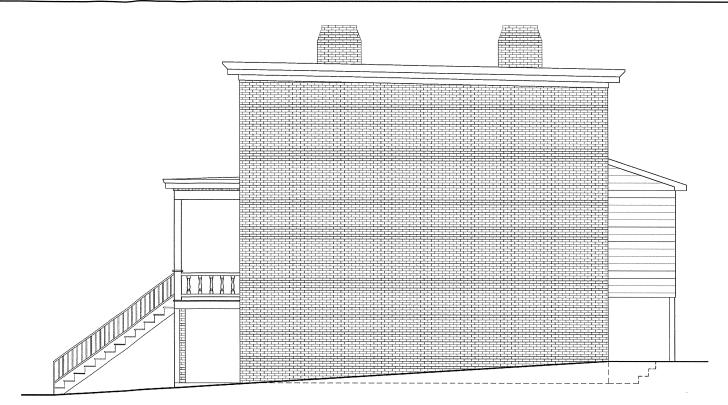
EXISTING
REAR ELEVATION
SCALE: 1/4"=1"-0"

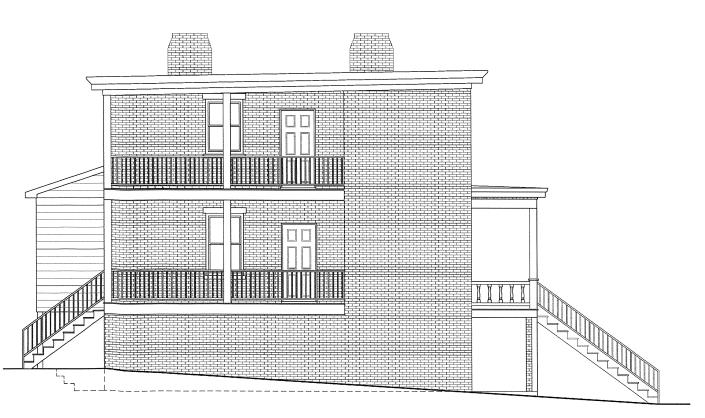
EXISTING
LEFT ELEVATION
SCALE: 1/4"=1'-0"

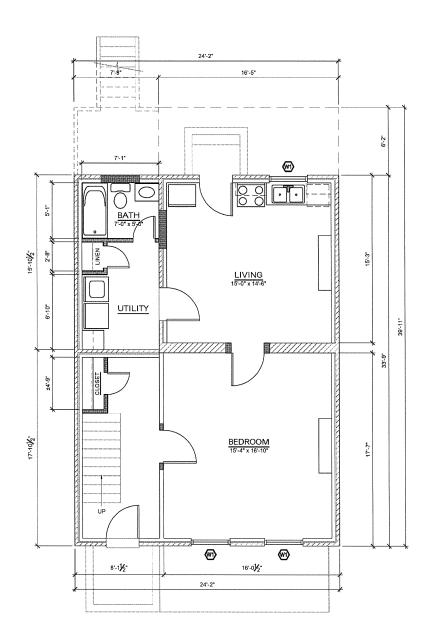
PROPOSED BASEMENT FLOOR PLAN SCALE: 1/4"=1'-0"

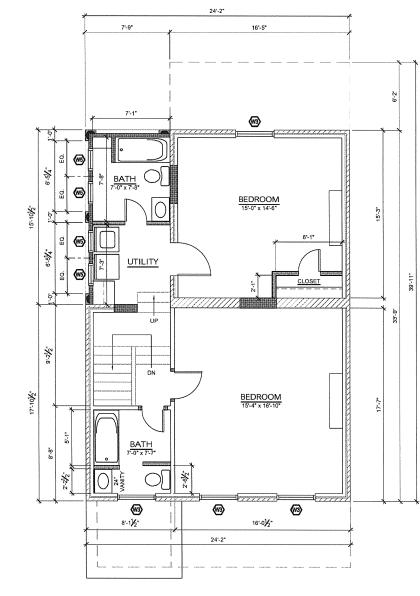
PROPOSED SECOND FLOOR PLAN SCALE: 1/4"=1'-0"
